**California Institute of Technology
Massachusetts Institute of Technology**

DCN No. E021115-00-C

Document Change Notice (DCN)

DOCUMENT No. (DOC-REV-GP.ID)	TITLE	NEW REV
D000347 -B	Gain Slider Problem Fix	B1
D990694 -00		A1
D000086 -02		A3

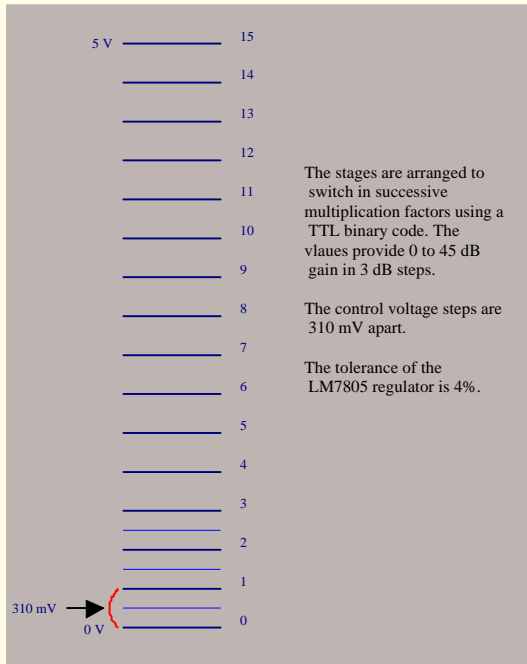
Title		
Voltage regulation for the Gain Sliders		
Size	Number	Revision
A		
Date:	11-Dec-2002	Sheet of
File:	D:\MyFiles\fixes\regulator1.Sch	Drawn By:

REASON FOR CHANGE: Gain value changes were occurring due to improper voltage reference for the ADCs.

- (1). Cut the trace on connector P1 pins 9B and 10B
- (2). Connect U_add1 regulator pin1 and the one side of the C_add1(1uF) capacitor to the test point TP26
- (3). Connect U_add1 regulator pin3 and the one side of the C_add2 (1uF) capacitor to the test point TP29
- (4). Connect U_add1 regulator pin2 to the ground.
- (5). After the changes on the board mark the front panel as Rev B1.
