# LASER INTERFEROMETER GRAVITATIONAL WAVE OBSERVATORY

Document Type <b>Technical Note</b>	<b>DCC Number</b> <b>LIGO-t-10112-00-R</b>	Date 5 <sup>th</sup> of October 2001
<b>The GAS blade creep measurements, problems and some solutions.</b>		
Lia Stellacci, Alessandro Bertolini, Riccardo DeSalvo, Francesco Fidecaro, Charlotte Py, Virginio Sannibale

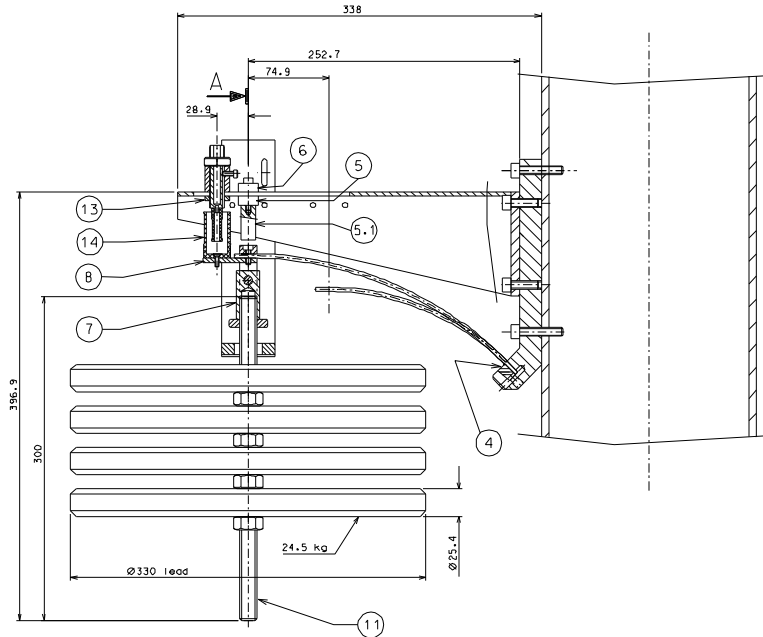
Blades have been fastened to a central pole (totem) and loaded with weights.

The drooping produced by creep is readout by LVDT position sensors (13 and 14 in the figure below).

The experiment is made in a thermally stabilized room with less than  $\pm 50 \text{ m}^\circ\text{K}$  temperature fluctuations.

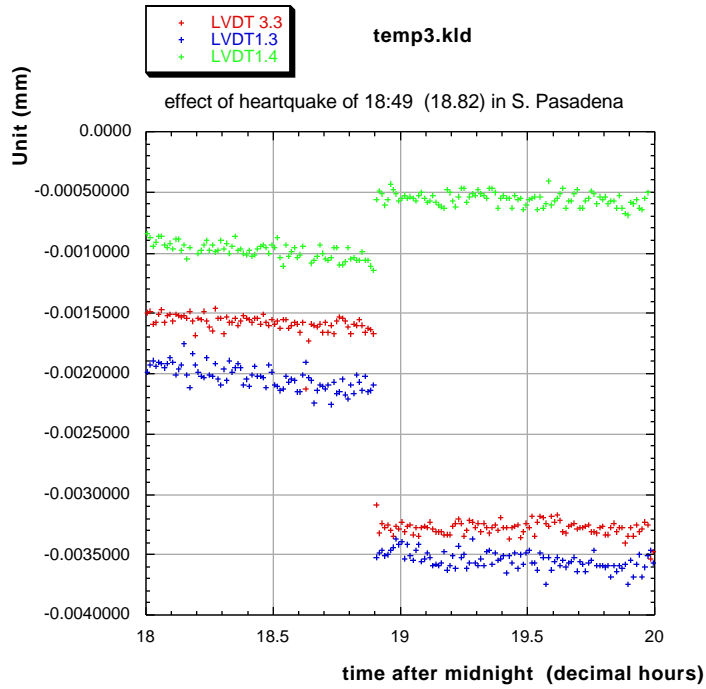
The earthquake produced large LVDT reading changes, on some blades

The only possible explanation being that the verticality of the center column of the totem was tilted on one side by about  $150 \mu\text{radians}$ . If this tilt happens the blades on one side will raise while the blades on the other side will lower and the blades in front and back will not be (or be little) affected by the tilt. Each blade will respond with a step proportional to the amplitude of the tilt in its longitudinal direction, times its integrated elongation from its at rest position to its loaded position. Of course no earthquake effect is visible on a witness LVDT.

One only solution we could figure out, apart to relocate the experiment, is to simply suspend the totem pole from its top with the aid of a wire.

Then the totem will hang down and supposedly find its verticality. Of course it will be useful to mount identical blades in opposite positions to both balance the totem pole and allow filtering of the differential mode of the residual variations of verticality.

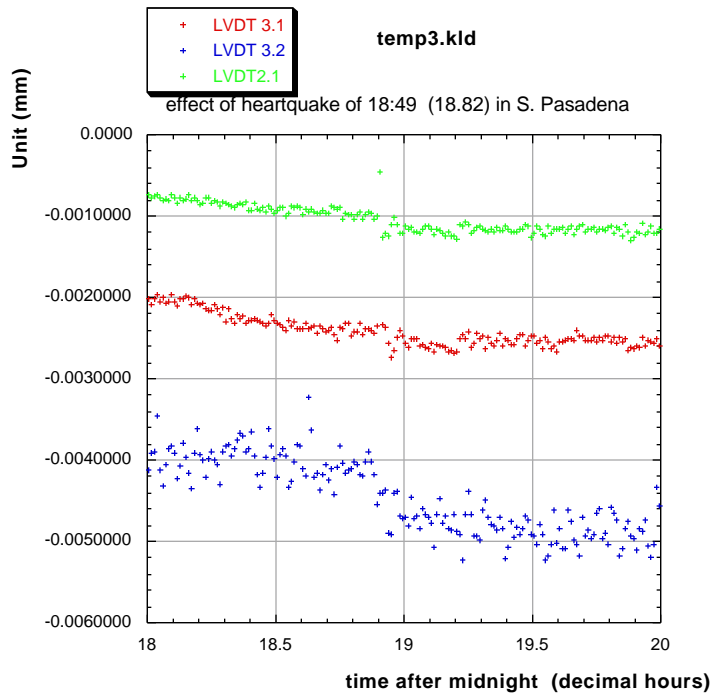
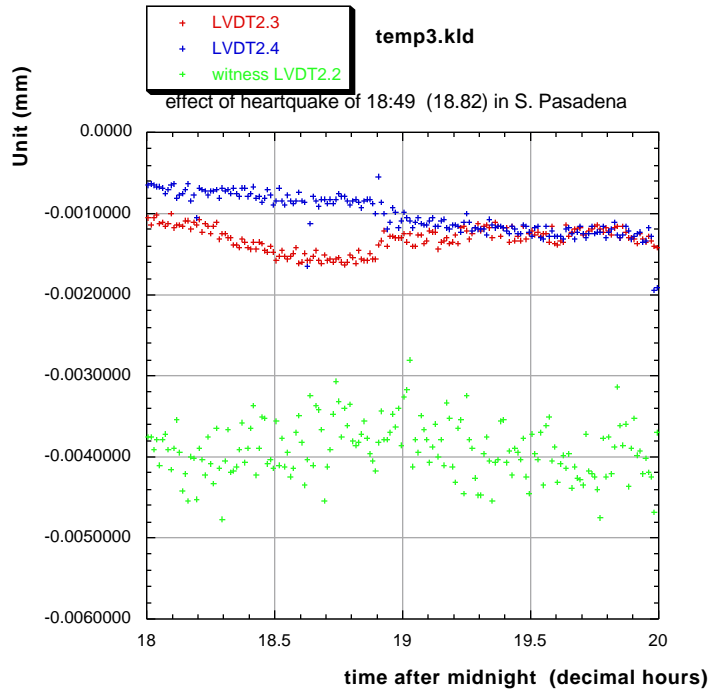
Small or no steps on other blades:

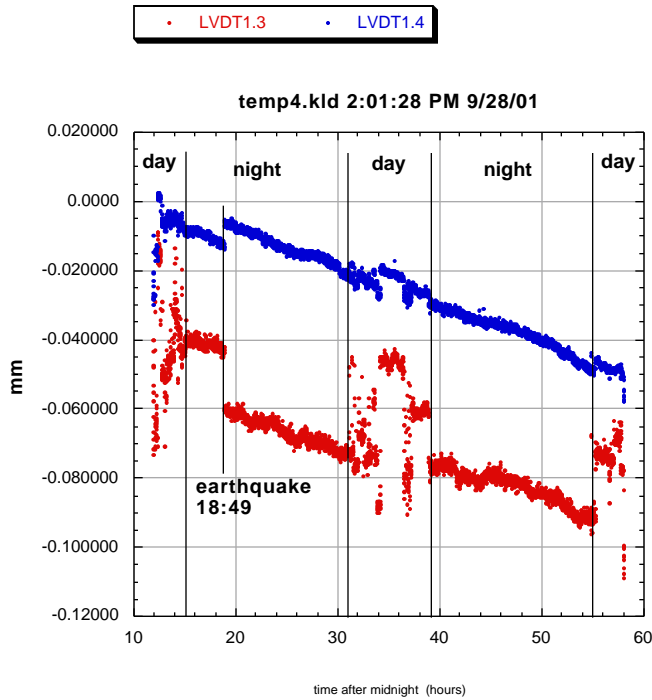
This large event finally seemed to explain the multiple small event visible during the Minos working time. The observed small steps can be easily explained with small (of the order of  $10 \mu\text{radian}$ ) shift of verticality of the totem, which in their turn can be explained with the overhead crane movements.

One could think of just gating out the daytime data and measure the creep with the remaining night time data. Occasional earthquake events could be reconnected by hand. The problem with the Minos activity is that at the end of the day it does not necessarily leave the totem in the original verticality and it is difficult to determine the integrated tilt to be subtracted and the creep measurement is strongly polluted.

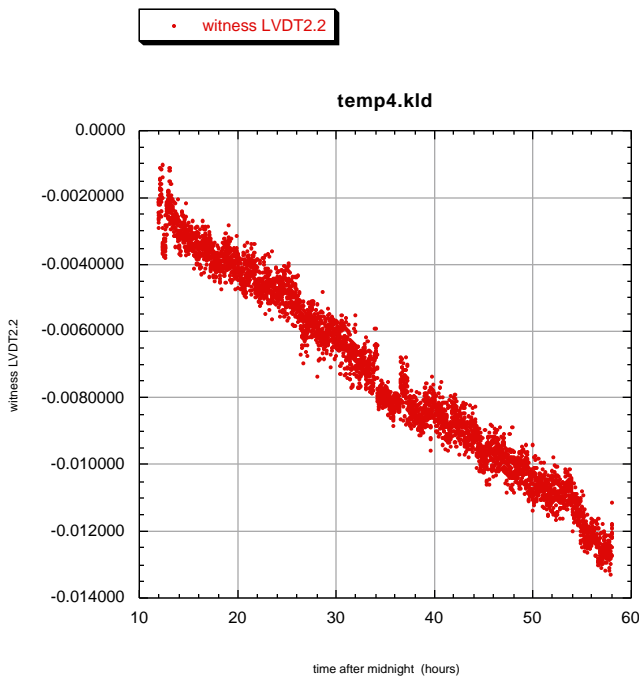
They also show some “creep”-like signal, i.e. the readout position did progressively move to lower values with decreasing rate despite the fact that the two parts of the LVDT were rigidly mounted together.

The most likely explanation for this effect is the following. Since the system was not intended for “in vacuum” applications, we decided to make the LVDTs of nylon, and some of PVC. It turns out that nylon absorbs up to 4% in weight of water and can expand more than 1% in length, which, over the 50 or 60 mm of LVDT, makes for up to a few hundred microns. We suspect that the plastics, in the dry oven atmosphere, will lose humidity and shrink. As they shrink the emitter and the receiver are effectively separated, just as it would happen in creep.

The LVDT shrinkage and the blade's creep are indistinguishable. The only solution is to **replace all the LVDTs with ceramic or Peek ones.**

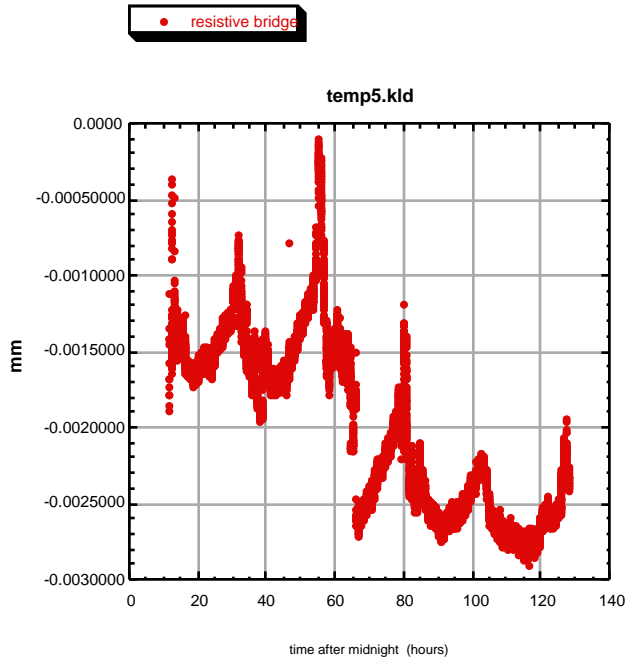
The observed “creep” is not in the electronics, as can be seen by examining the signal of a resistive bridge “LVDT”. Also this effect was not visible in Virgo where ceramic LVDTs were used.

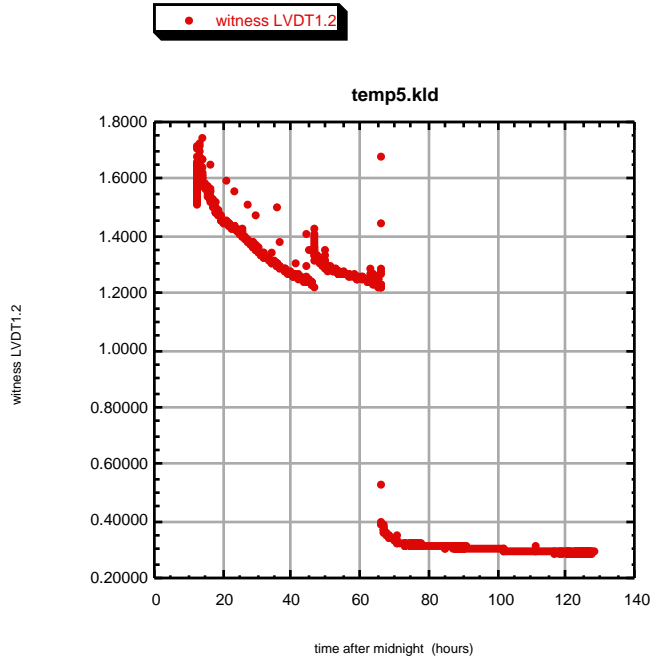
The last **major** problem recognized is a second kind of signal jump, that seems to be purely software in nature. The jumps can be large or small, and go both directions and appear in selected channels, see the resistive bridge above or the graphs of a witness LVDT below.

**We will try first to use different DAQ software. If this fails and this behavior will continue to be observed, we will try to use DAQ cards from another company.**

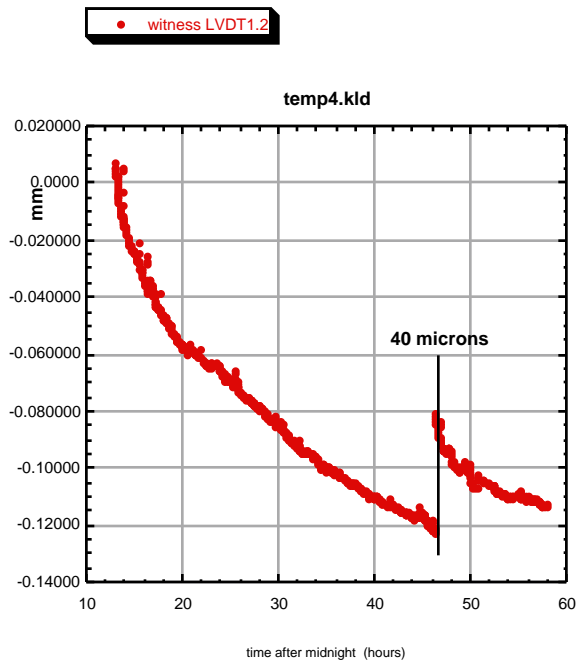
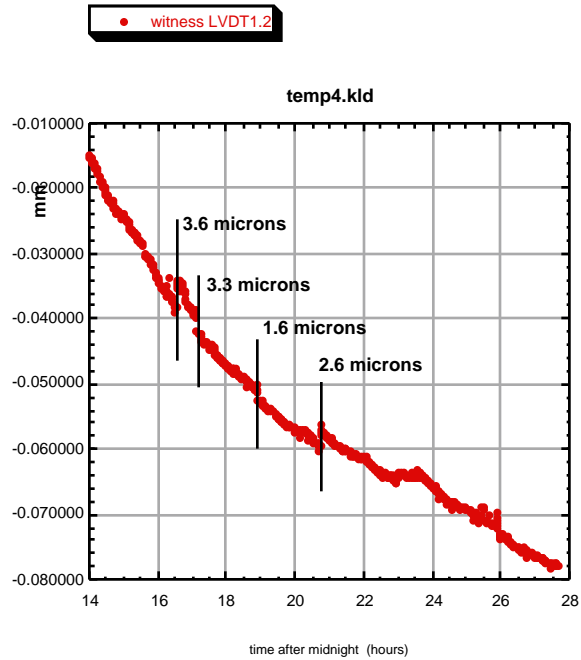
The jumps have both a macro, a meso and a micro structure

The theory to explain these unexplainable shifts is that some pedestal file in the DAQ driver may be corrupted and overwritten at random times and random amplitudes.

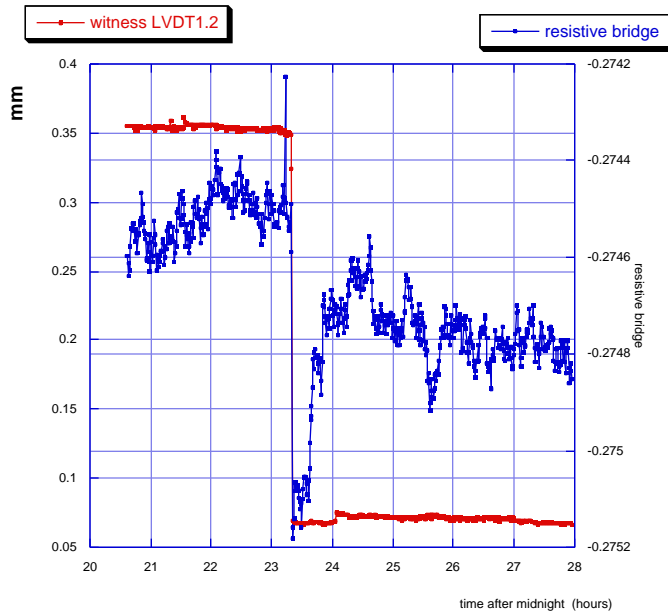
new NI DAQ card

The first suspect was the acquisition card hardware, possibly some bit jumping. The jumps have been observed in two separate NI DAQ cards; it is unlikely to find two cards, bought at one year of distance from each other to fail in the same way.

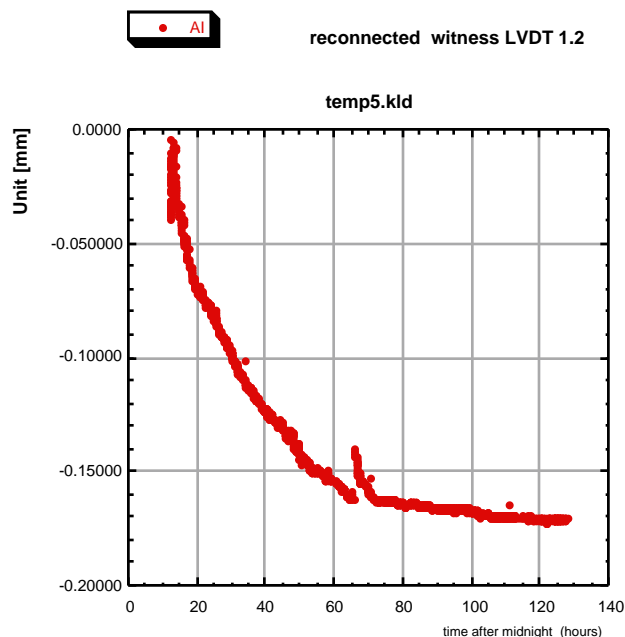
The signal of the first witness LVDT, after roughly recombining its cleavages, is behaving roughly logarithmic, as one would expect from drying, with a overall drop of 170 microns. The recombination of cleavages, though is far from satisfactory.
