Items culled from elog on the 6/28/02 suspension wire breakage incident/
AJW, 8/28/02

Suspension Wire Broken on 2k MMT2

EVENTS LEADING UP TO THE FAILURE OF THE 2K MMT2
SUSPENSION
and some wild speculations

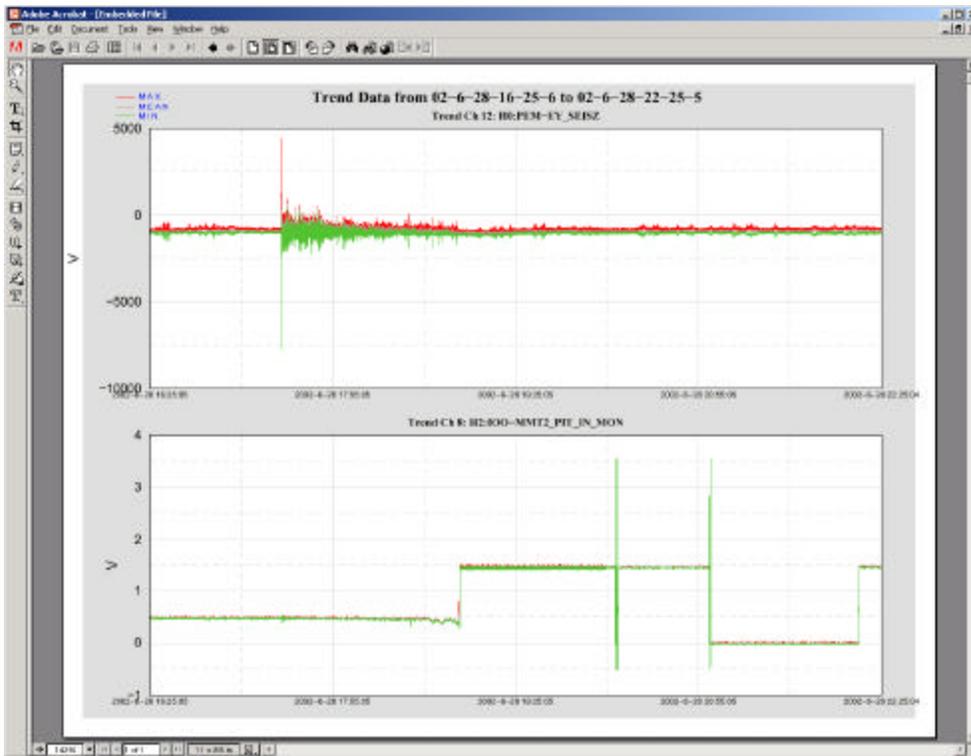
Plot 1: The earthquake was all but over when MMT2 shifted.

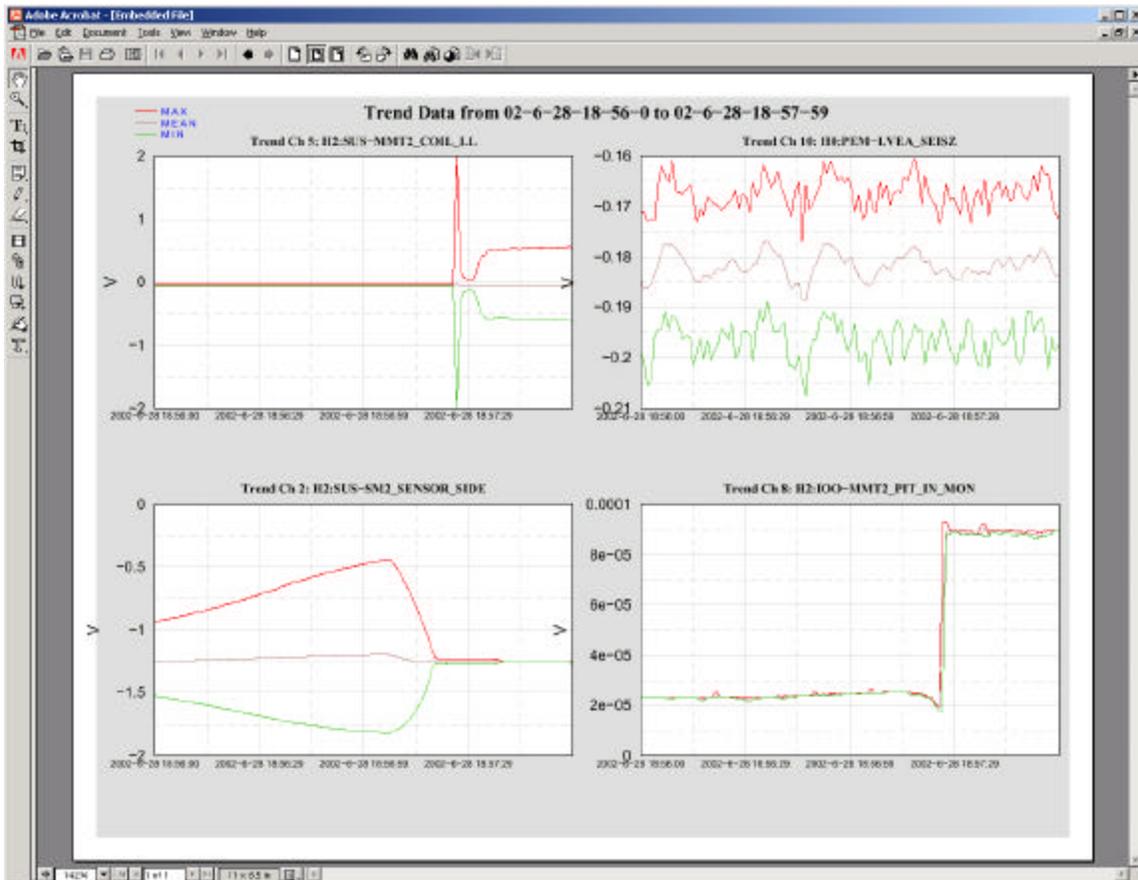
Plot 2: MMT2 shifted after SM2 calmed down.

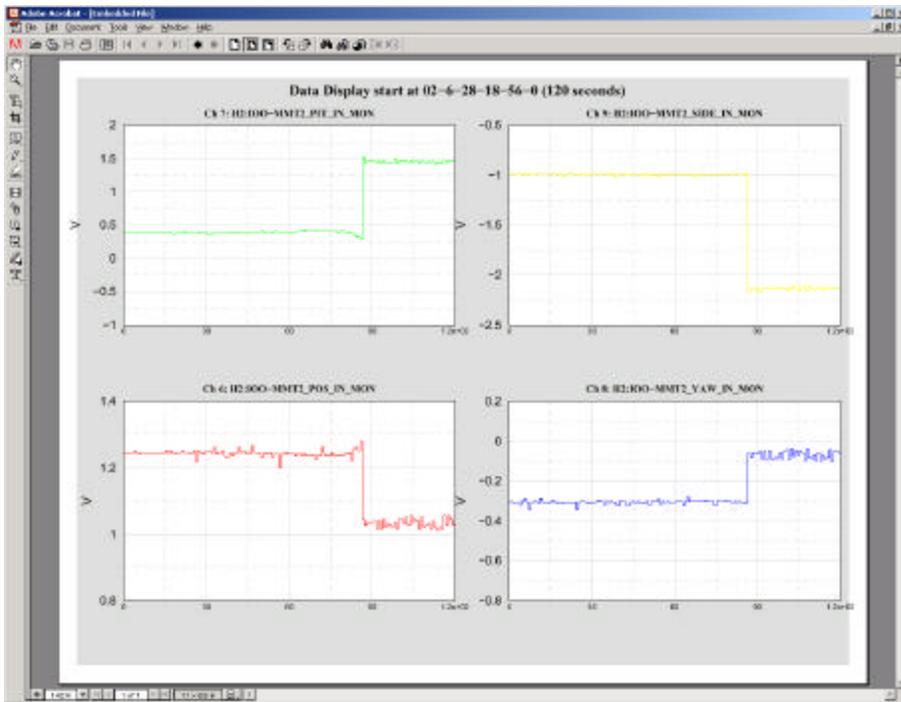
Plot 3: Shift of sensor POS, PIT, YAW and SIDE.

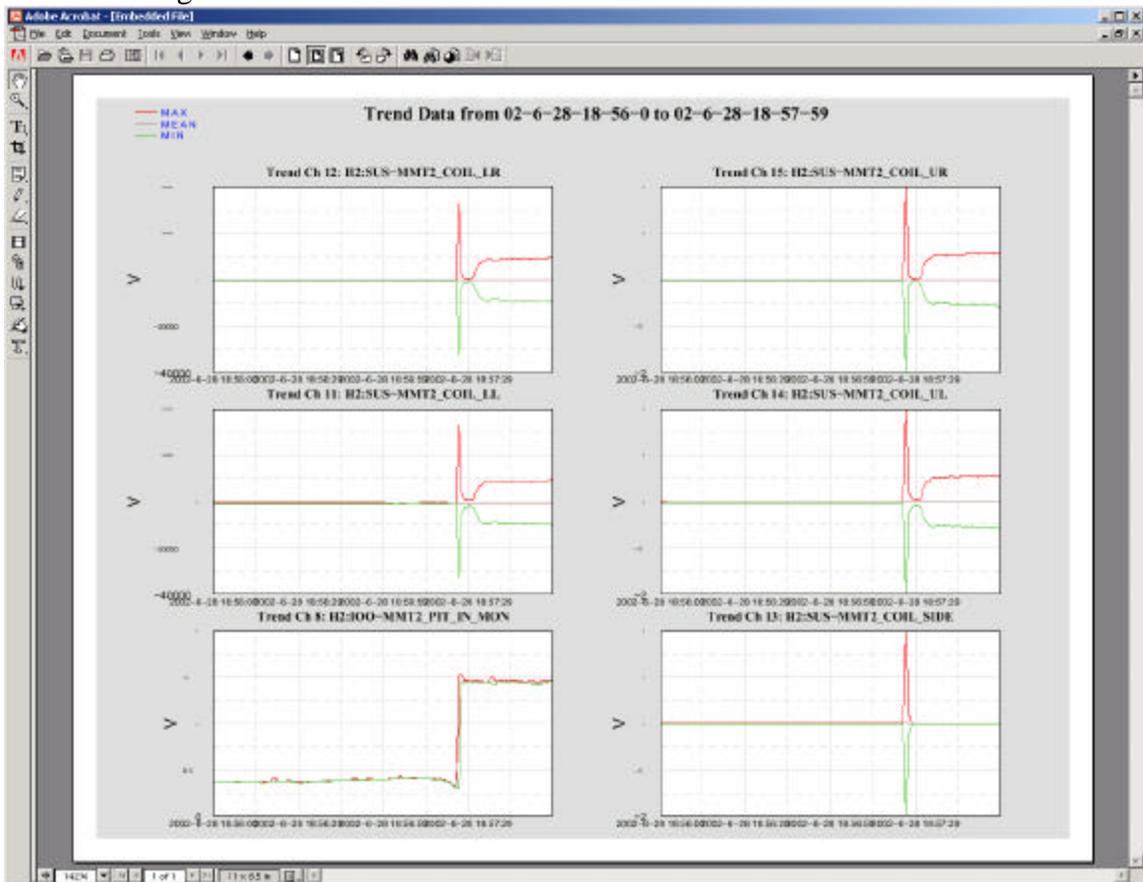
Plot 4: Coil readouts of MMT2. The local damping is unstable in the new configuration!

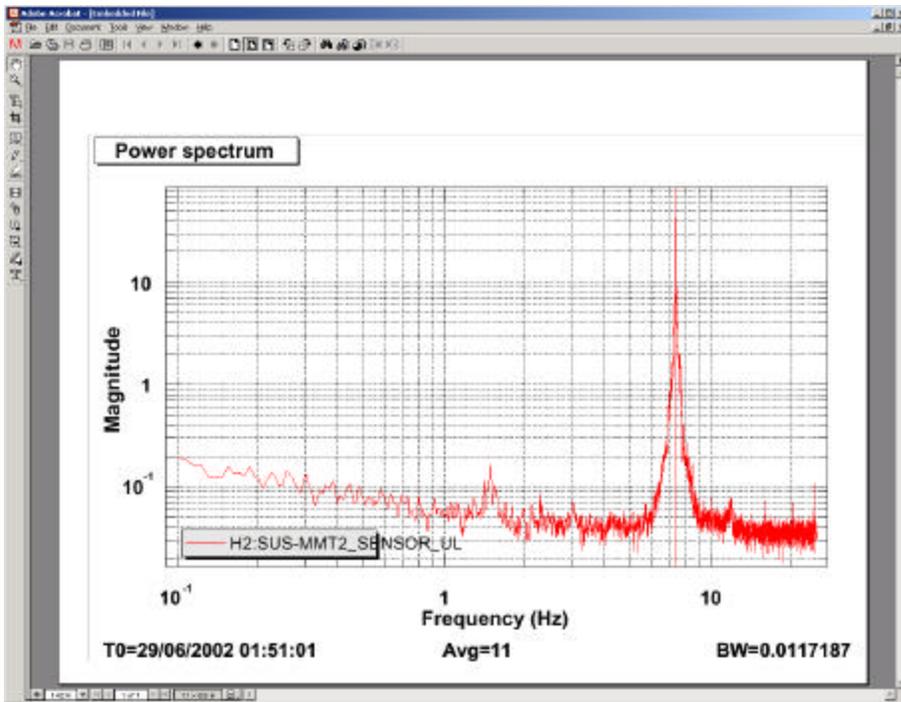
Plot 5: The new 7.4Hz eigenfrequency of MMT2.

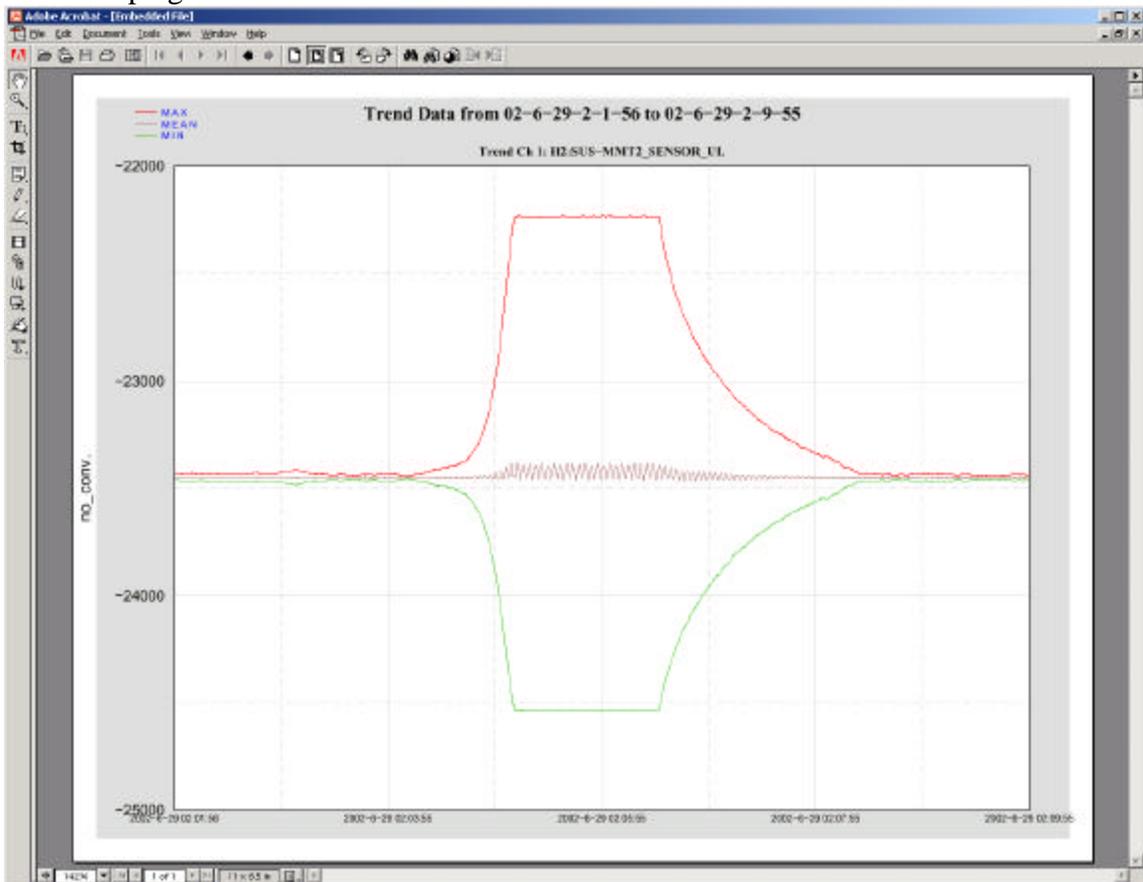
Plot 6: Ring-down of the 7.4Hz mode after it was excited with the local damping turned on.

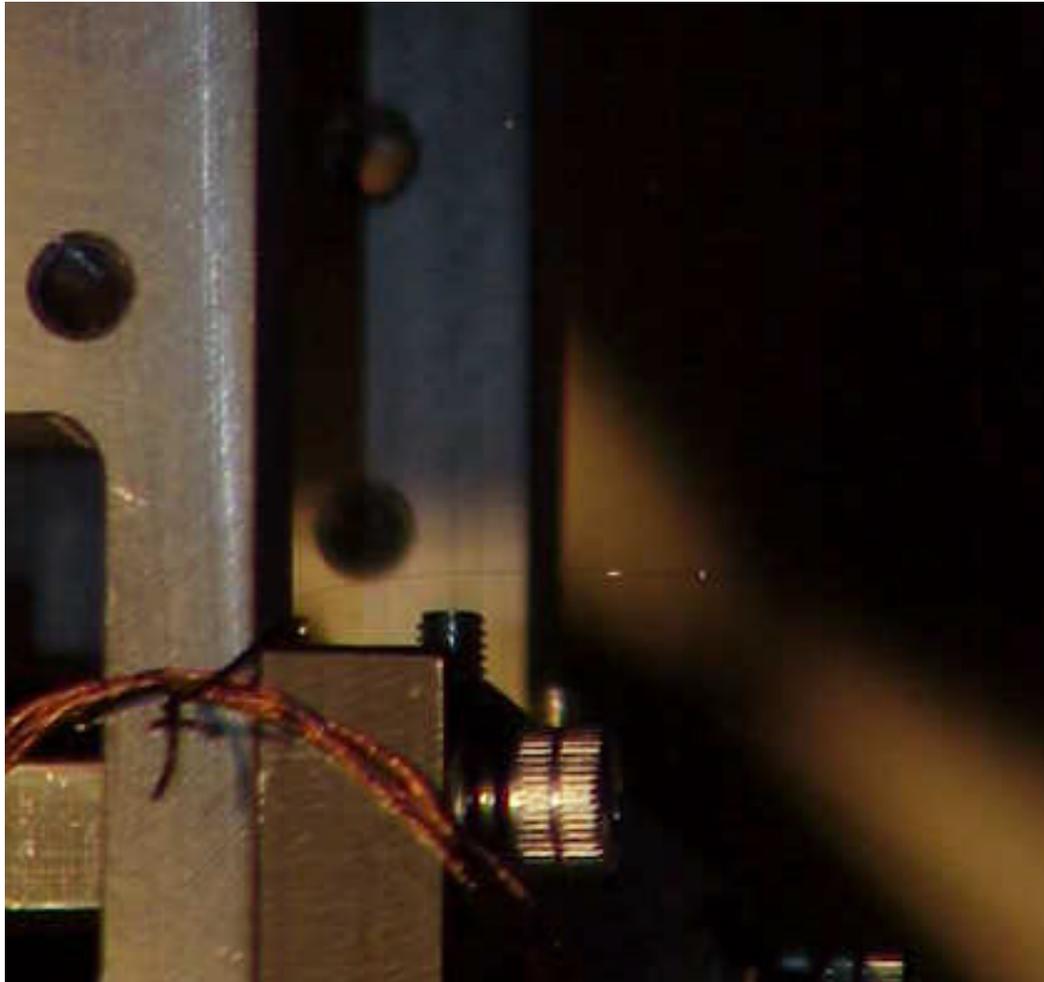
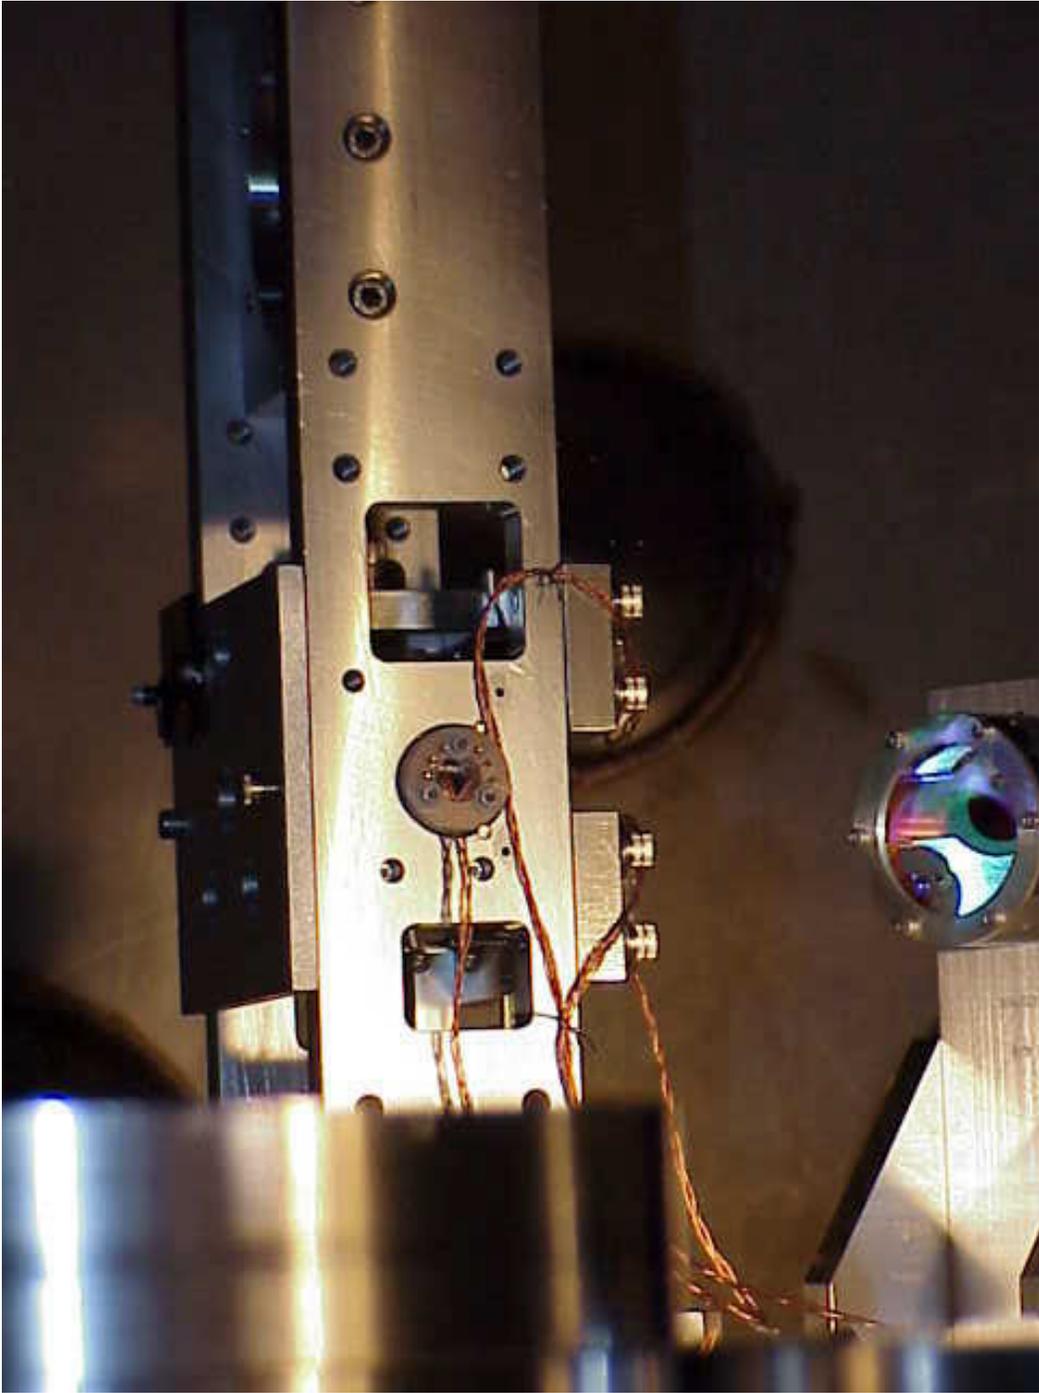
Betsy and I went out to look into HAM-7 as we were venting it. We convinced ourselves that we could see a slack wire, using modified binoculars, but it would have been tough to convince others. However, when John turned up the purge air we saw the wire blow out the back of the support structure where it was quite evident and, with Virginio's help, we photographed it.

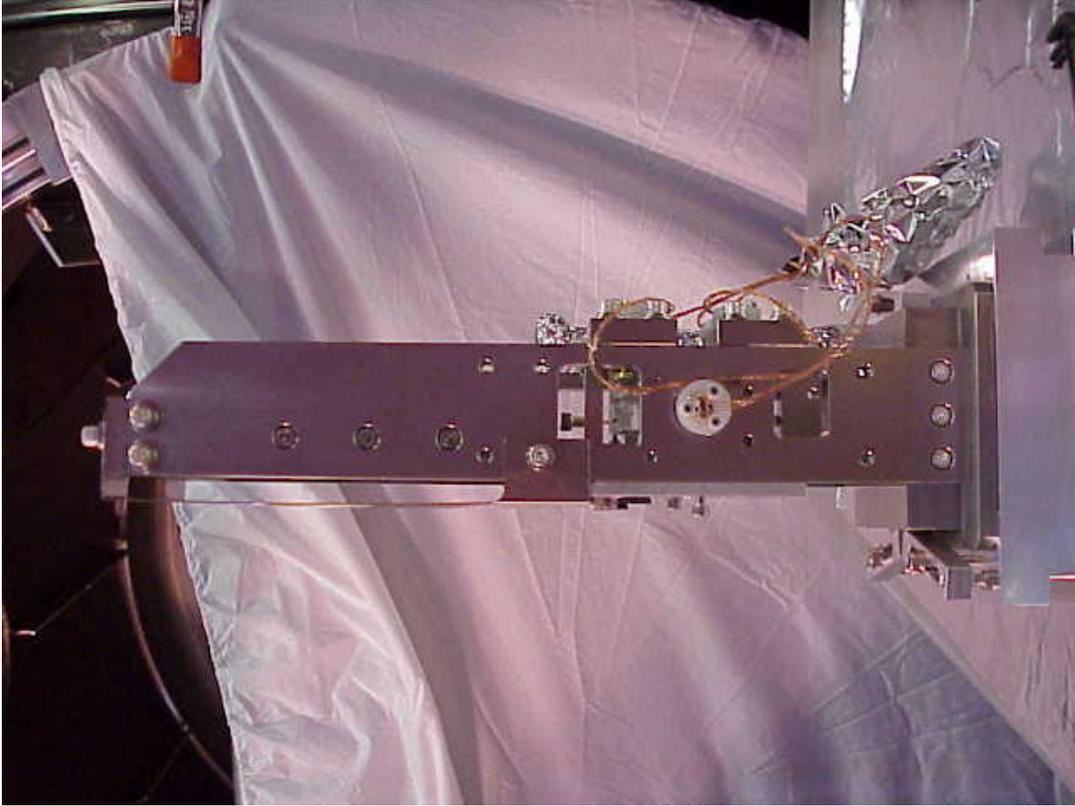
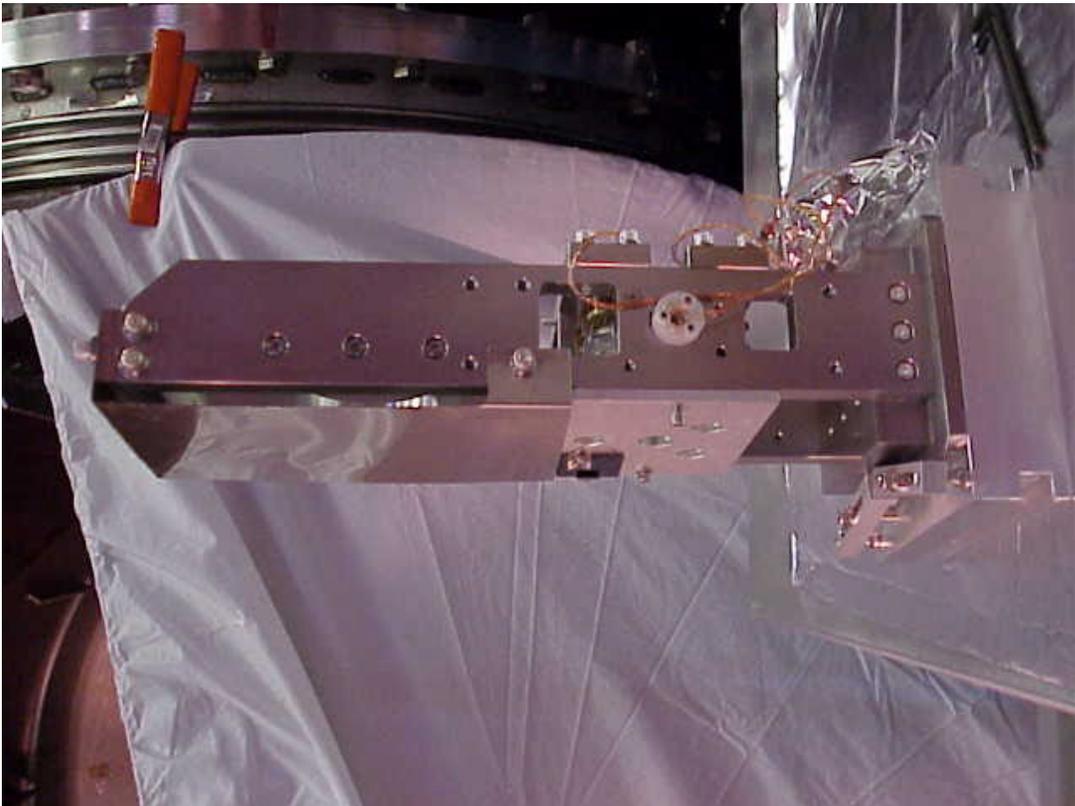
MMT2 with baffles

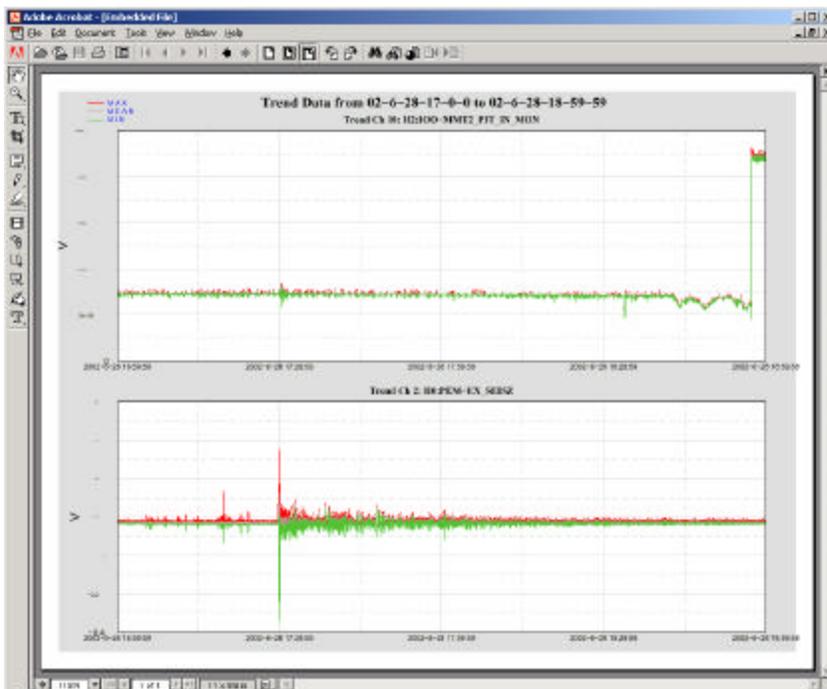
Two significant events are evident in the channels monitoring MMT2 prior to failure:
the Russian-Chinese border quake (1.5 hours before failure) and a slow drift in pitch, yaw, and position beginning 15 minutes before the final jump (see plot 1). The optic appears to recover from the quake within a couple of minutes and neither the slow drift nor the final jump appear to be correlated with quake signals or with other seismic signals in the LVEA (plot 2). I don't think that the quake or other seismic signals directly triggered this event. MC2 shows no correlation with the final events in the life of the MMT2 suspension.

Plot 1. Earthquake is at the left, slow drift of MMT2 is at the right, and the final dive is at the far right.

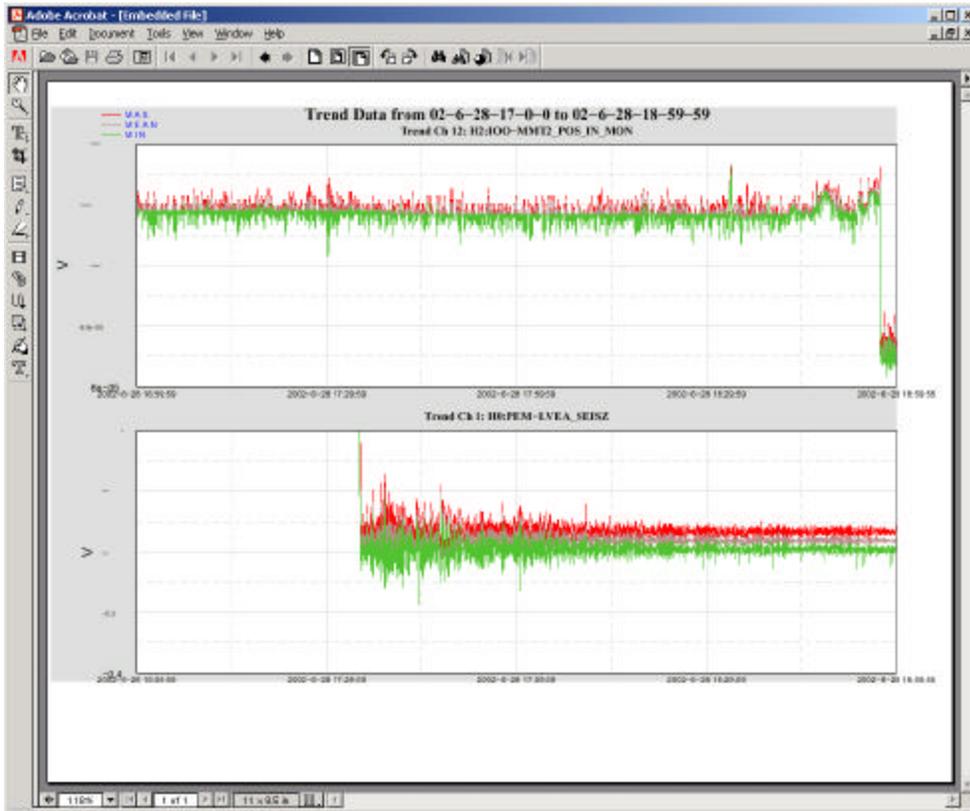
Plot 2. Shows LVEA seismometer, which wasn't on for the arrival of the quake, and position rather than pitch of MMT2

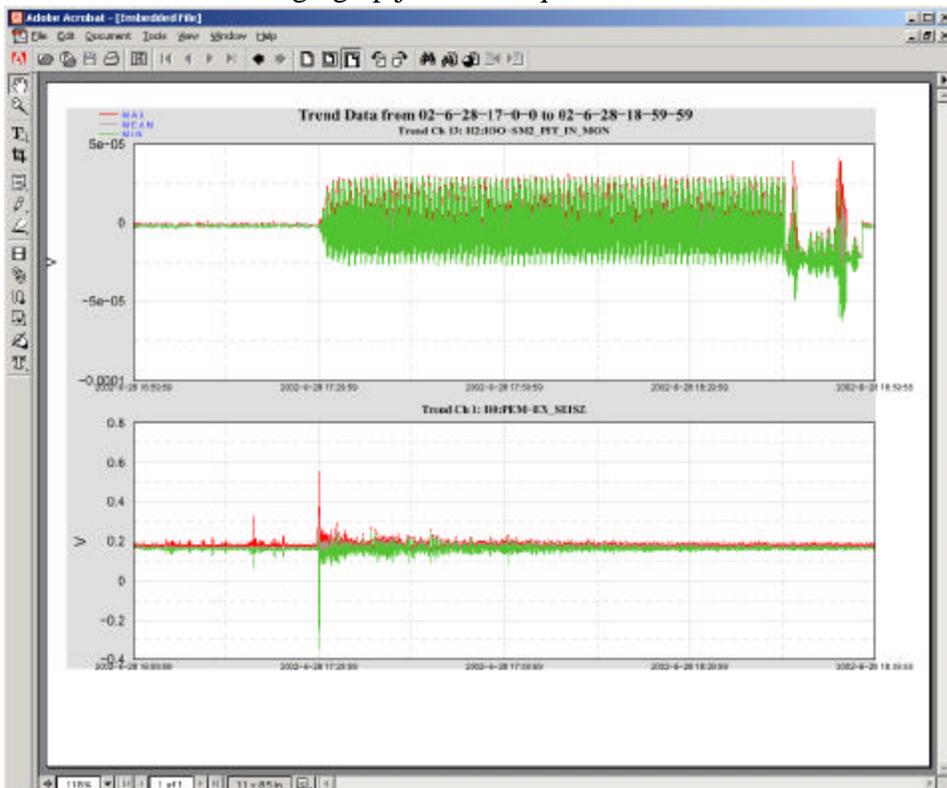
The only other optic with unusual signals during this period was SM2. SM2 began to ring up within 2 seconds of the quake signal arrival (plot 3 and zoom in - not shown), possibly because the quake swung it into a positive feedback regime. This swinging continued until Josh and others halted the swinging just 5 seconds before the final jump in MMT2 (plot4). Again, Mike showed that the conlog recorded these activities but nothing that should directly affect MMT2.

Plot 3. Shows SM2 ringing up just as the quake strikes.

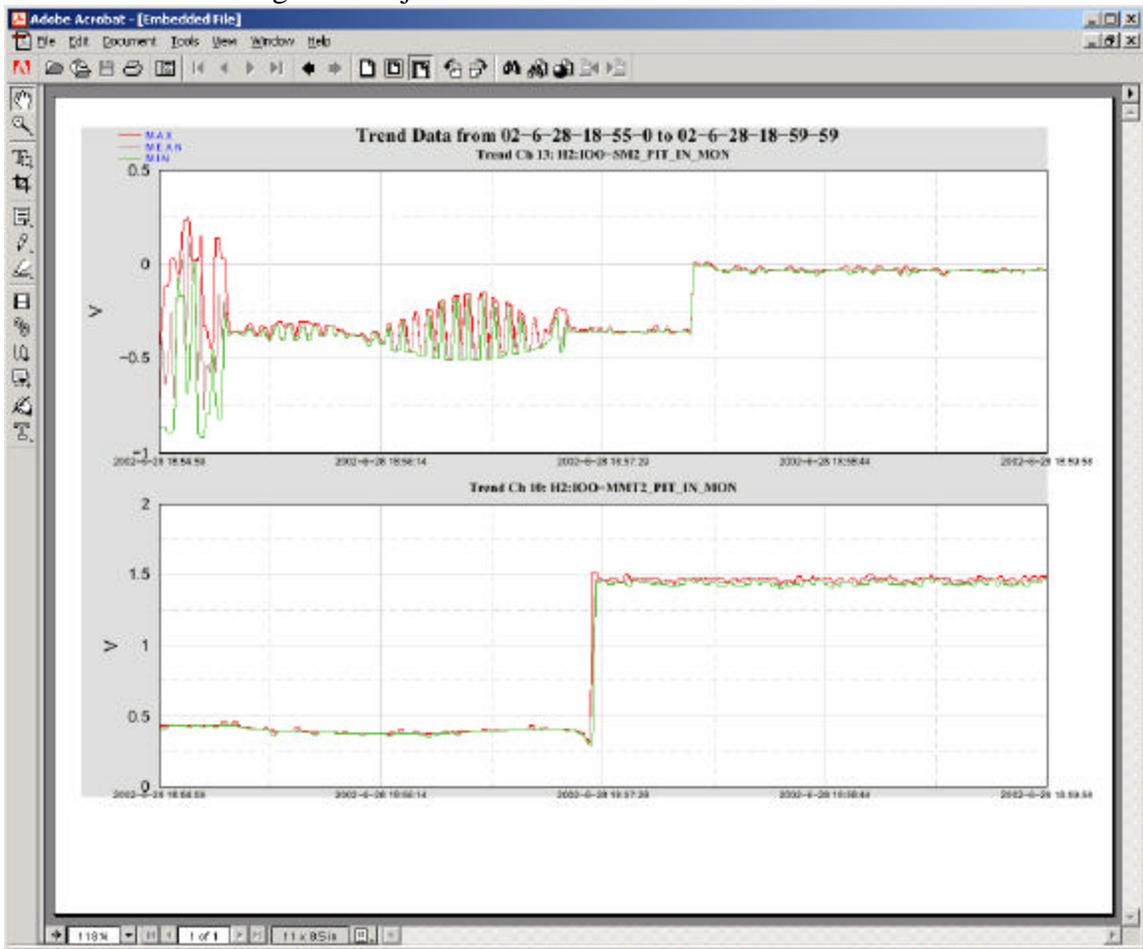
Plot 4. Josh's tamming of SM2 just seconds before the final dive of MMT

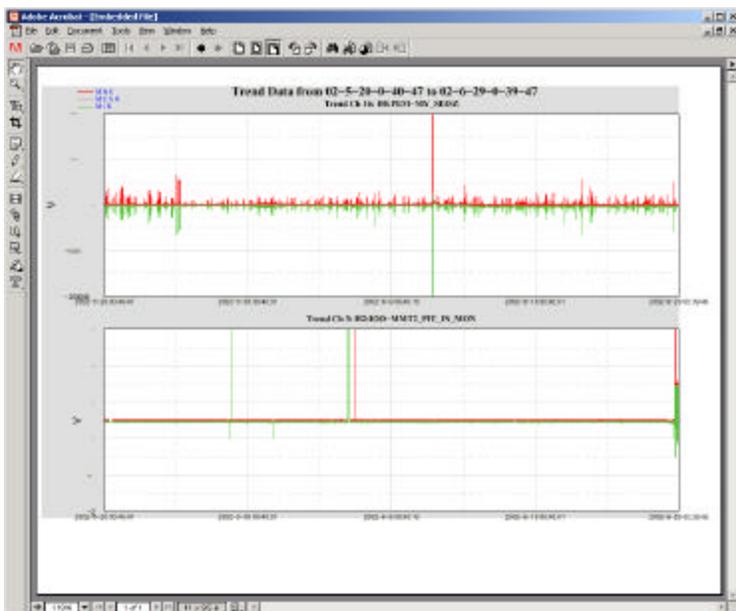
This plot shows that the Chinese quake was the third or fourth largest peak seismic velocity in the last 40 days.

The quake before the failure is the last glitch at the right side of the trend. I have picked the MY seismometer because it doesn't show as many of the bangs typical in the LVEA that may produce high velocities but which are mainly at high frequencies that get filtered by the stack.
