LIGO-T050211-00-K

Advanced LIGO

4th October 2005

Bonded ear strength tests
(Serial Numbers 0001, 0002 and 0011 to 0014)

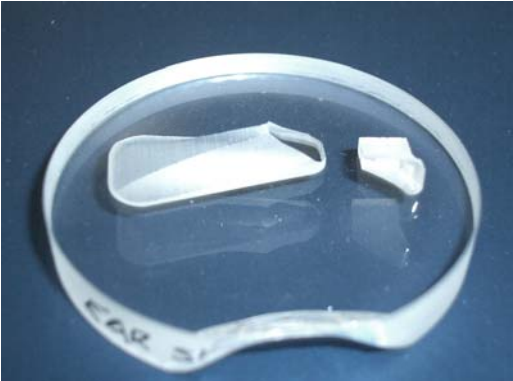
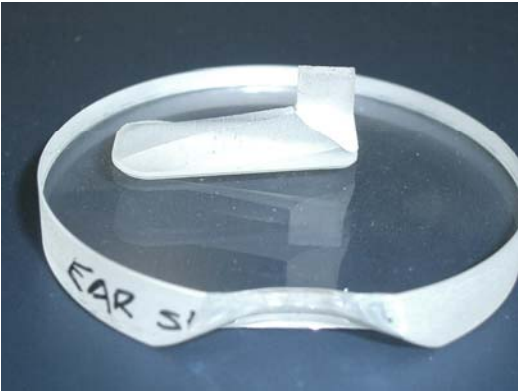
Strength Test on Bonded Ear Serial Number SN 0012	
Drawing Number	D050168-06
Description	Preliminary test ear (triangular faced) – flat to $\lambda/10$, with ground finish elsewhere
Manufactured by	Vendor ‘A’
Material	Suprasil 2
Bonded to	Suprasil 312 disk (Vendor ‘A’)
Bond date	14/07/05
Strength test date	10/08/05
Set-up	Loaded at groove location using rigid aluminium hook device. Load increased over several seconds.
Result & conclusion	Ear horn failed at 9.3 kg (25.4 lbs minus 4.9 lbs correction for mass of clamp). Premature horn failure due to stress concentration at sharp transition from horn to ear main body. Problem exacerbated by rough ground finish on ear providing prime sites for crack propagation. Bond did not fail at this load.
<p><i>Photo 1</i> Horn failure which propagated from transition between horn and main body of the ear.</p> <p><i>Photo 2</i> Broken horn placed on top of ear shows clearly the failure location</p>

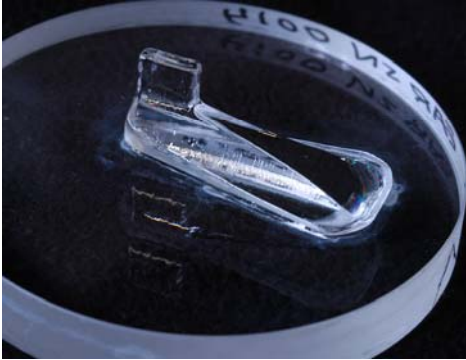
Strength Test on Bonded Ear Serial Number SN 0014	
Drawing Number	D050168-06
Description	Preliminary test ear (triangular faced) – flat to $\lambda/10$, with ground finish elsewhere – <i>flame polished whole ear four weeks after bonding</i>
Manufactured by	Vendor 'A'
Material	Suprasil 2
Bonded to	Suprasil 312 disk (Vendor 'A')
Bond date	14/07/05
Strength test date	11/08/05
Set-up	Loaded at groove location using rigid aluminium hook loading device. Load increased over several seconds.
Result & conclusion	Loaded to around 18 kg but loading hook slipped. Potential for damage to have occurred during this. Reloaded to 27.2 kg (64.6 lbs minus 4.6 lbs correction for mass of clamp) when horn failed. Note: prior to the initial test the bond was inspected and was seen to have a semicircular fracture-like feature towards the toe of the bond. This may have resulted due to thermal stresses between the dissimilar grades of Suprasil during flame polishing. In addition to the failure at the horn there was another smaller fracture evident in this region but at a higher vertical inclination to the fatal fracture.

<p><u>Photo 1</u> <i>Flame polished bonded ear prior to testing. Note the residual silica vapor deposits around the bond.</i></p>

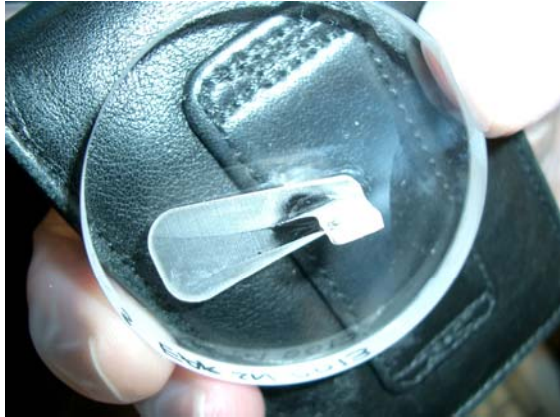
Strength Test on Bonded Ear Serial Number SN 0013	
Drawing Number	D050168-06
Description	Preliminary test ear (triangular faced) – flat to $\lambda/10$, with ground finish elsewhere – <i>flame polished horn region mostly towards the front</i>
Manufactured by	Vendor ‘A’
Material	Suprasil 2
Bonded to	Suprasil 312 disk (Vendor ‘A’)
Bond date	14/07/05
Strength test date	11/08/05
Set-up	Loaded at groove location using rigid aluminium hook loading device. Load increased over several seconds.
Result & conclusion	Loaded to 37.5 kg (87.2 lbs minus 4.5 lbs correction for mass of clamp) when horn failed. Bond still intact and not tested to destruction. This is a factor of x 3.7 above Advanced LIGO working load. Corresponds to a maximum stress on bond area of 2.1 MPa compared to operating stress of 0.6 MPa (10 kg per ear).
<i>Photo 1</i> <i>Bonded ear with flame polishing of horn mainly towards the front of the horn in high stress region.</i>

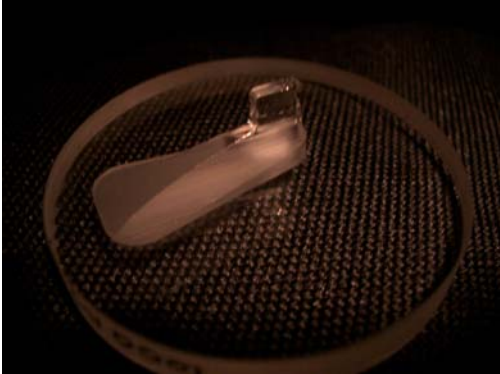
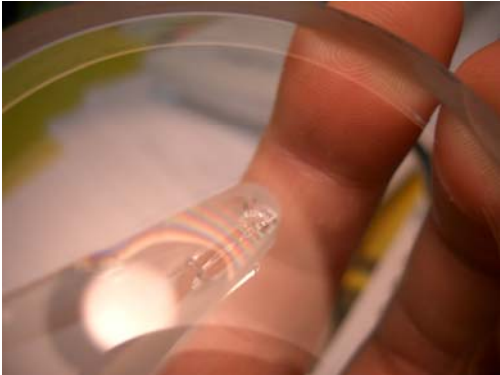
Ears SN 0001 and 0011 showed obvious bond degradation probably due to thermal stresses introduced by flame polishing.

Flame Polishing of Bonded Ear Serial Number SN 0001	
Drawing Number	D050168-06
Description	Preliminary test ear (triangular faced) – flat to $\lambda/10$ (comment from bonding report T050121-00-K more like $\lambda/4$), with ground finish elsewhere – <i>flame polished horn region mostly towards the front</i>
Manufactured by	Vendor ‘B’
Material	Suprasil 2A
Bonded to	Suprasil 312 disk (Vendor ‘A’)
Bond date	14/07/05
Flame polishing date	12/08/05
Result & conclusion	Fringes evident after polishing indicating bond peeling due to thermal stresses introduced by flame polishing.
<p><u>Photo 1</u> Bonded ear with flame polished horn.</p> <p><u>Photo 2</u> Fringes near toe indicate bond peeling due to thermal stresses induced by flame polishing (photo date 19/08/05, one week after flame polish). Checked on 22/09/05 and fringes still evident as before.</p>

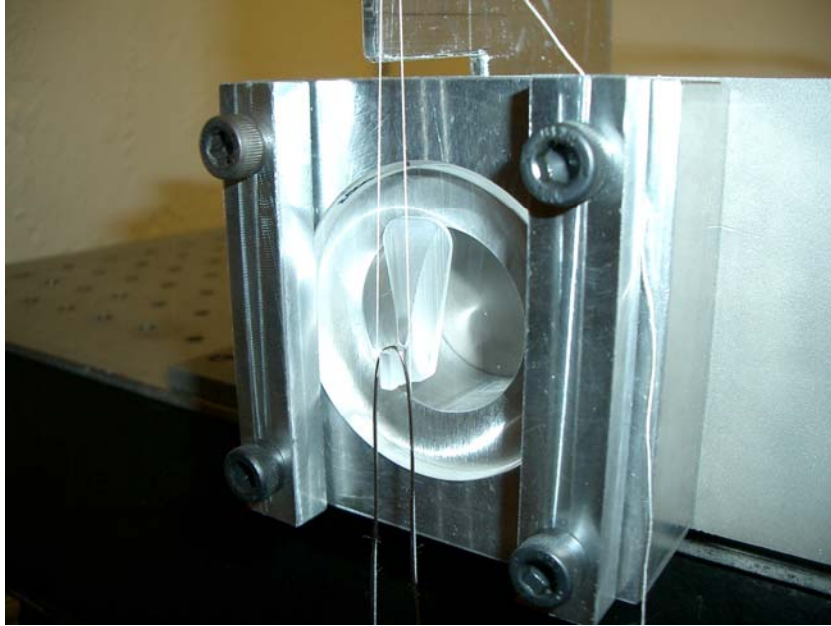
Figure 1 Bonded preliminary test ear arrangement for long-term loading test. The light flame polish in the horn region is just visible.
