G960025-01-O-P

2 24 '96

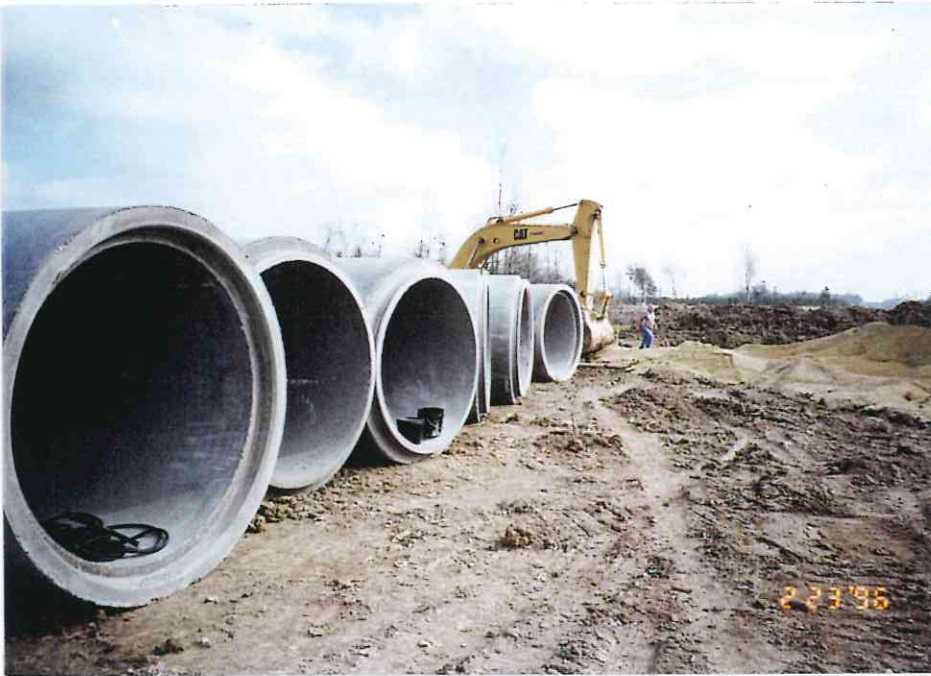
1.Southwest Arm at station 89+00 culvert crossing , 72" pipe just arrived.

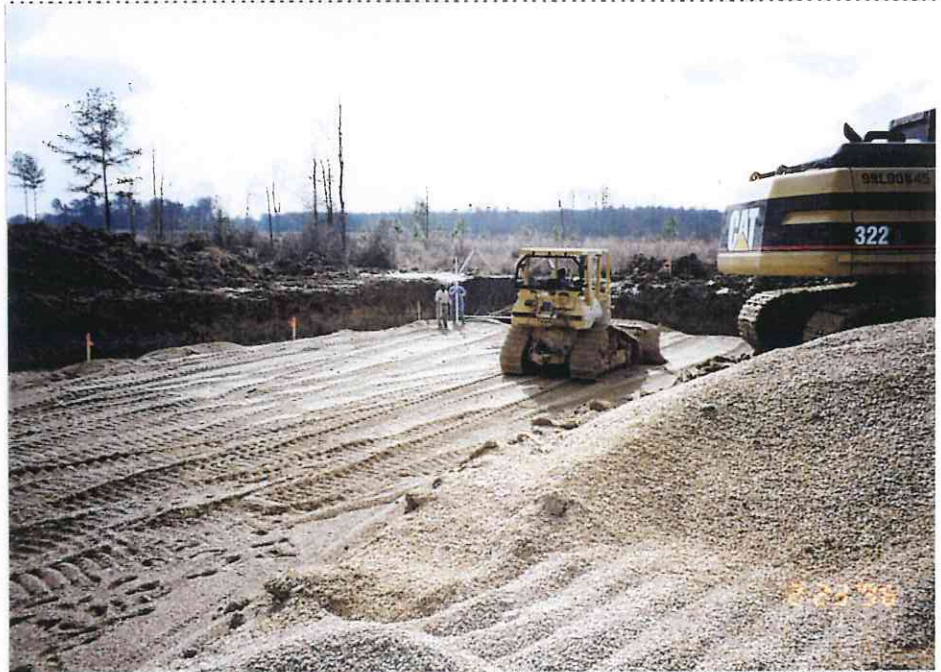
G960025-02-O-PV

2.Southwest Arm at station 89+00 Installing culvert pipe bedding.

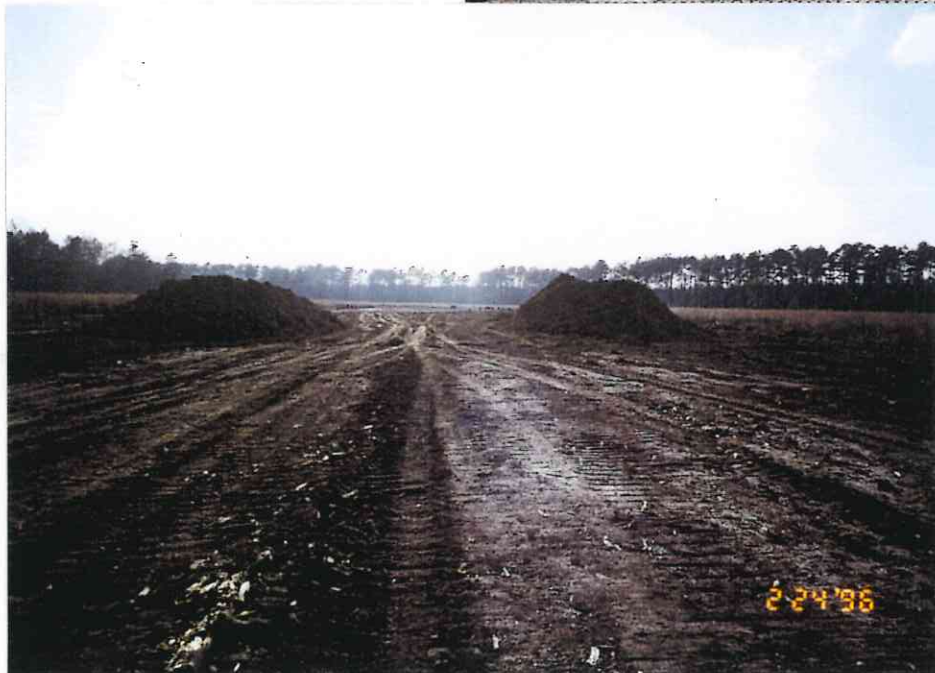
G960025-03-O-P

3.Southwest Arm at station 123+00 looking west.

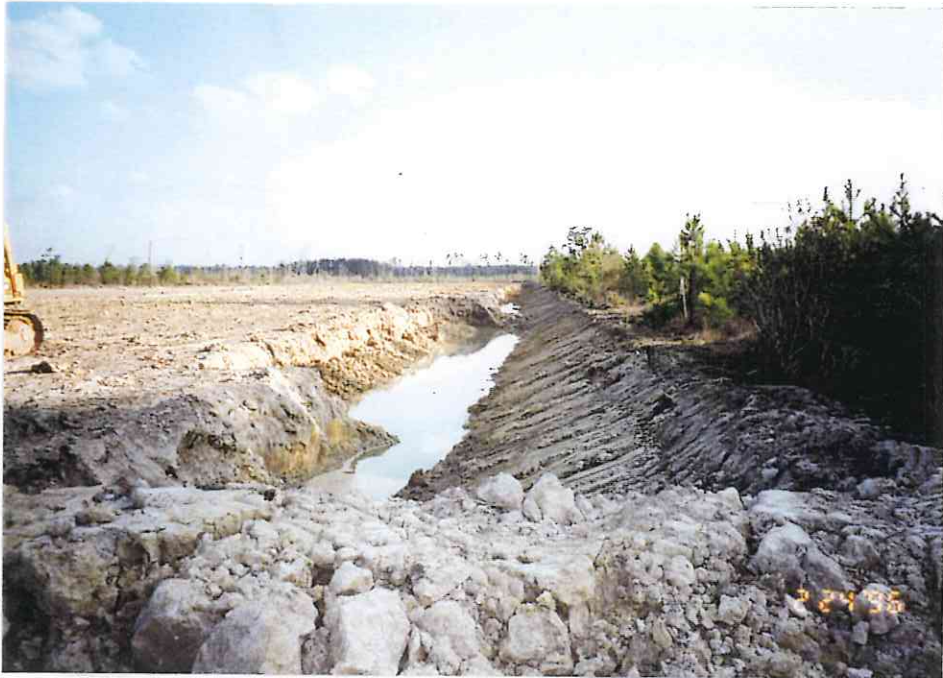
G960025-04-O-P

4. Southwest arm , at Station 120+00,permanant drainage ditch.

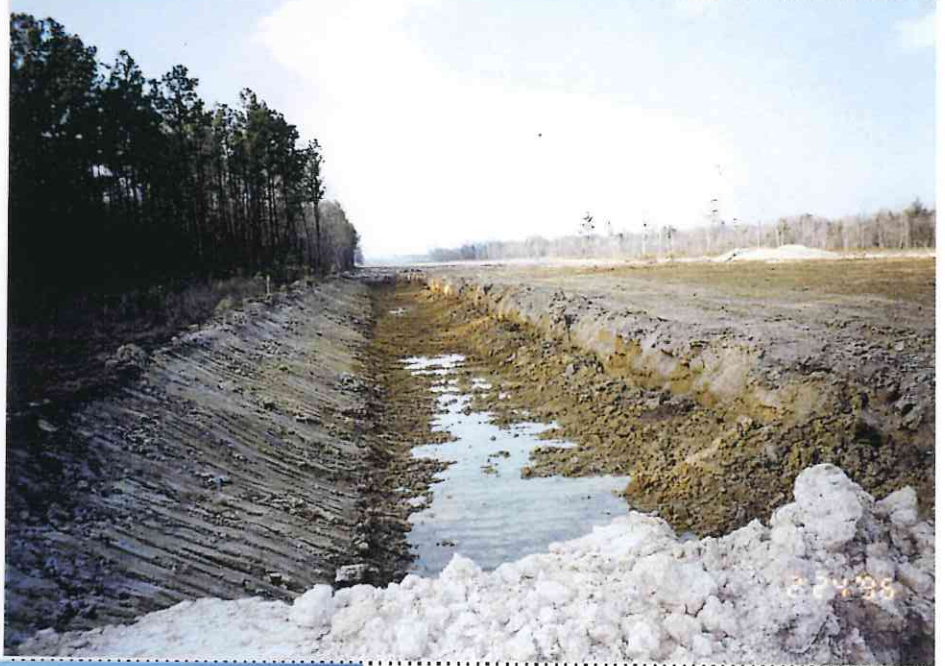
G960025-05-O-P

5.Southewast Arm at station 120+00 looking south at permanent drain ditch

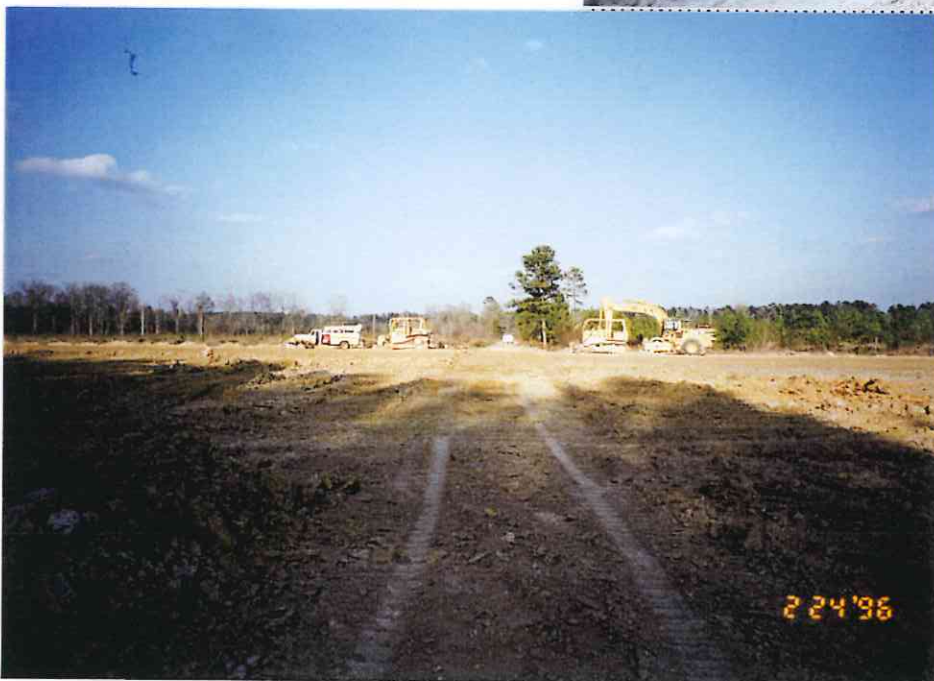
G960025-06-O-P

6. Southeast Arm at station 113 +00 looking at construction equipment being being repaired and serviced

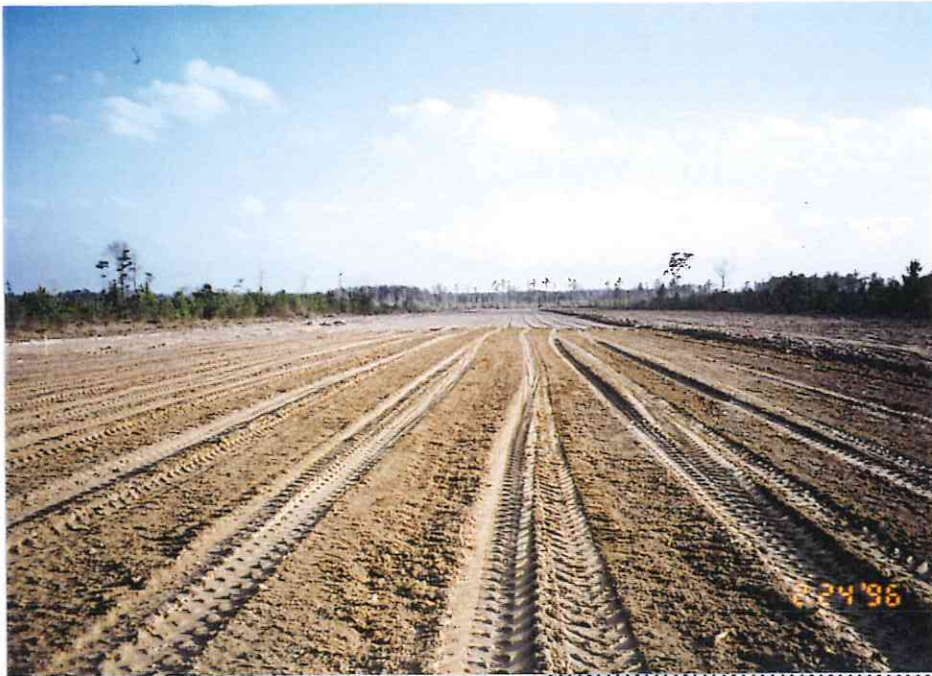
G960025-07-O-P

7.Southeast Arm at station 113+00 , looking southeast at berm construction.

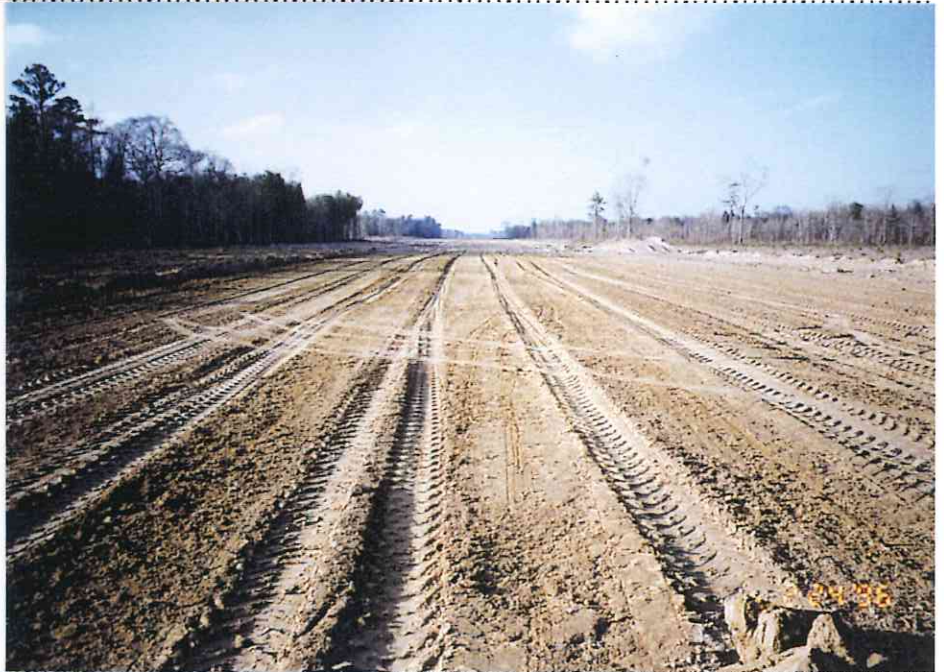
G960025-08-O-PV

8.Southeast Arm looking north from station 114+00 culvert crossing 106+00 in the background.

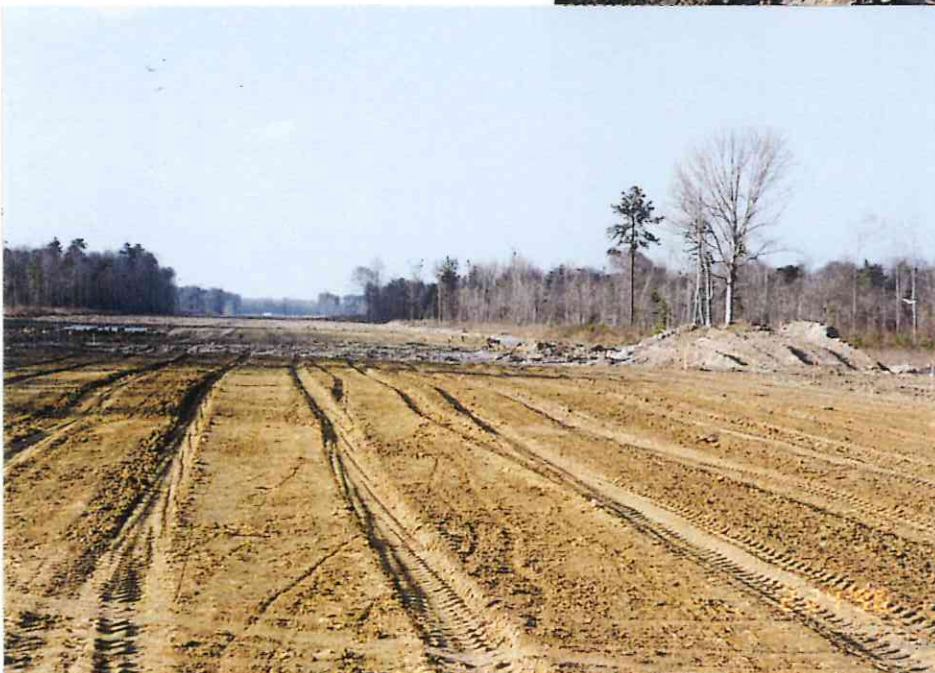
G960025-09-O-P

9.Southeast Arm looking north at station 106+00

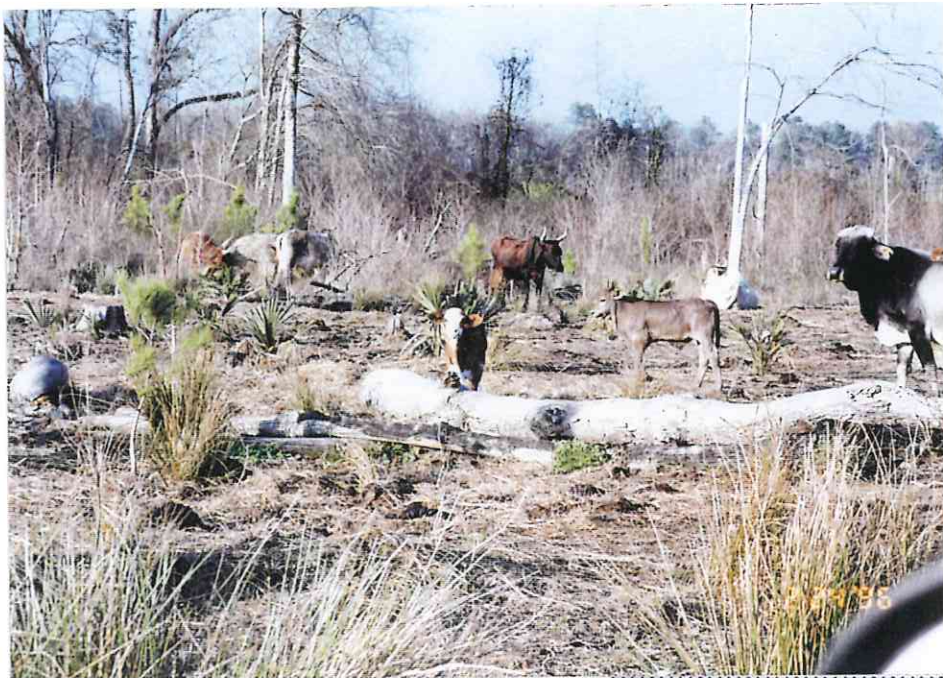
G960025-10 -O-P

10. Southeast Arm
Progress Coexisting
together

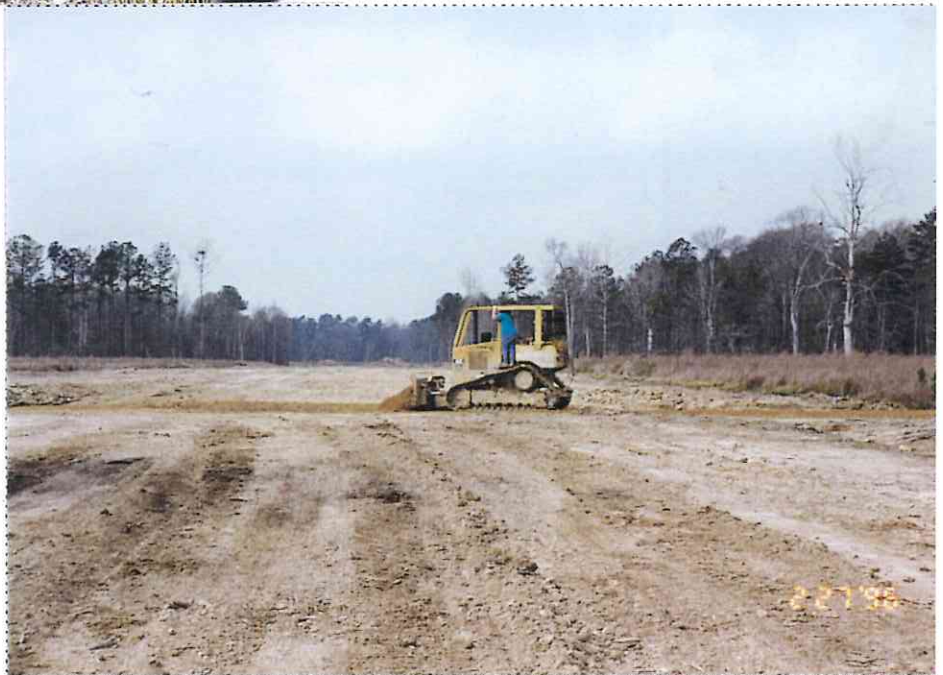
G960025-11 -O-P

11. Southwest Arm at
station 98+00 repairing
existing road for
hauling.

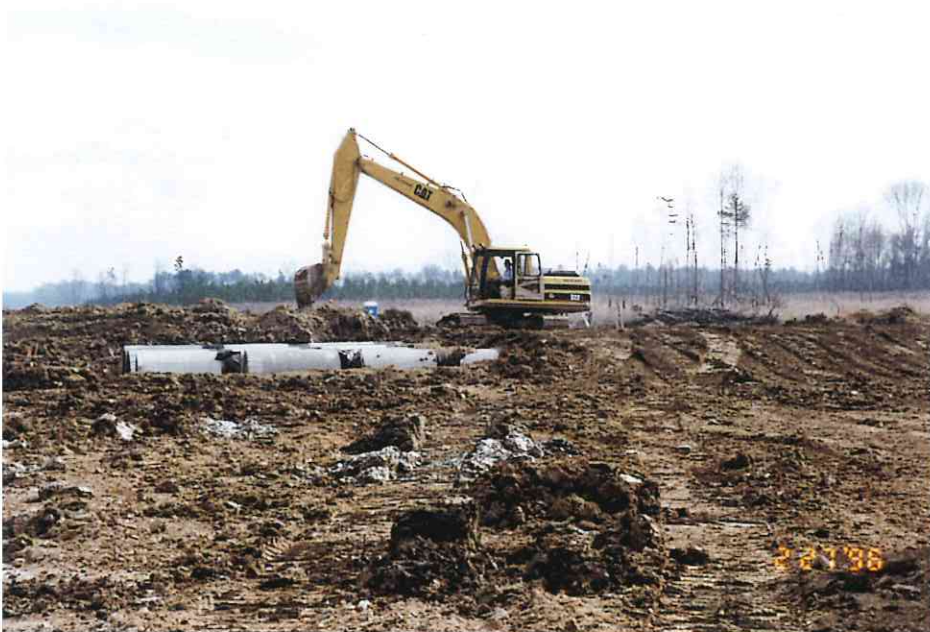
G960025-12 -O-P

12. Southwest arm at
station 89+00 clearing
away banked material to
receive bedding material

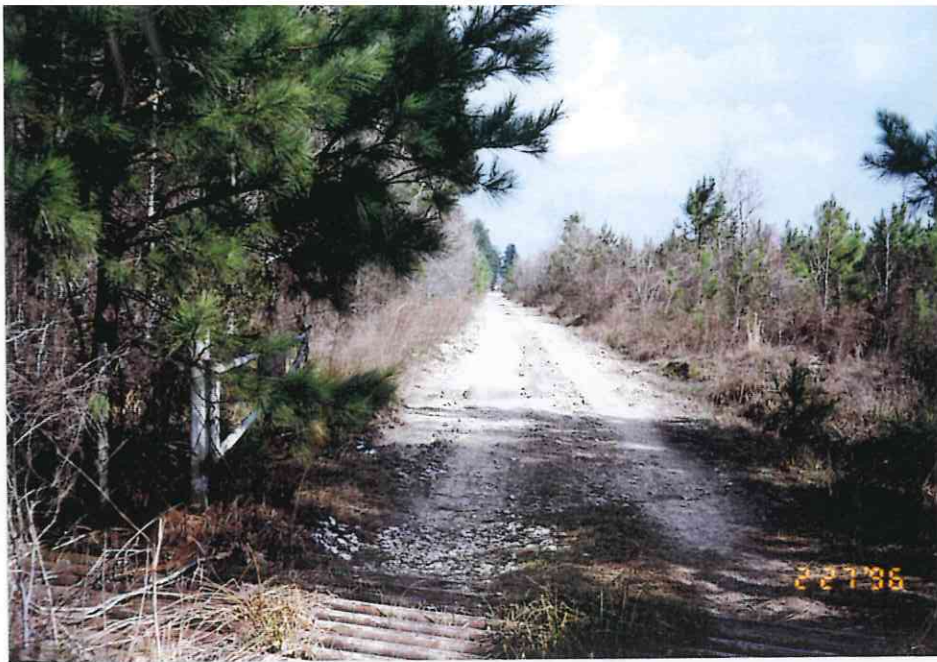
G960025-13 -O-P

13.Southeast Arm at the far end access road entering from the south showing road up grade for hauling.

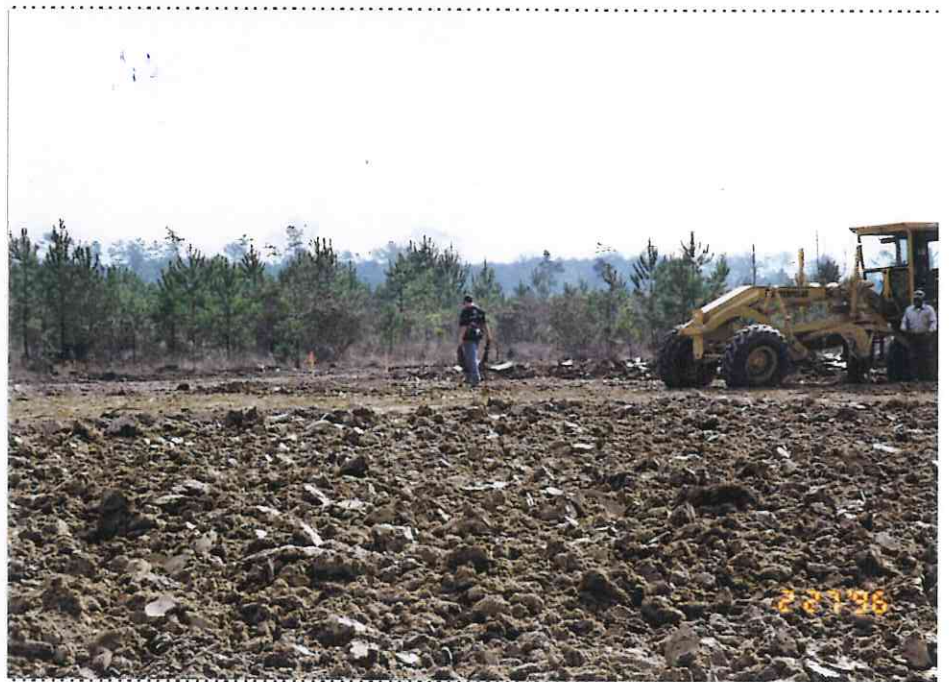
G960025-14 -O-P

14.Southeast arm at station 115+00 removing tree parts.

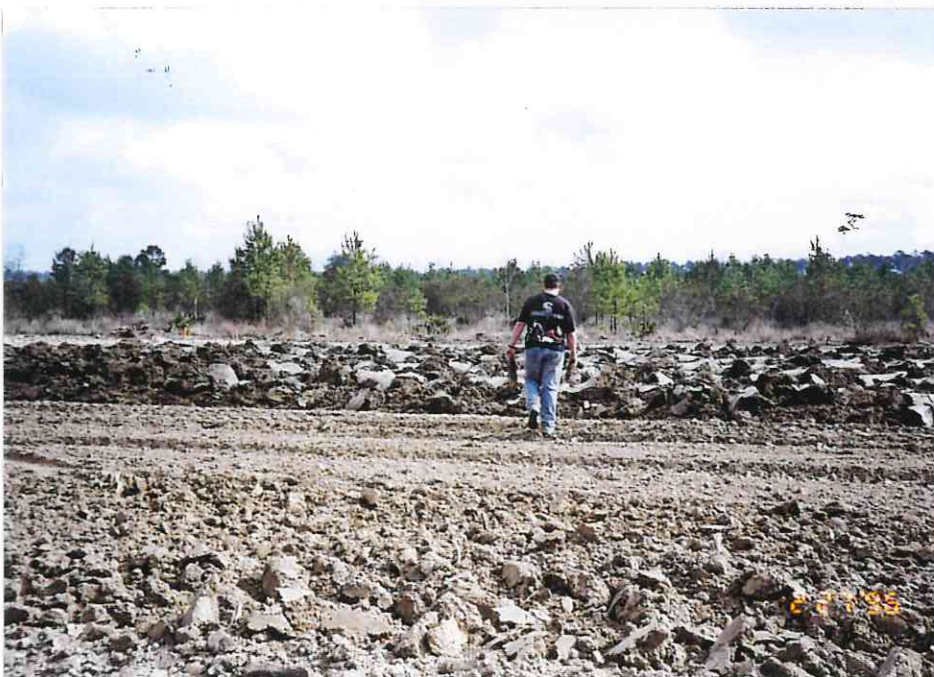
G960025-15 -O-P

15.Southeast arm at station 114+00 spreading out excavated fill to start the drying process.

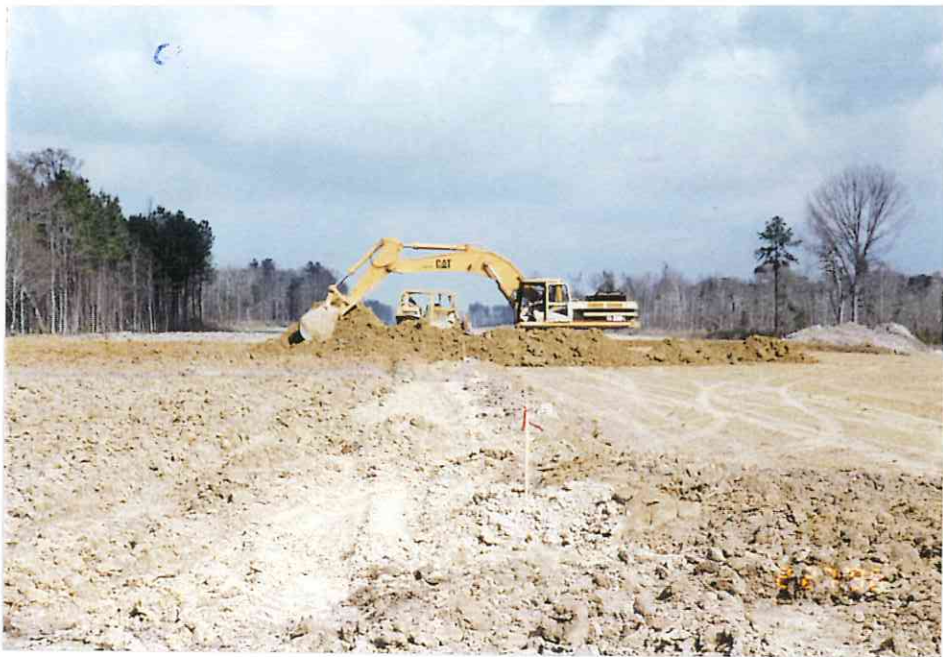
G960025-16 -O-P

16.Southeast arm at station 113+00 removing tree parts.

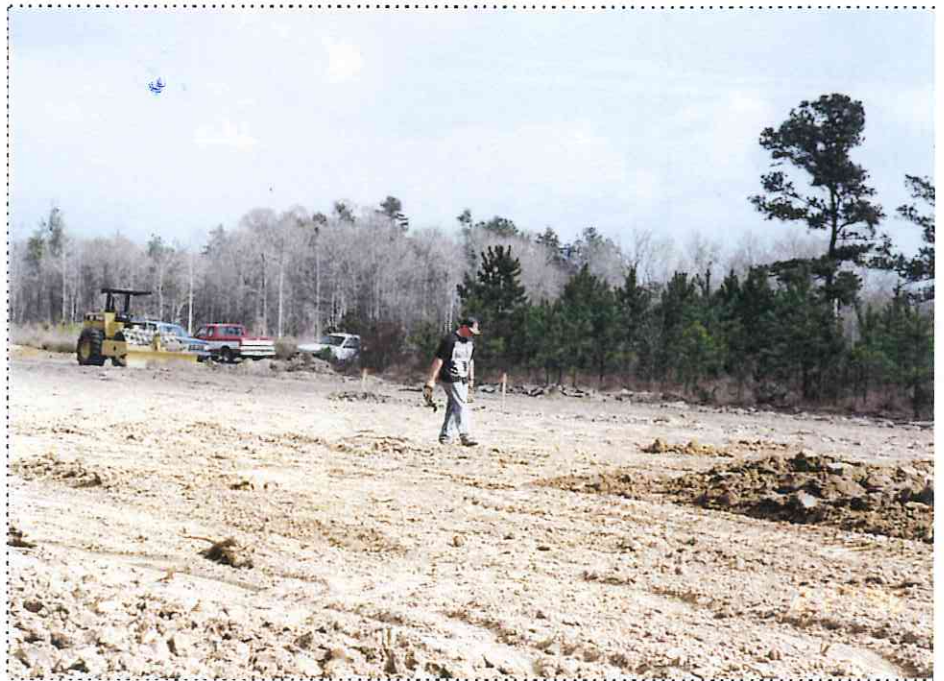
G960025-17 -O-P

17.Southwest arm at station 114+00 showing stump picker in action.

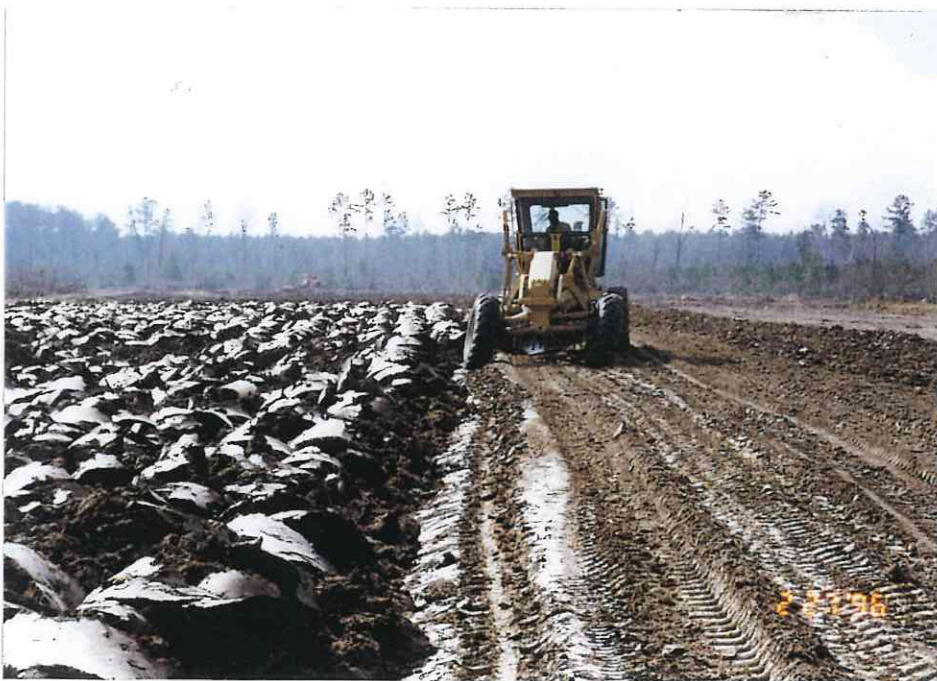
G960025-18 -O-PV

18. Southeast arm at station 119+00 windrowing material to eliminate excess moisture .

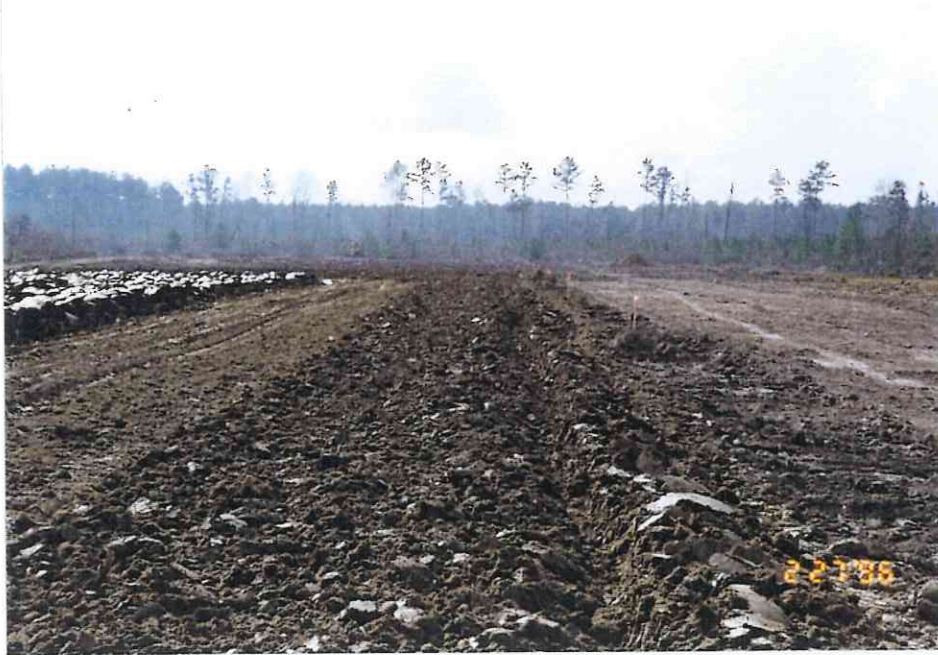
G960025-19 -O-P

19. Southeast arm at station 121+00 looking south showing the results of disking the windrow material.

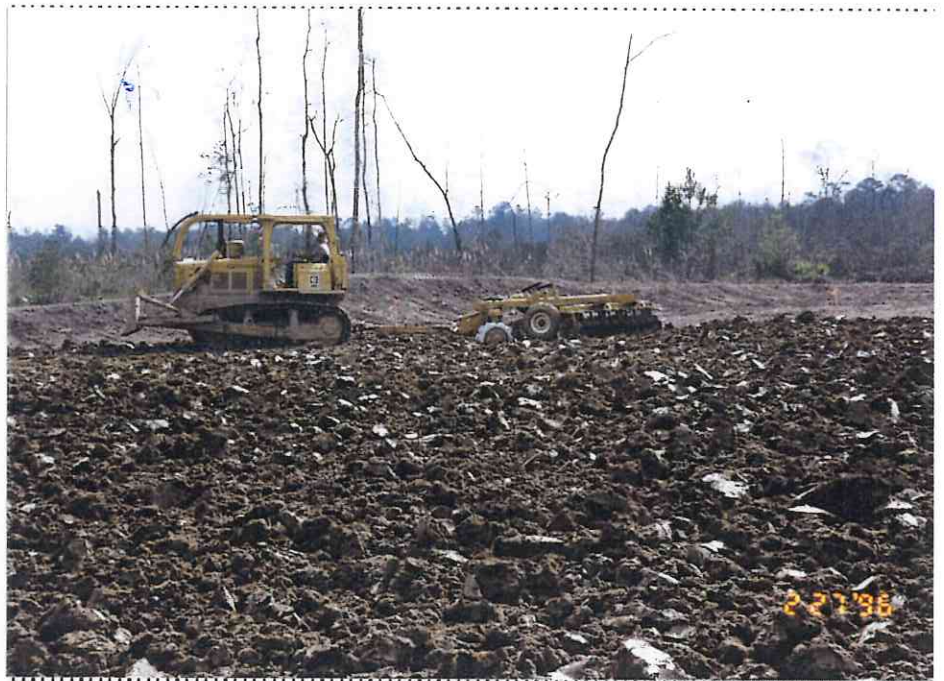
G960025-20 -O-P

20 Southeast arm between stations 119+00&121+00 showing disking operation.

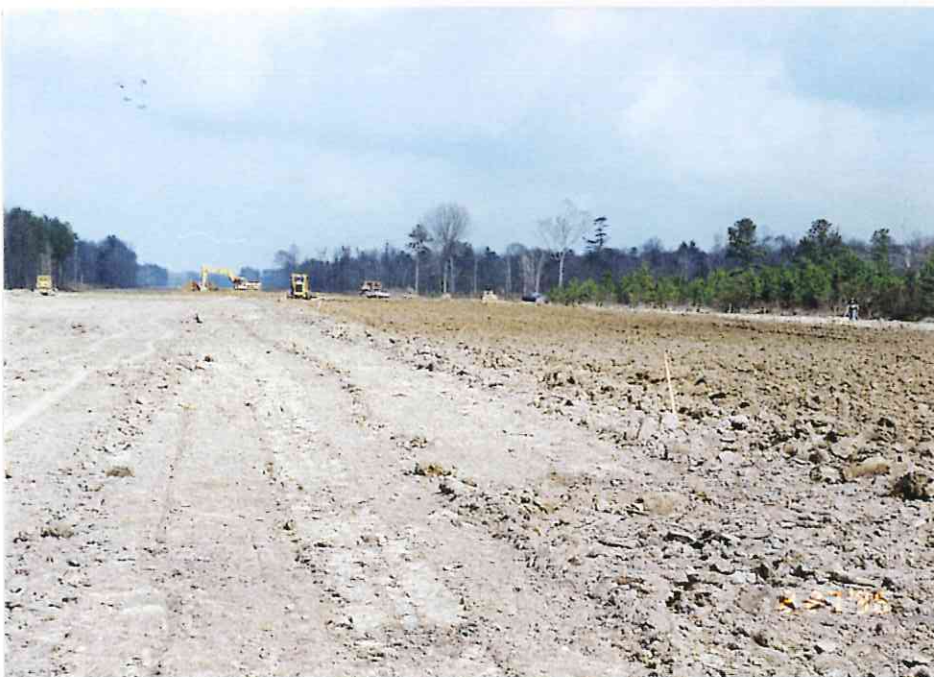
G960025-21 -O-P

21. Southeast arm standing at station 112+00 showing berm fill dried and ready for compaction roller.

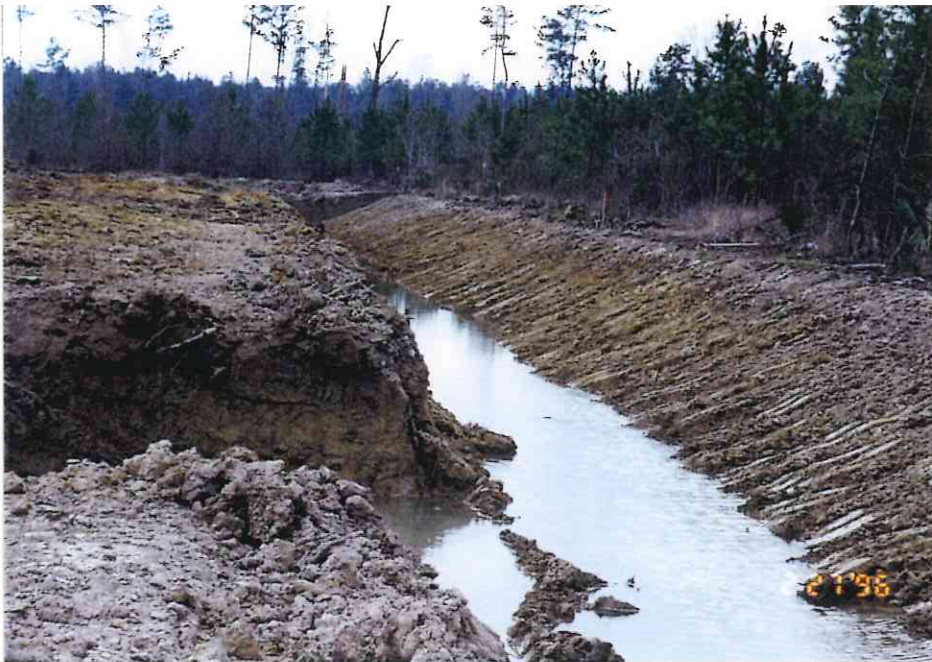
G960025-22-O-PV

22. Southeast Arm looking south at end station 131.23 , drain trench.

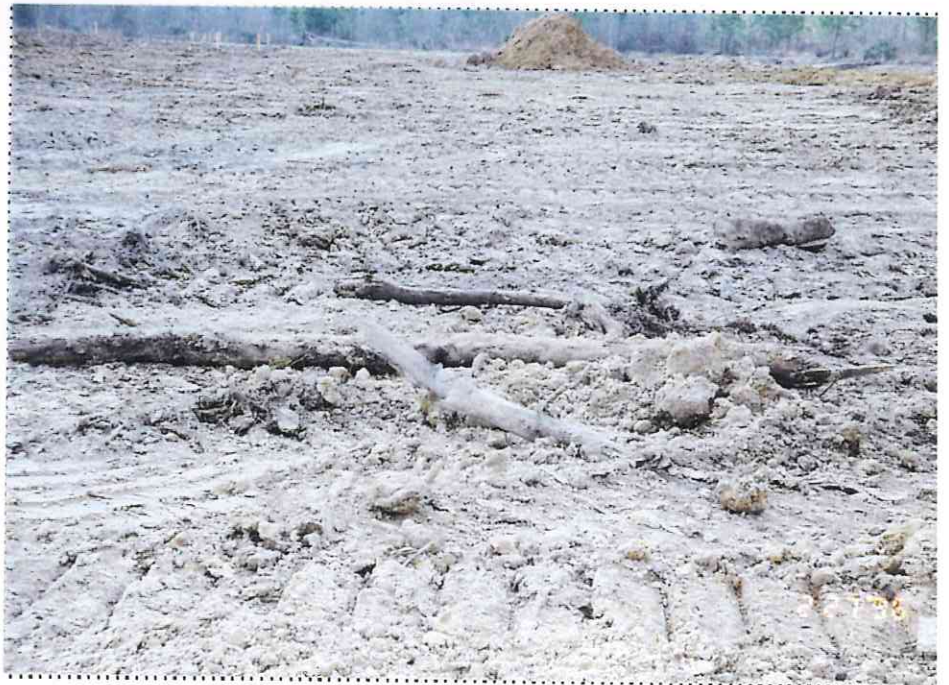
G960025-23-O-P

23. Southeast arm about station 129+00 looking south at tree parts in the foreground and excavated fill in the background.

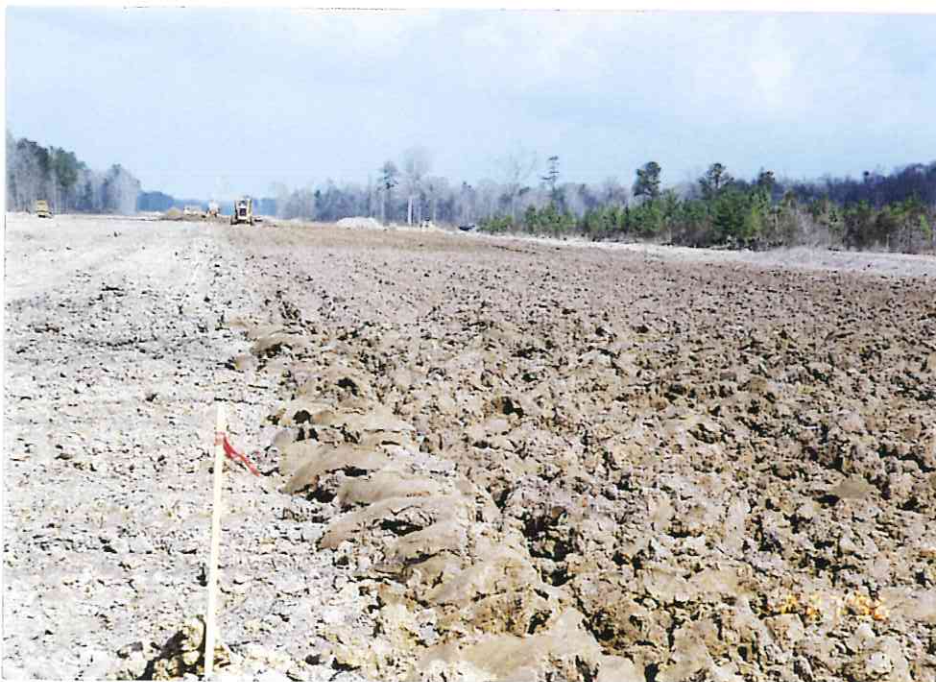
G960025-24-O-P

24. Southeast arm looking north at about station 129+00 fill drying operation.
