G960135-

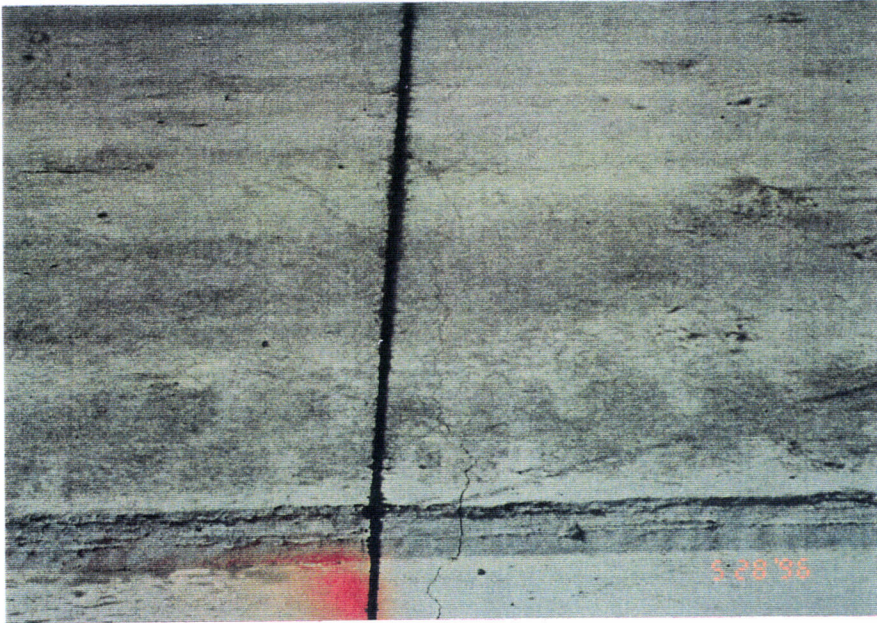
G960135-01-OP

At one location a natural crack developed at the time when the design joint was cut. The designed joint was sealed and the natural crack will be the expansion joint.

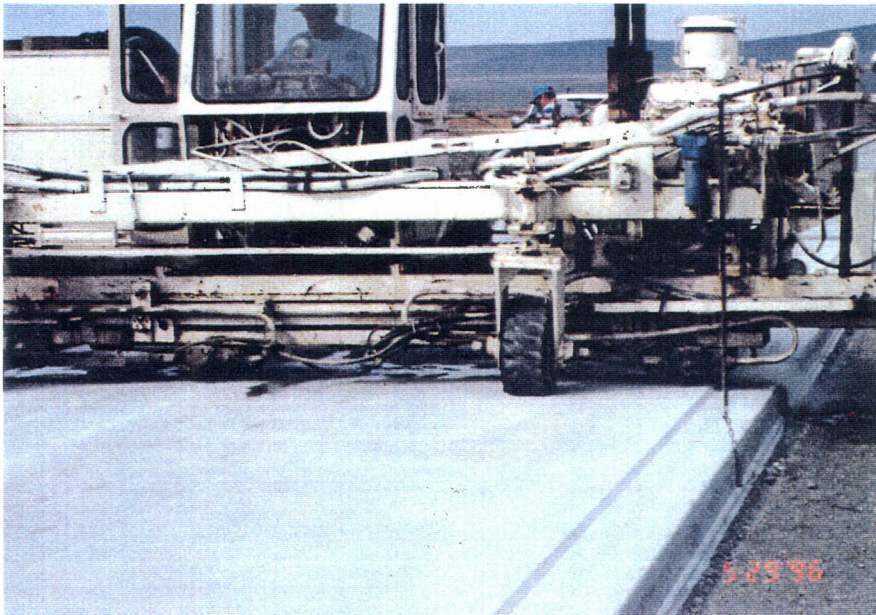
G960135-02-OP

Saw-cutting activities are ongoing

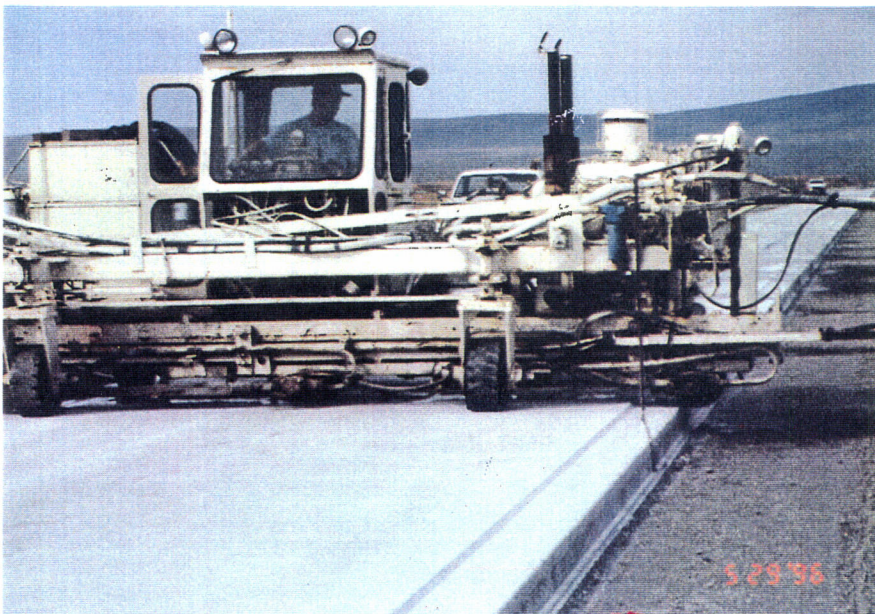
G960135-03-OP

Another view of the saw-cutting activity

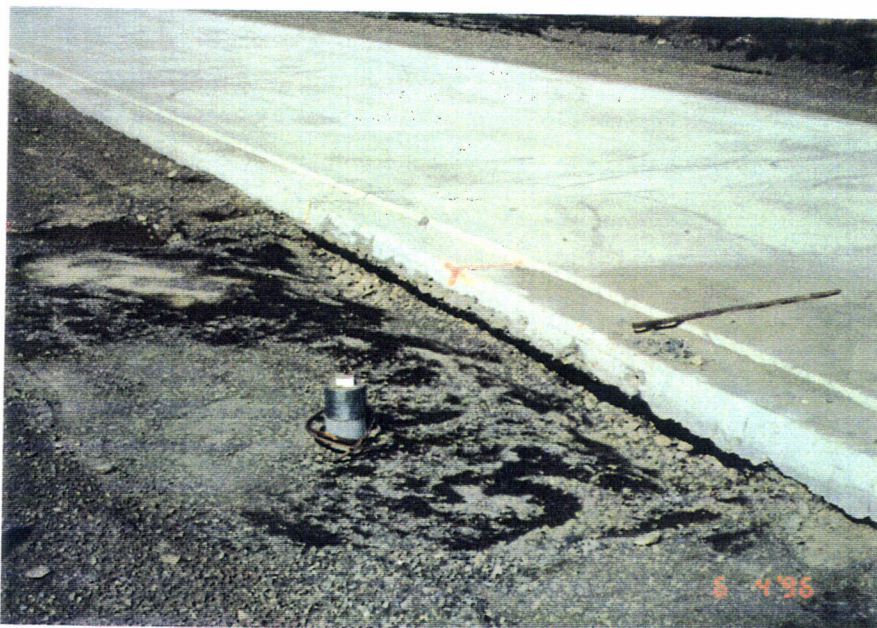
G960135-04-O-P

At the service entrance location the electrical contractor raised the bake-out conduit.

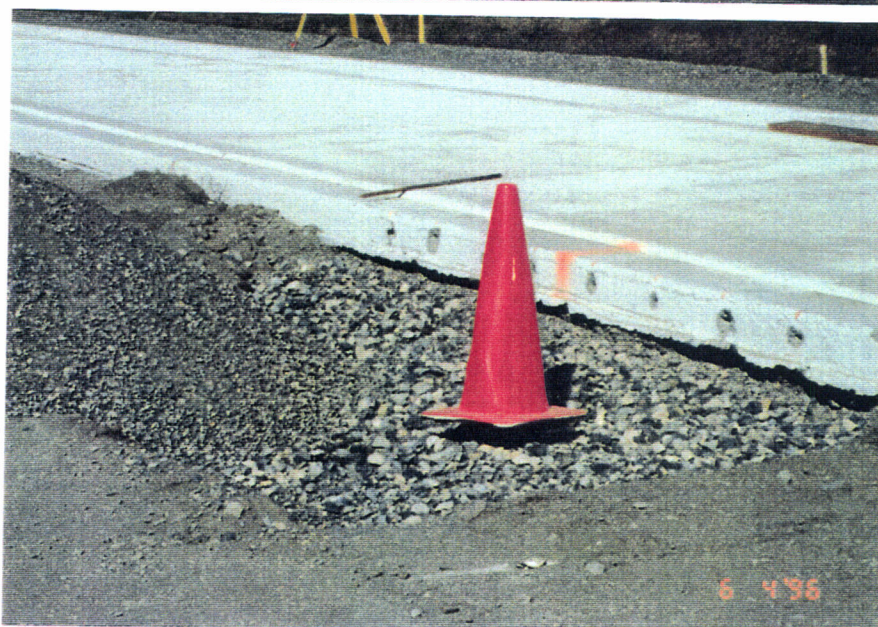
G960135-05-O-P

Typical bed preparation for the service entrance slab

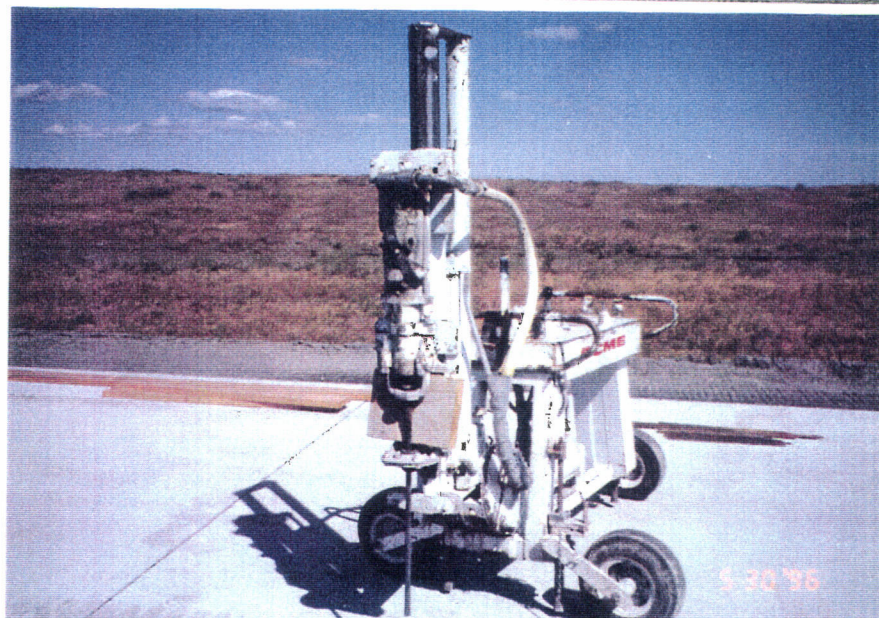
G960135-06-O-P

The equipment that was utilized to provide the dowel hole at the service entrances.

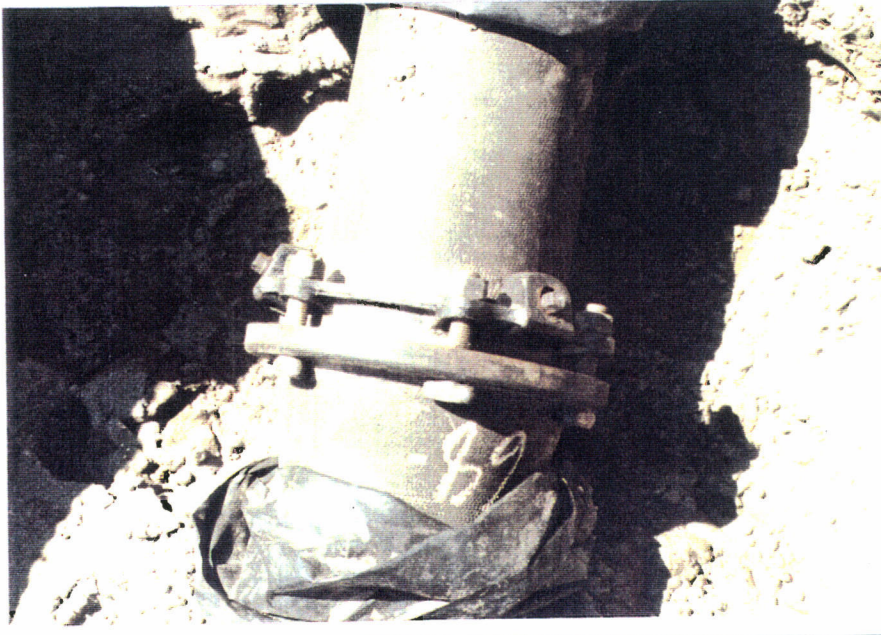
G960135-07-O-P

Typical fire water
pipe joint location

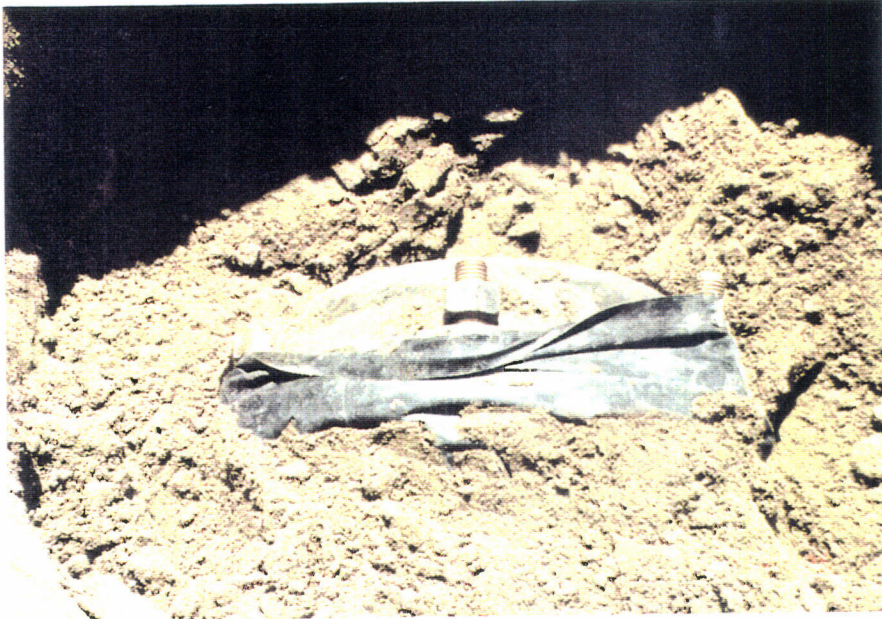
G960135-08-O-P

Typical installed end
cup of the fire water
pipe.

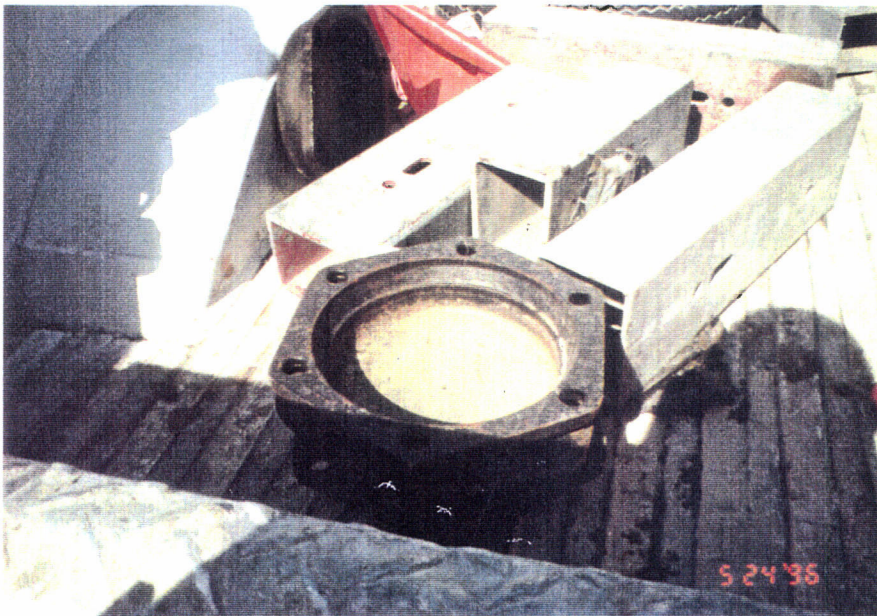
G960135-09-O-P

Typical pipe end
cup.

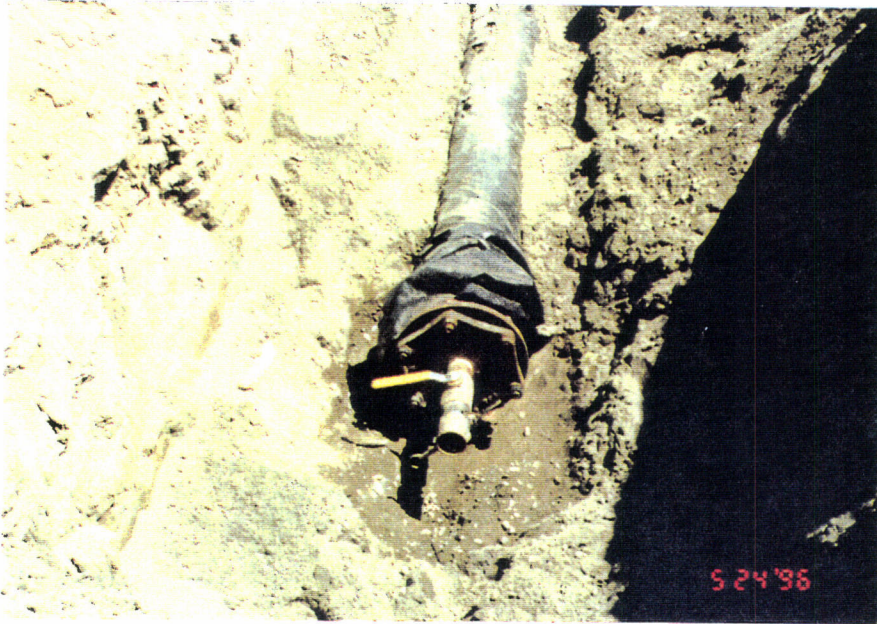
G960135-10-O-P

Fire water line hydro
test connection.

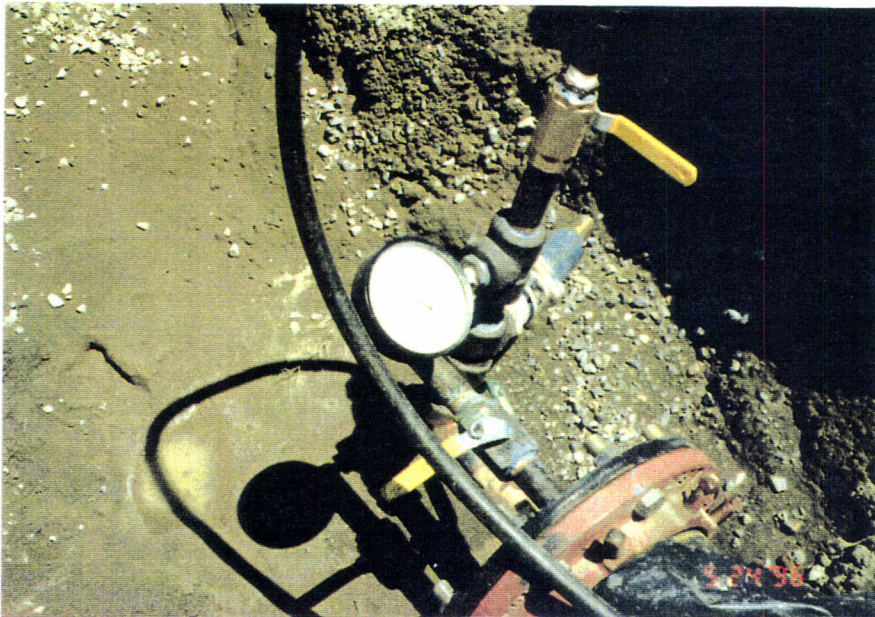
G960135-11-O-P

Fire water line
during the hydrotest
activities.

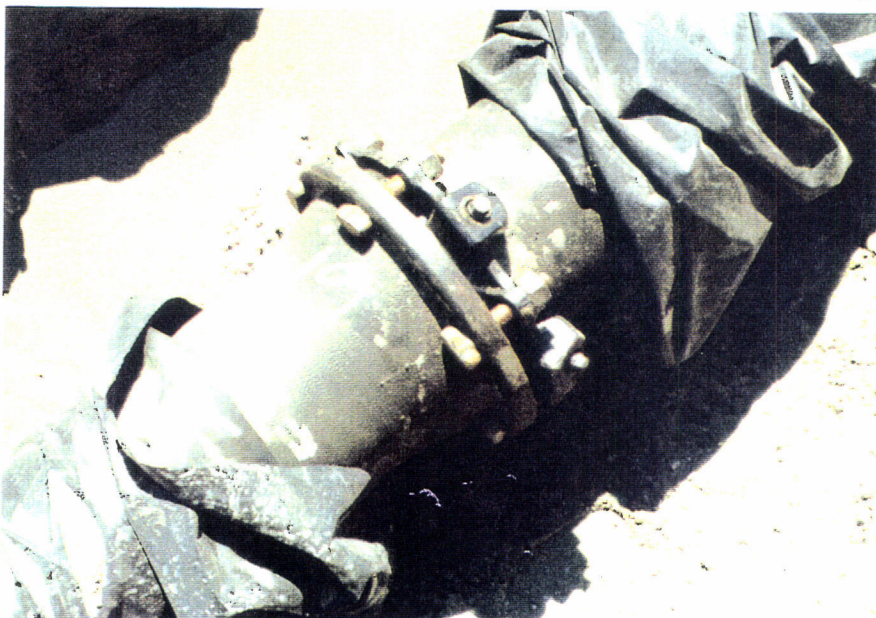
G960135-12-O-P

Leak check at the
flange during the
hydrotest activities.

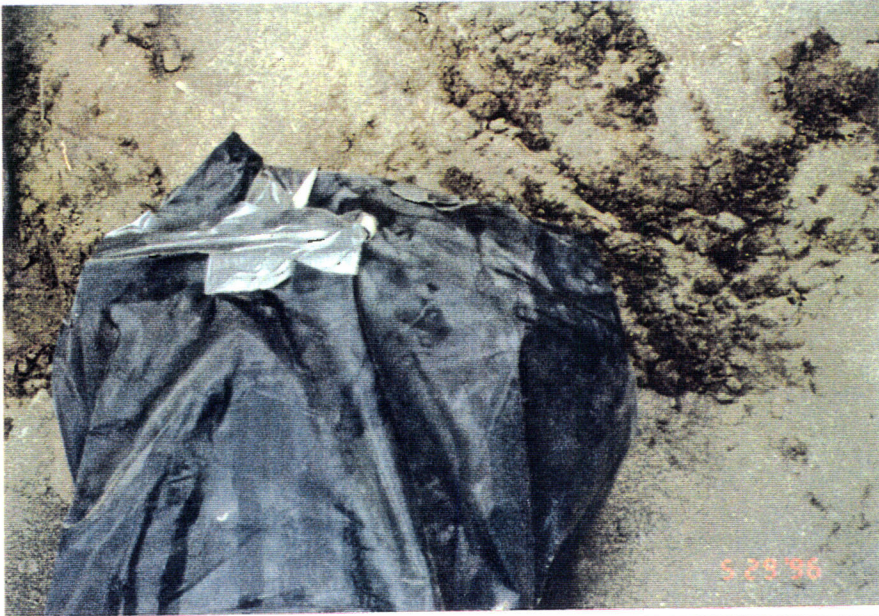
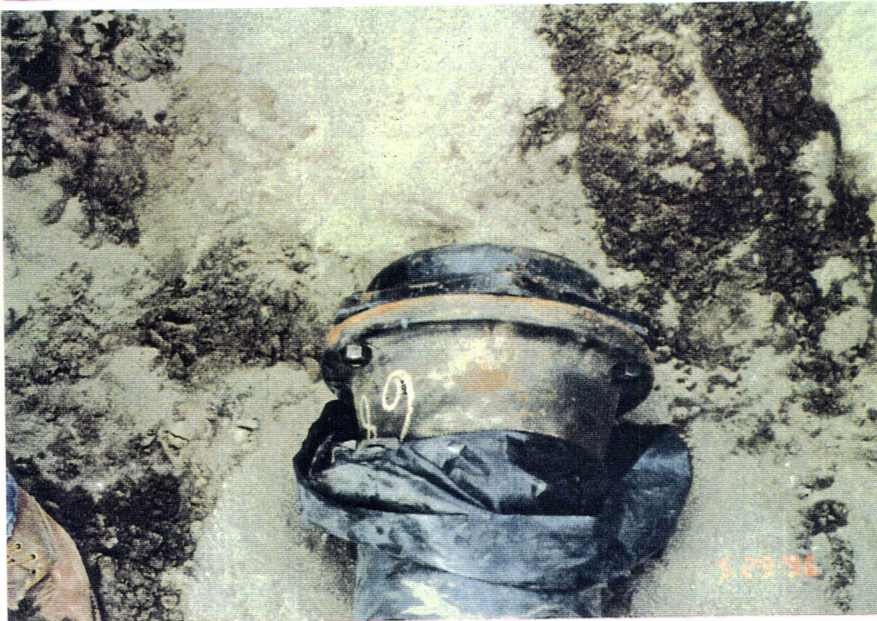
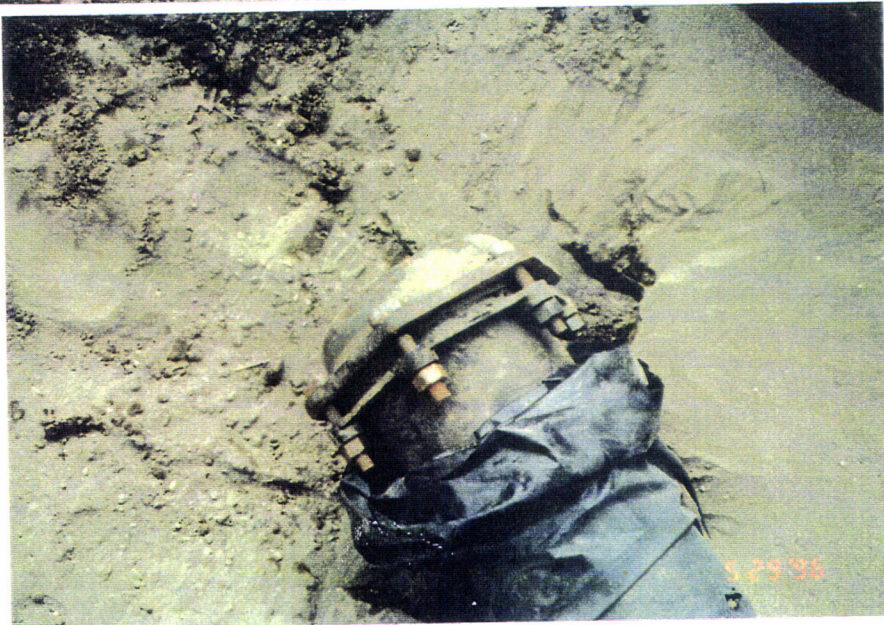
After the hydrotest was completed the pipe was wrapped and backfill commenced. (three view).
