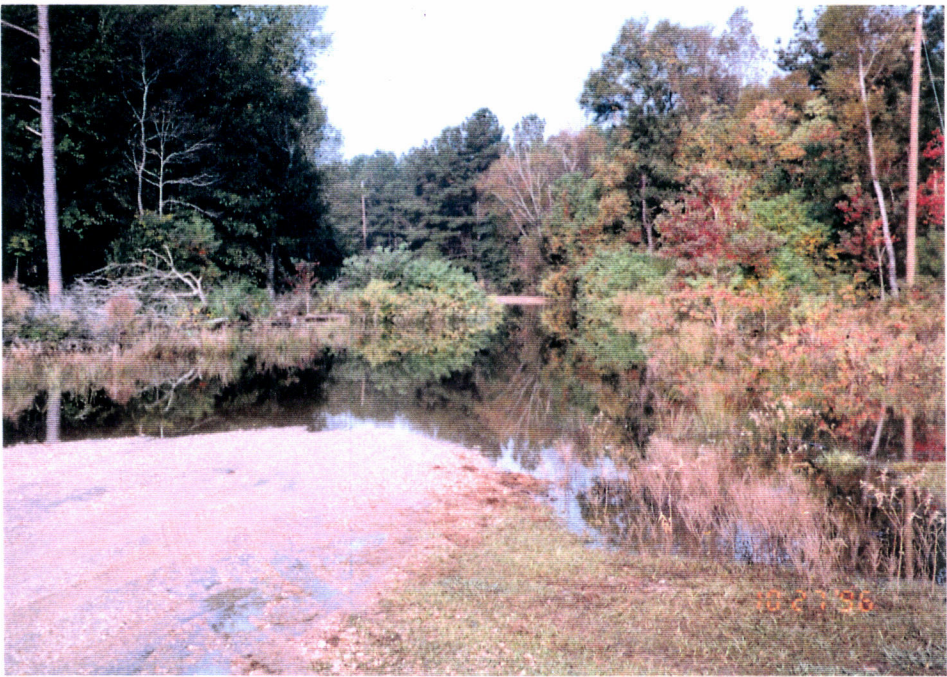
G960189-01 -O-P

1. Flooding at access road bridge.

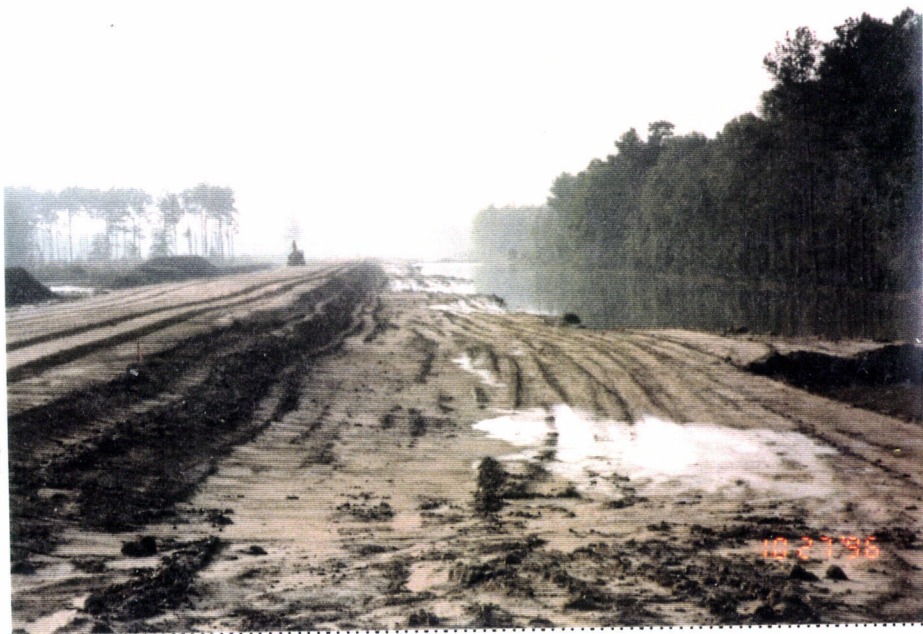
G960189-02 -O-P

2. Southeast arm at corner station.

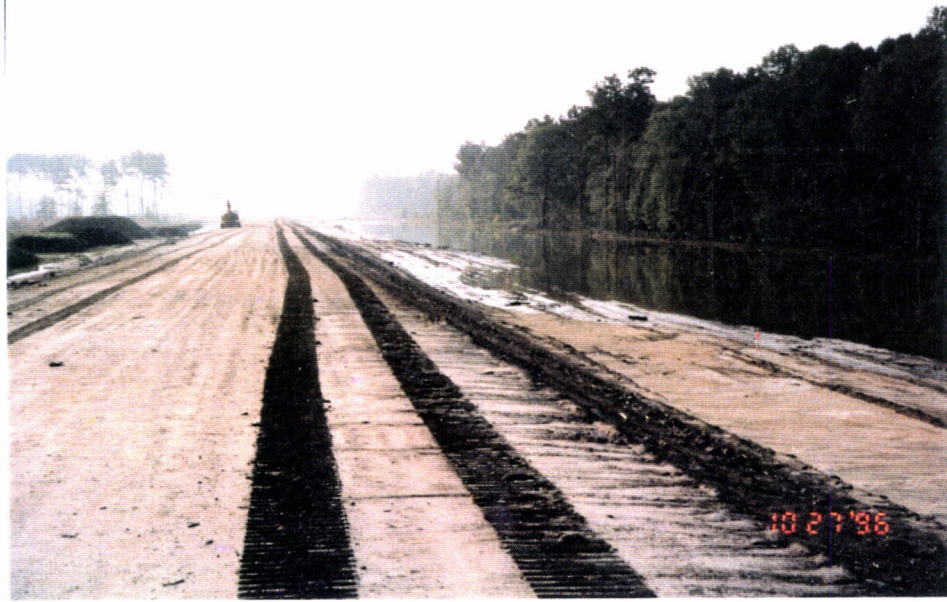
G960189-03 -O-P

3. Southeast arm at station 10+00.

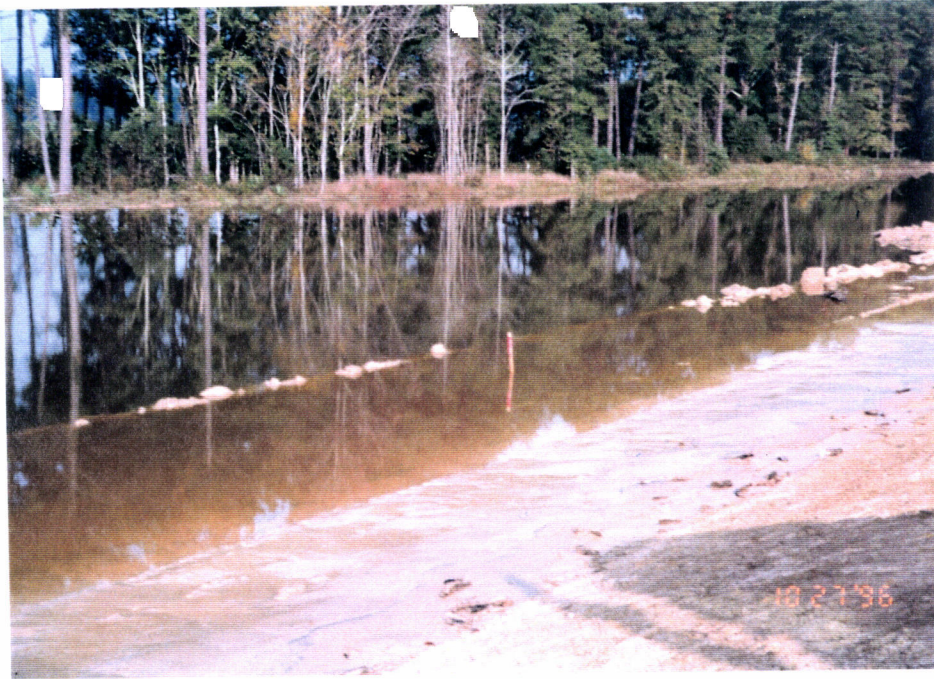
G960189-04-O-P

4. Southeast arm at station 27+00.

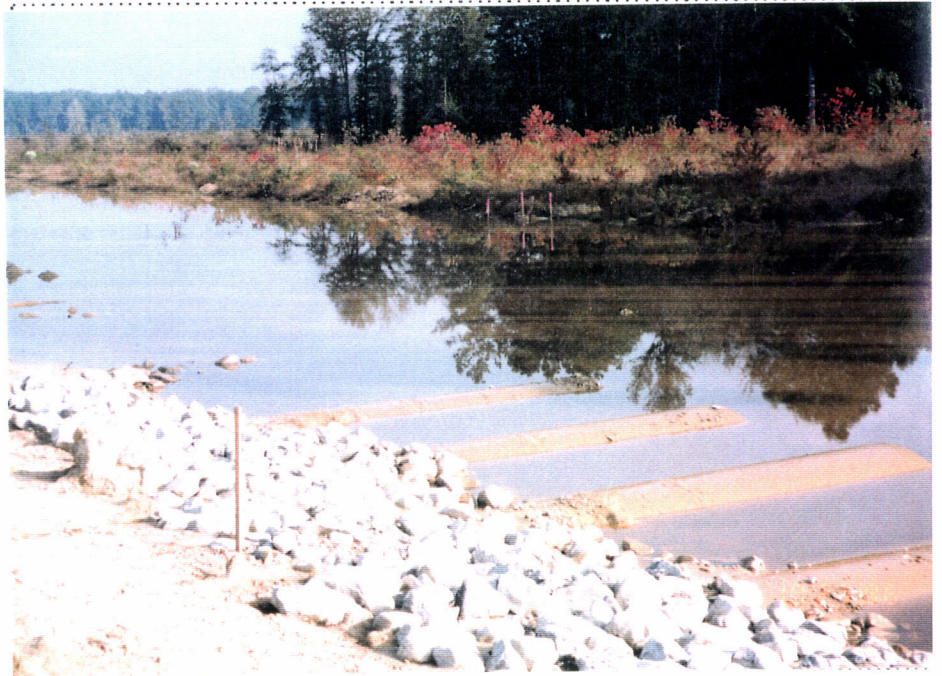
G960189-05-O-P

5. Southeast arm at station 27+00 at culvert crossing.

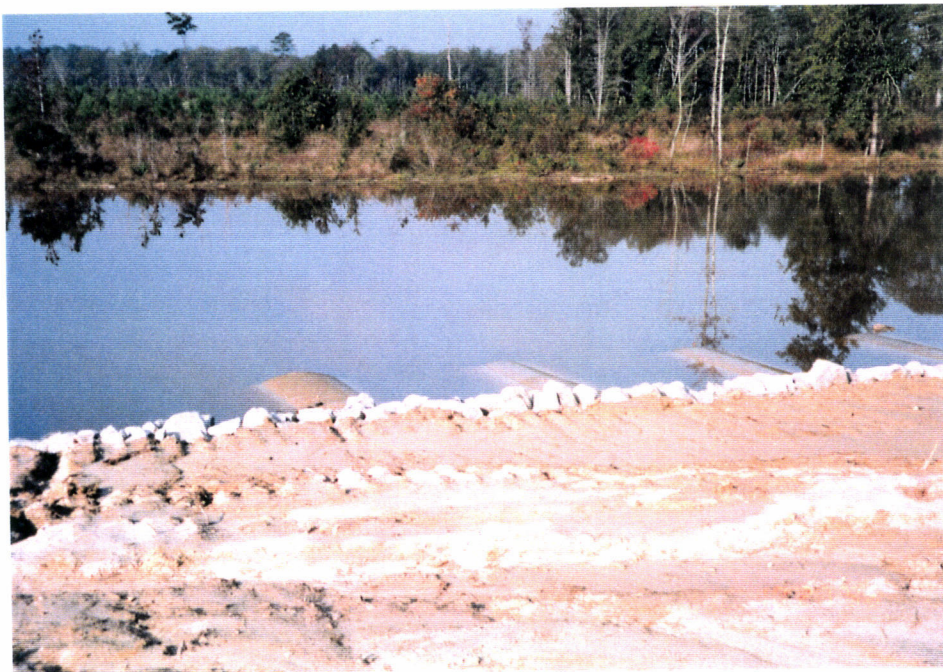
G960189-06-O-P

6. Southeast arm at culvert 27+00.

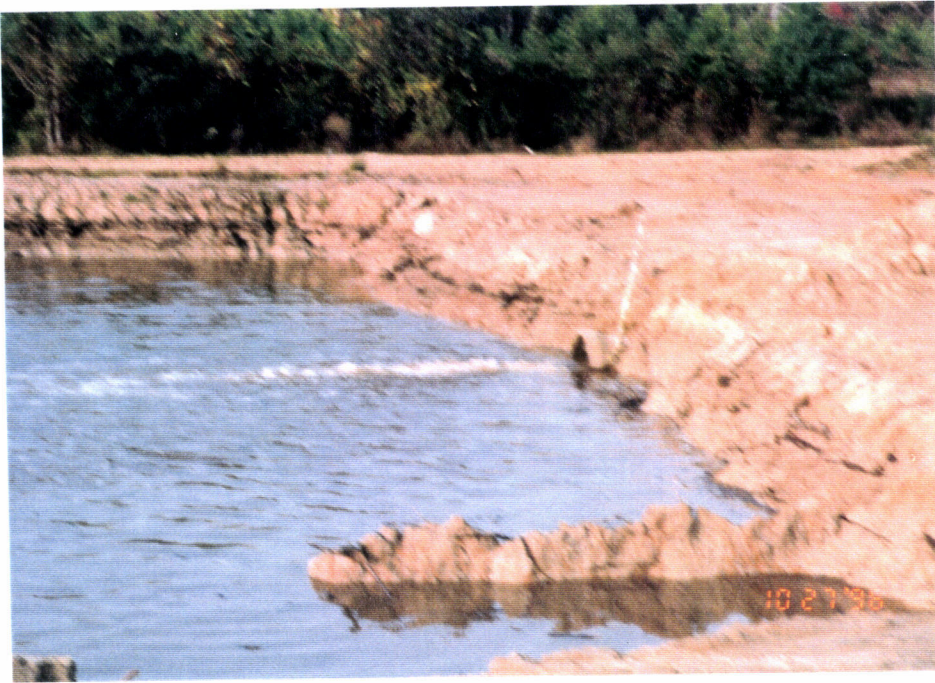
G960189- 07-O-p

7. Southeast arm at station 33+00 showing 24" line between trenches.

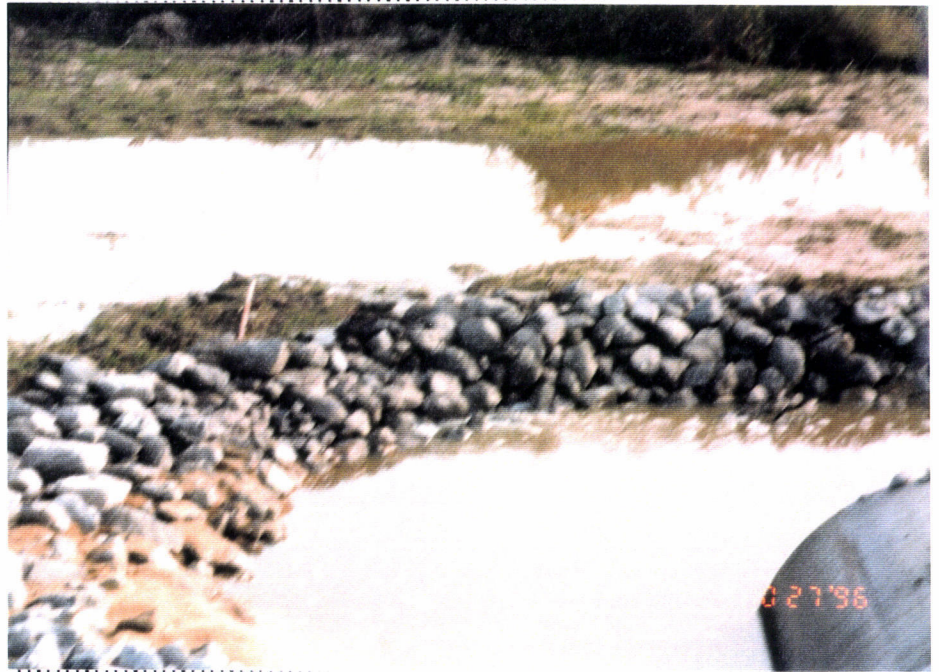
G960189- 08-O-p

8. Southeast arm at station 43+00.

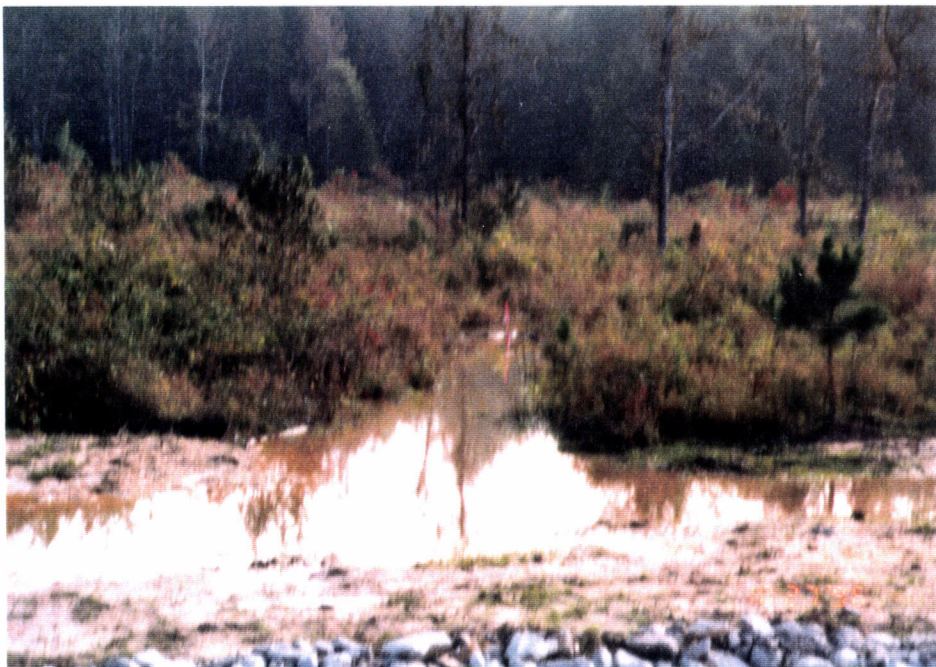
G960189- 09-O-p

9. Southeast arm at station 43+00.

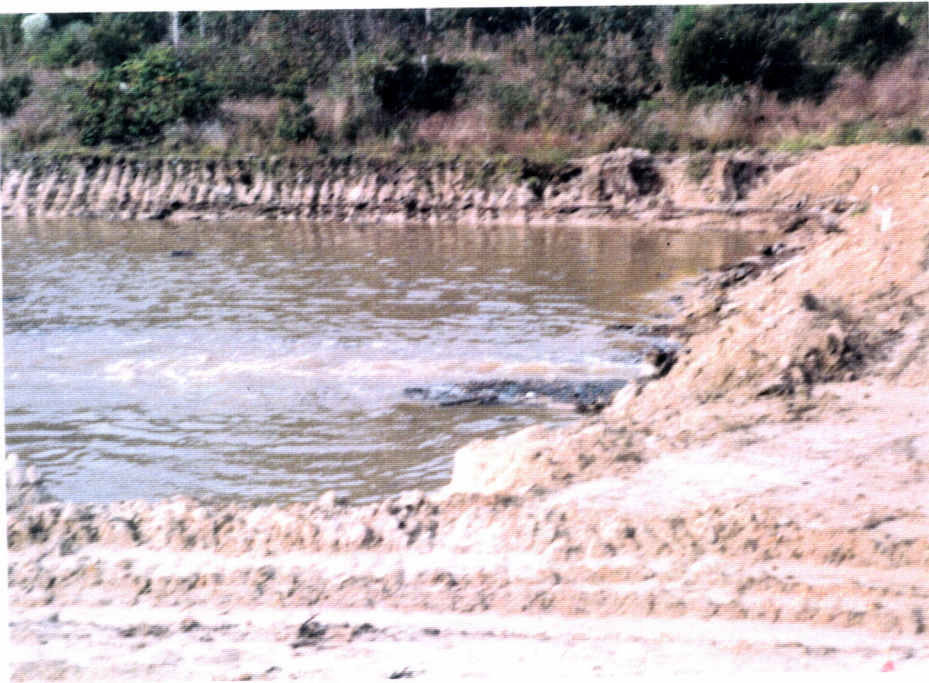
G960189- 10 -O-P

10. Southeast arm at station 87+00.

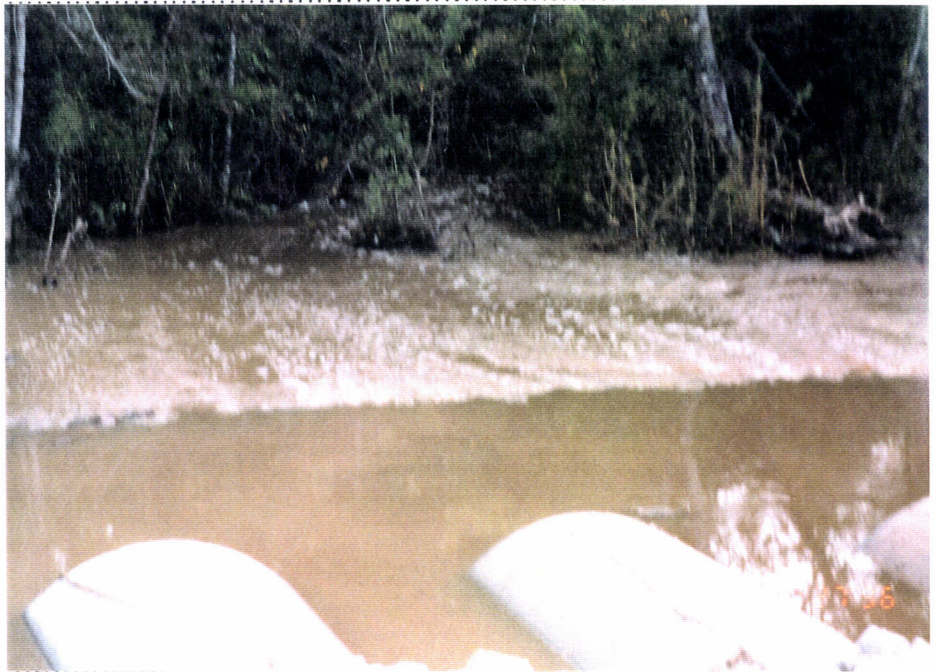
G960189- 11 -O-P

11. Southeast arm at station 83+00.

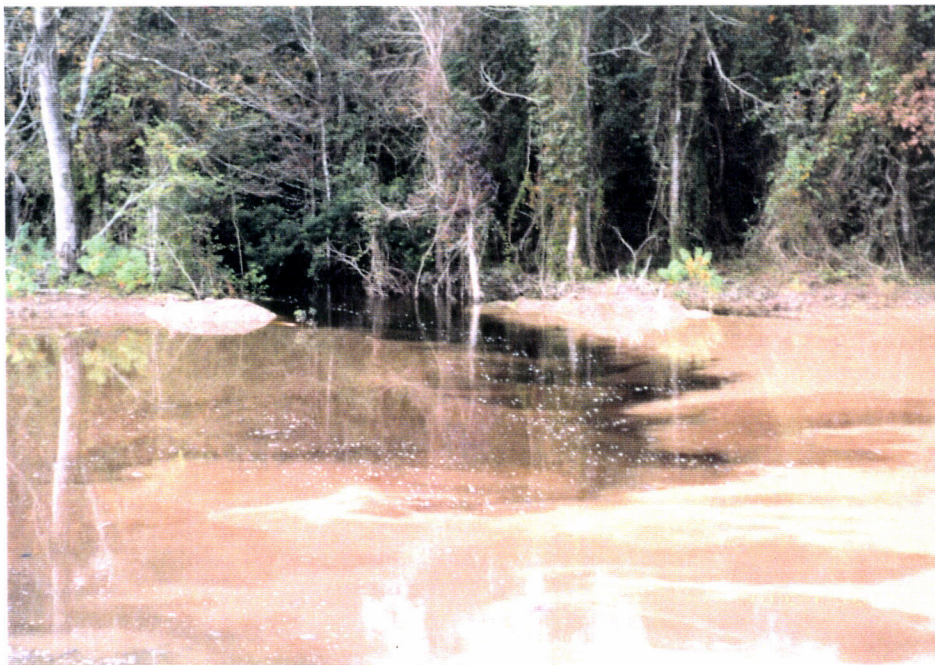
G960189- 12 -O-P

12. Southeast arm (#2) at station 106+00.

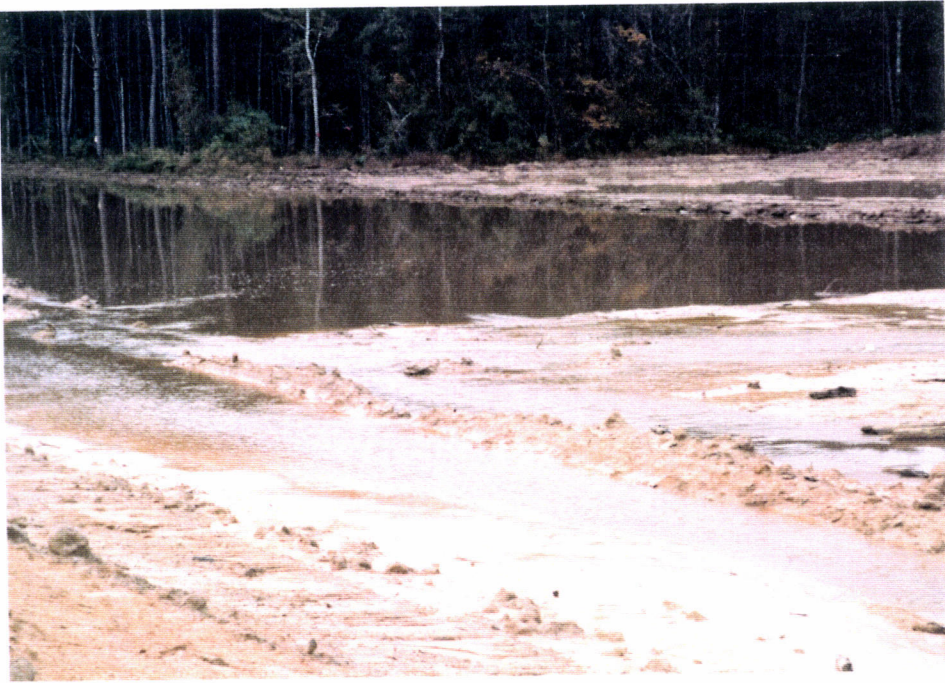
G960189- 13 -O-P

13. Southeast arm (#2) at station 90+00.

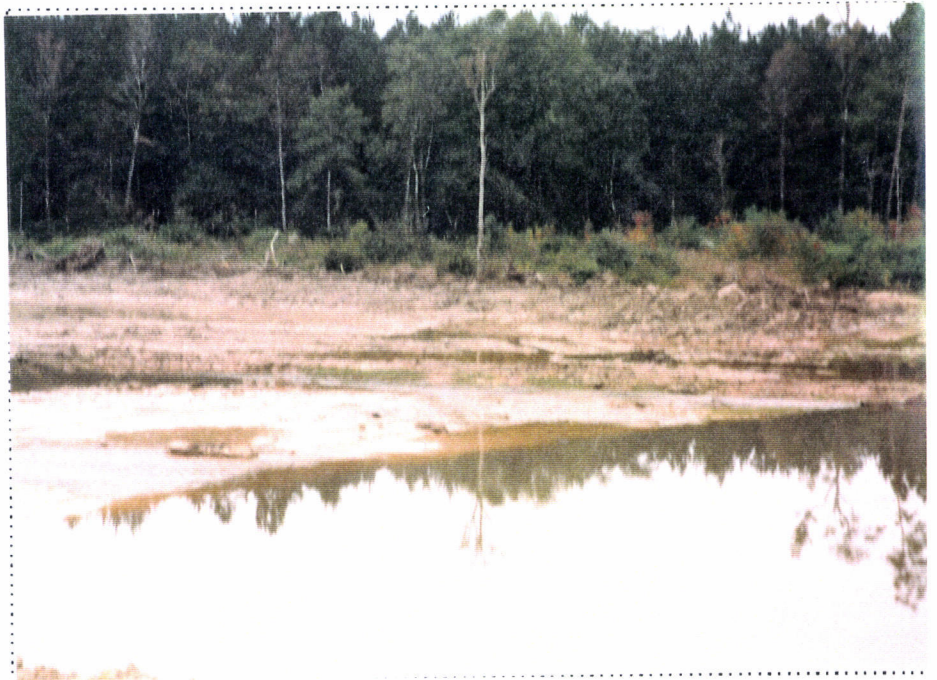
G960189- 14 -O-P

14. Southeast arm (#2) at station 90+00.

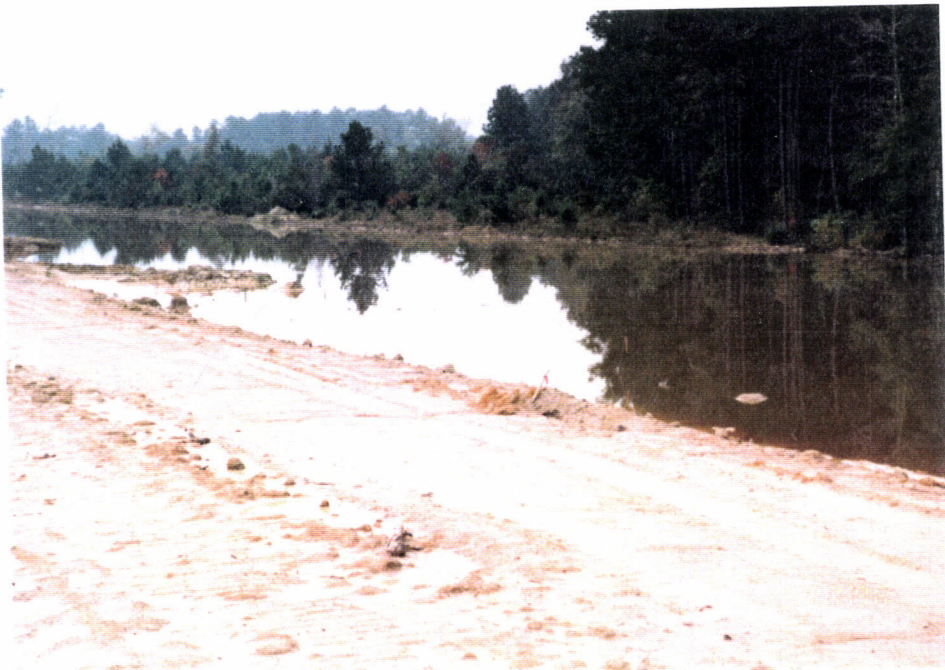
G960189- 15 -O-P

15. Southeast arm (#2) at station 106+00 inlet.

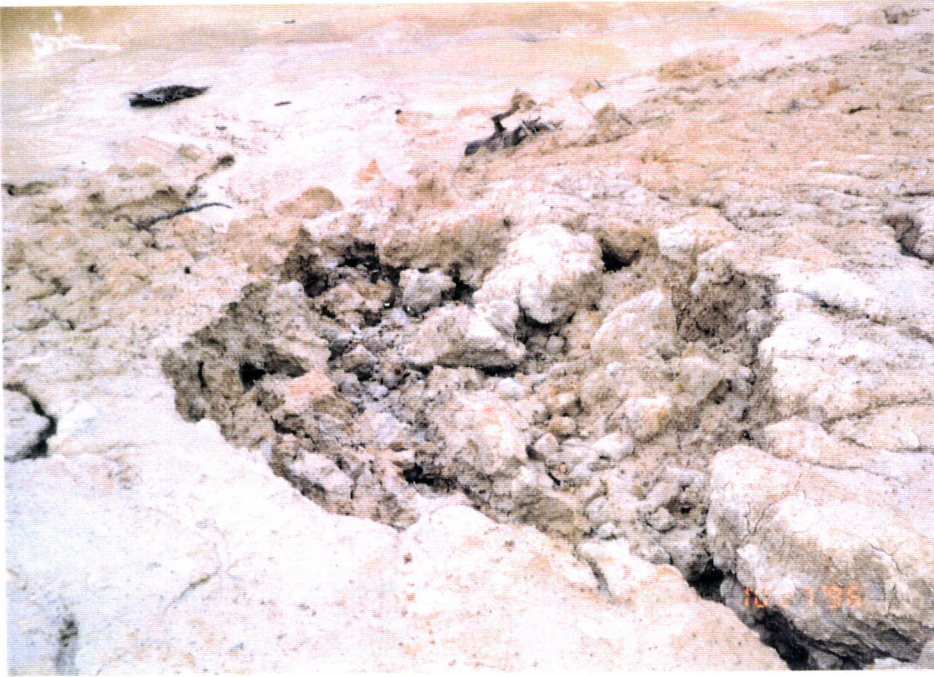
G960189-16 -O-P

16. Southeast arm (#2) at station 110+00 erosion to be repaired.

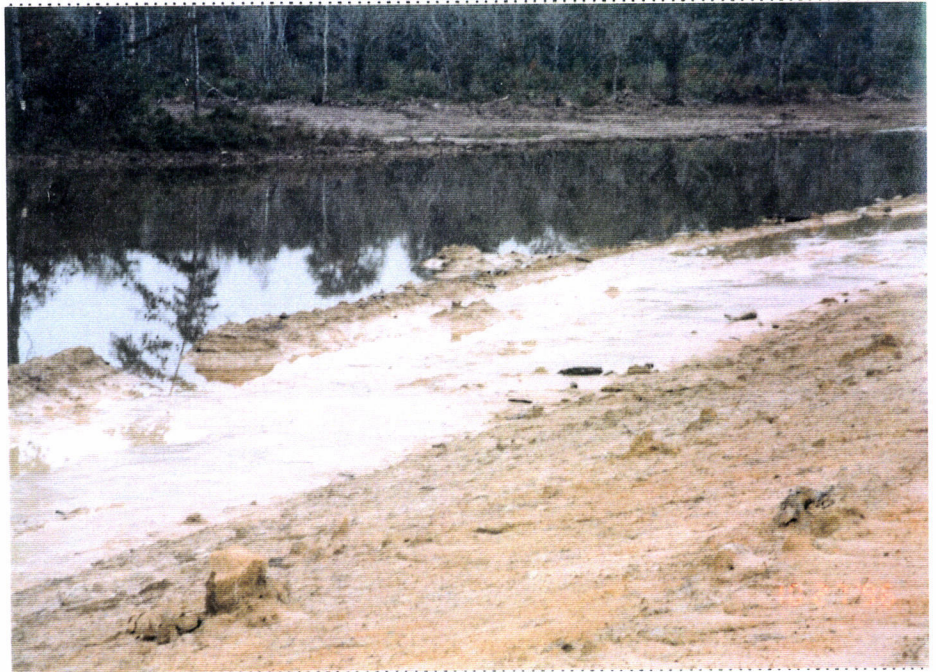
G960189-17 -O-P

17. Southeast arm (#2) at station 91+00.

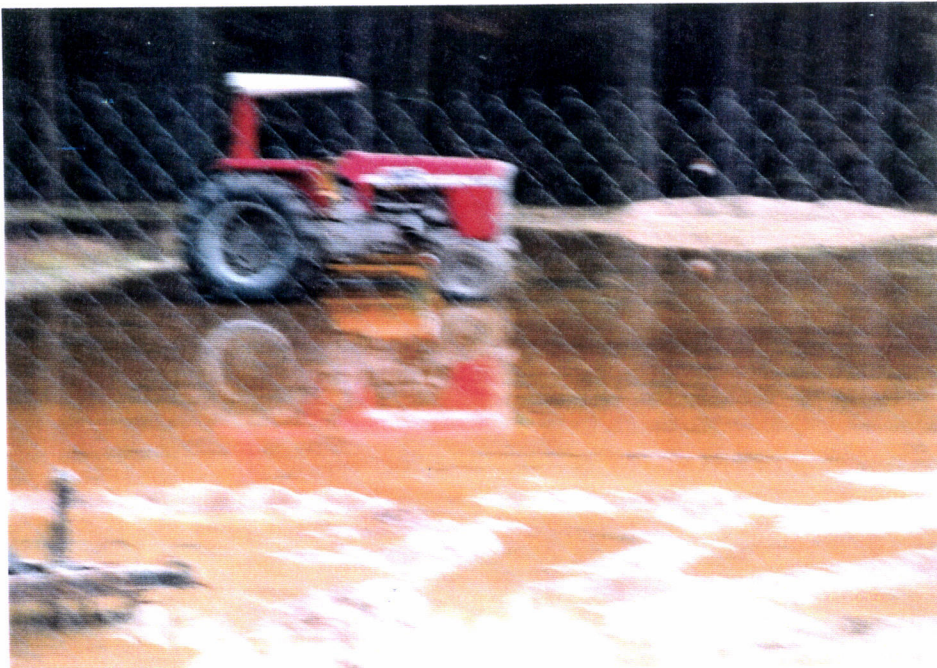
G960189-18 -O-P

18. East side of construction complex.

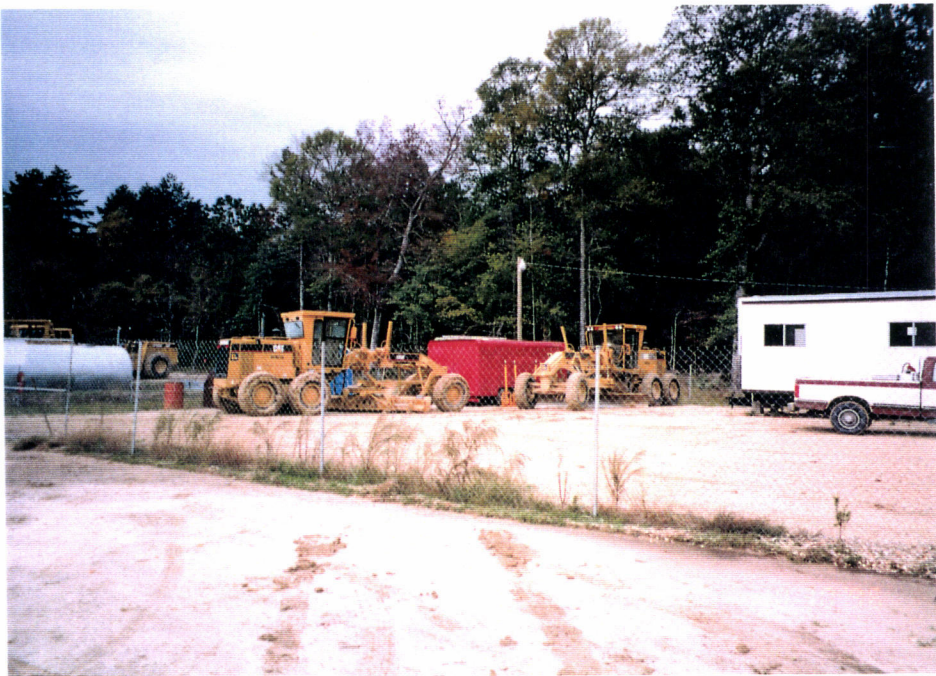
G960189-19 -O-P

19. Graders receiving laser monitoring equipment for fine grading.

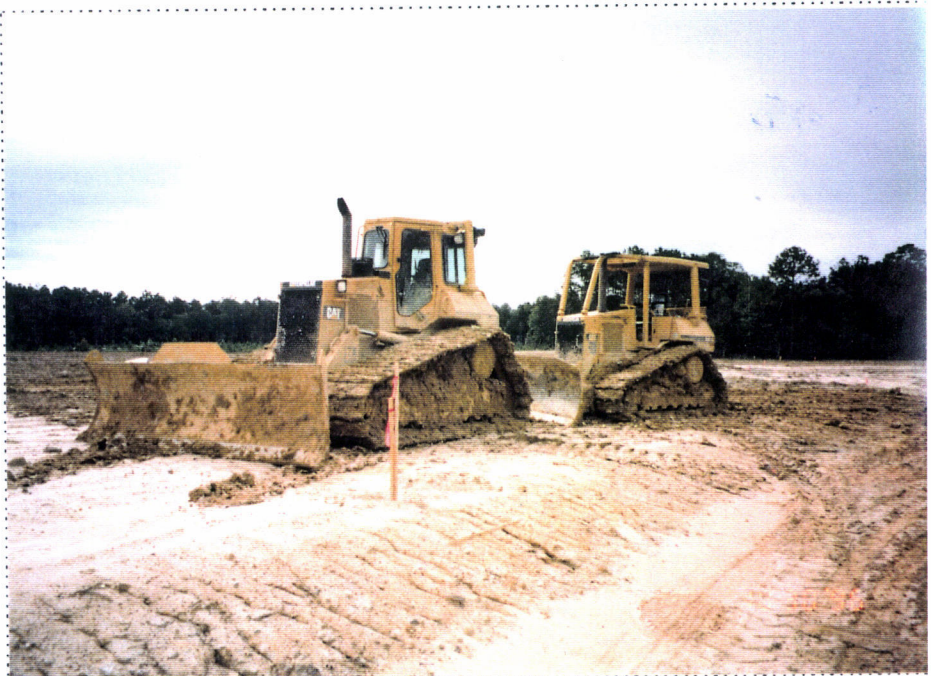
G960189-20 -O-P

20. Dozers parked, waiting for soil to dry enough to start the drying and compaction process.

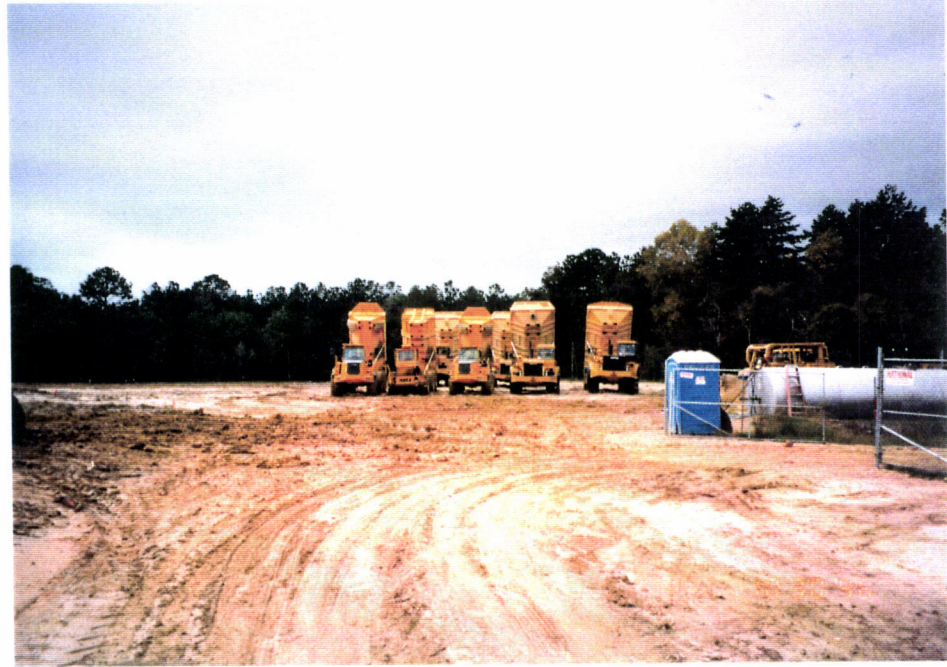
G960189-21 -O-P

21. Dump trucks standing by.

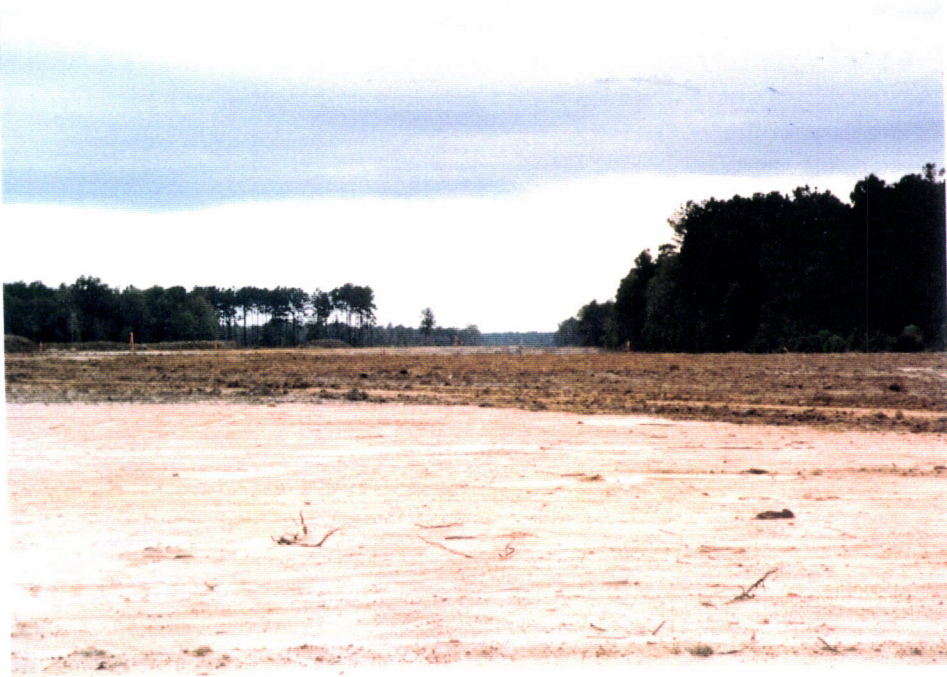
G960189-22-O-P

22. Northwest quadrant at center section showing the results of back dragging to remove puddles.

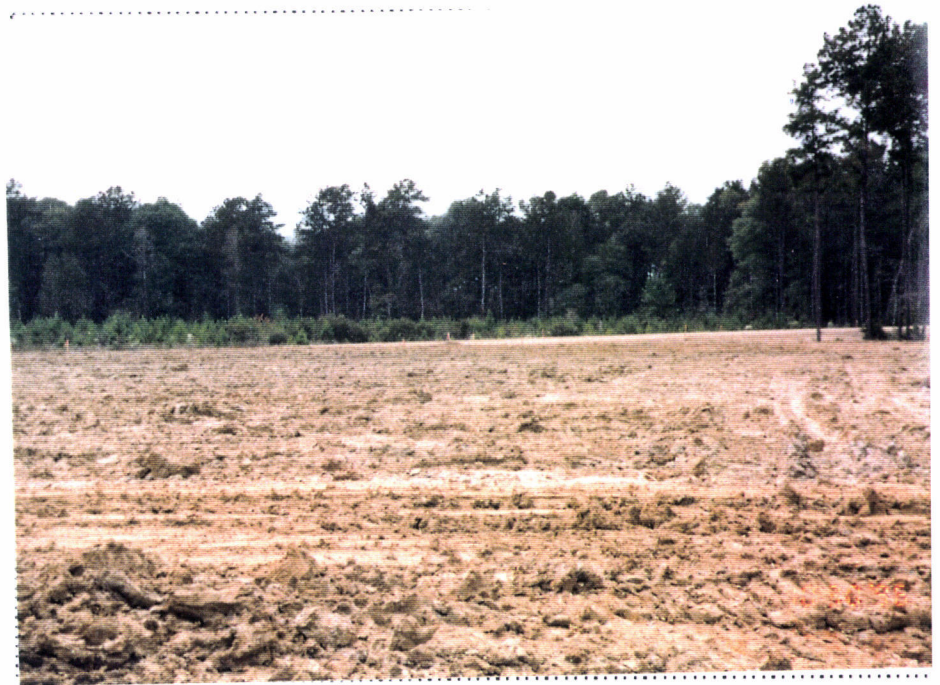
G960189-23-O-P

23. Same as previous photo #22.

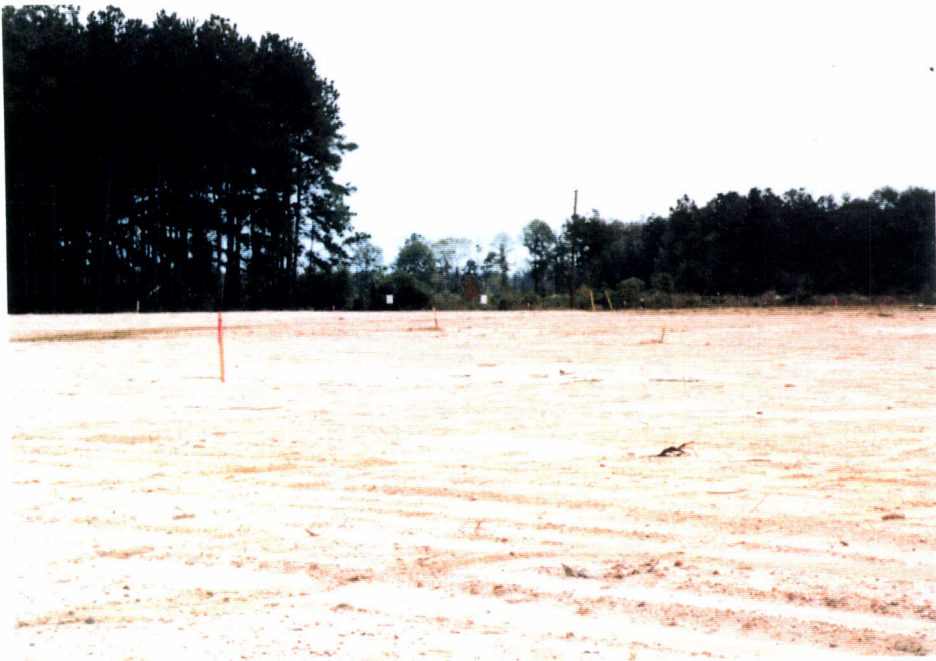
G960189-24-O-P

24. Corner station at NE quadrant showing puddling on rolled area.
