LIGO-T1200266-v3

May 21, 2012

Ground Loop Hunting on HXTS Suspensions at LLO

Kate Gushwa
Nichole Washington

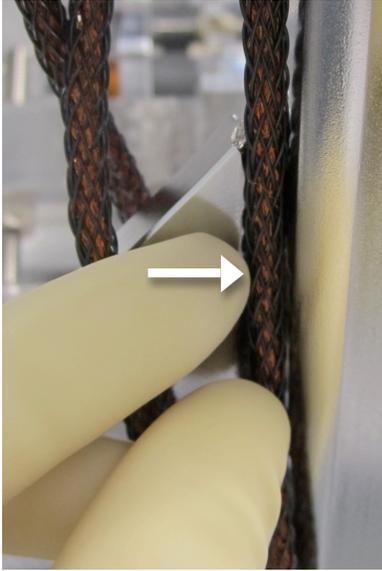
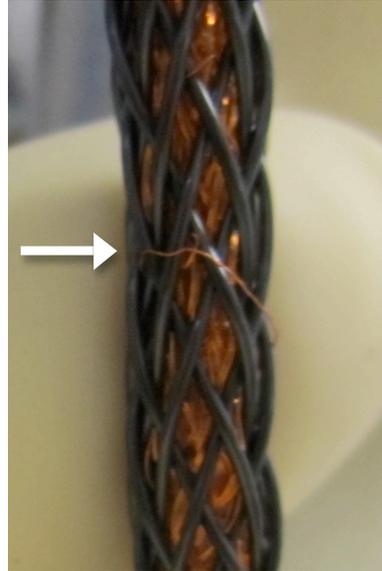
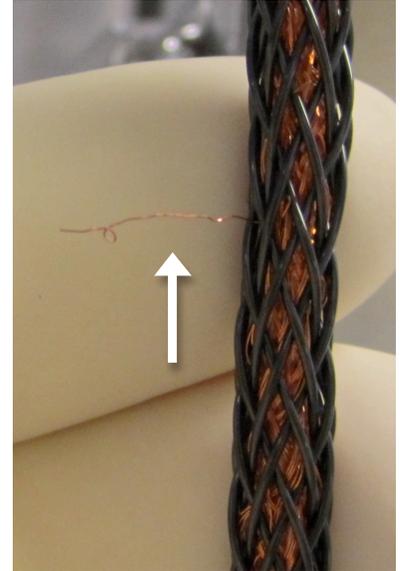
Figure 2. Location of the protruding copper strand

Figure 3. Cable pulled away and rotated to find strand

Figure 4. Strand unwound from leg

until the connection between the backshell and suspension was broken. On the Left Side (+Y) of the suspension, near the third gusset on the right leg, a stray strand of copper was found sticking through the PEEK overbraid. The initial placement of the quadrapuss made it impossible to see the protruding hair, which was sandwiched between the cable and the structure. Pulling the quadrapuss leg away from the suspension, and turning it slowly against a light backdrop (glove or wipe) made the tiny and highly reflective copper strand easier to find.

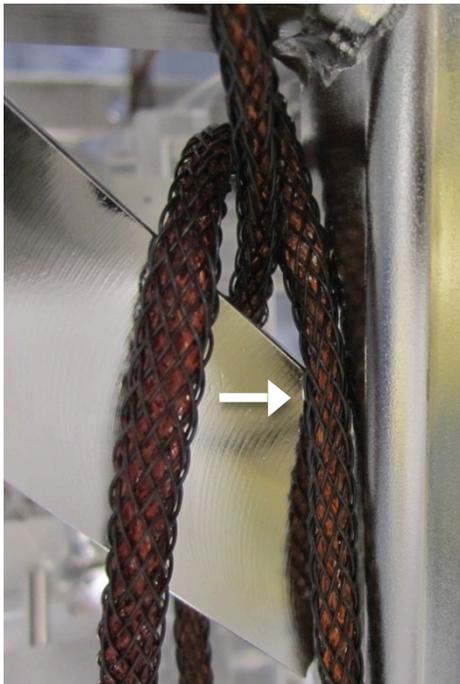
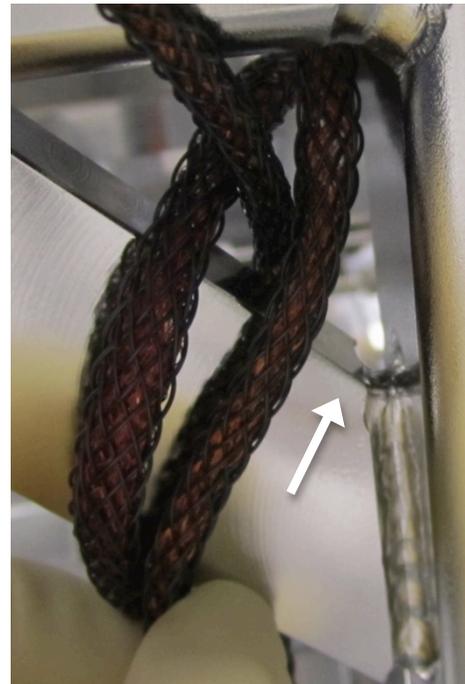
Figure 5. Top cable grounded by sharp notch in gusset

Figure 6. Grounding stops when cable pulled out of notch

The strand was snipped, but grounding continued. Wiggling the top cable near where the copper strand was found would start and stop grounding of the cable to the suspension. The movement would pull the cable into and out of a notch on the Left Side (+Y) where the top right gusset and suspension leg meet. All cables were pulled away from that sharp notch.

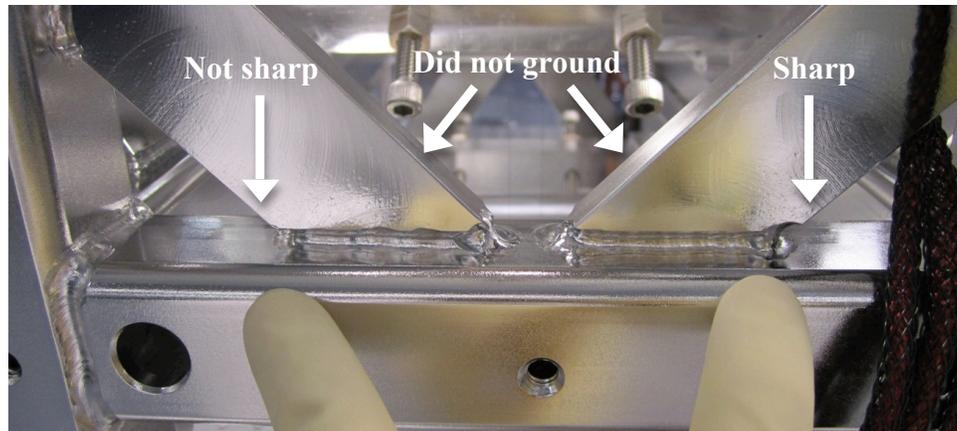
Figure 7. MC3 Left (+Y) – notch in third right gusset is much sharper than notch in third left gusset

If the Left Side's (+Y) top left gusset had a sharp notch, it seemed likely that its top right gusset would also have a sharp notch or that the corresponding legs on the Right Side (-Y) would cause grounding. This was not true. Not every notch is sharp, and not every notch would cause

grounding. MC3's gussets are not symmetrical, so the location of potentially hazardous notches was variable. This observation led to the grounding mitigation techniques described in Section 3.

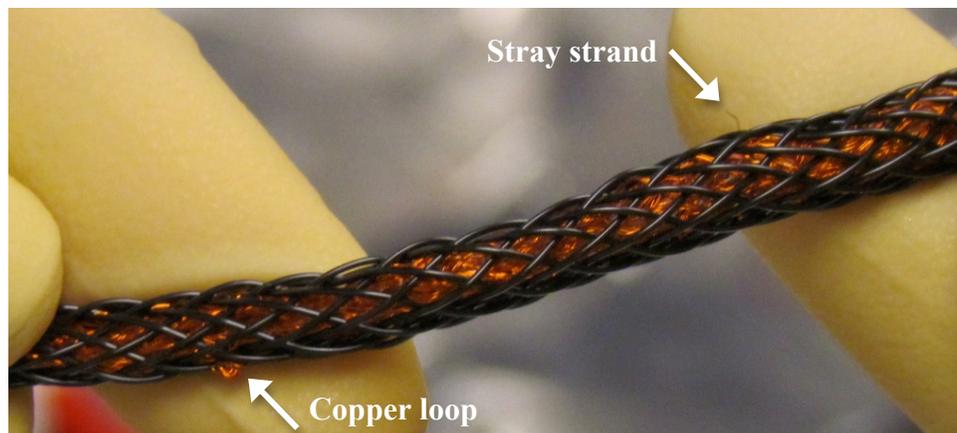
Figure 8. MC3's top shared quadrapuss

When grounding had been corrected, cables were gently pulled and prodded to induce a ground loop. Moving the cables around emphasized flaws in the top shared quadrapuss. Stray copper hairs were snipped, and protruding loops of copper were gently pushed under the PEEK overbraid with tweezers. Even when pressed against the edge of a gusset with more force than they should normally encounter during routing, the quadrapusses did not ground to the structure. However, the top cable frequently wedged back into the problematic notch when handled. As an experiment, a strip of aluminum was molded over that notch to prevent contact with the cable's copper shield. The quadrapuss could not be grounded to the structure while the strip was in place. This was captured in a video, [LIGO-T1200216](#).

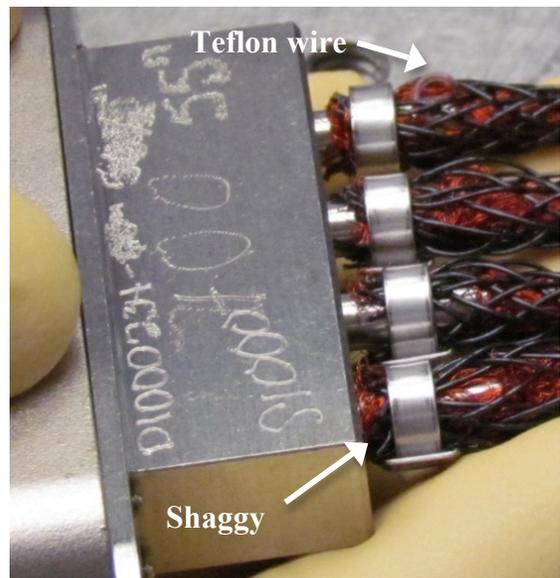
The estimated required length was 60" for the bottom, intermediate, and top shared cables. There were none on site, so 55" and 66" quadrapusses were used instead. The 55" bottom and intermediate cables had hairy snouts and loose double band-its. Due to time constraints and limited cable inventory, these issues were not corrected. The cables need to be refurbished or replaced.

Figure 11. Shaggy 55" quadrapuss

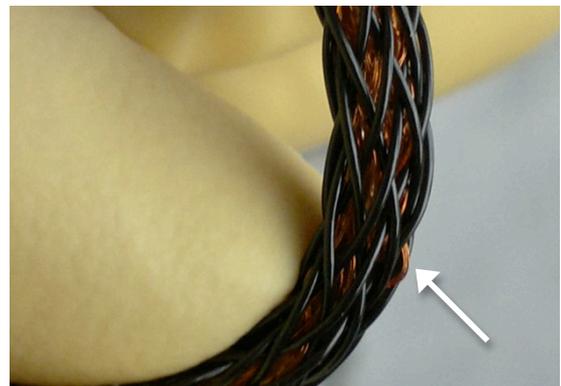
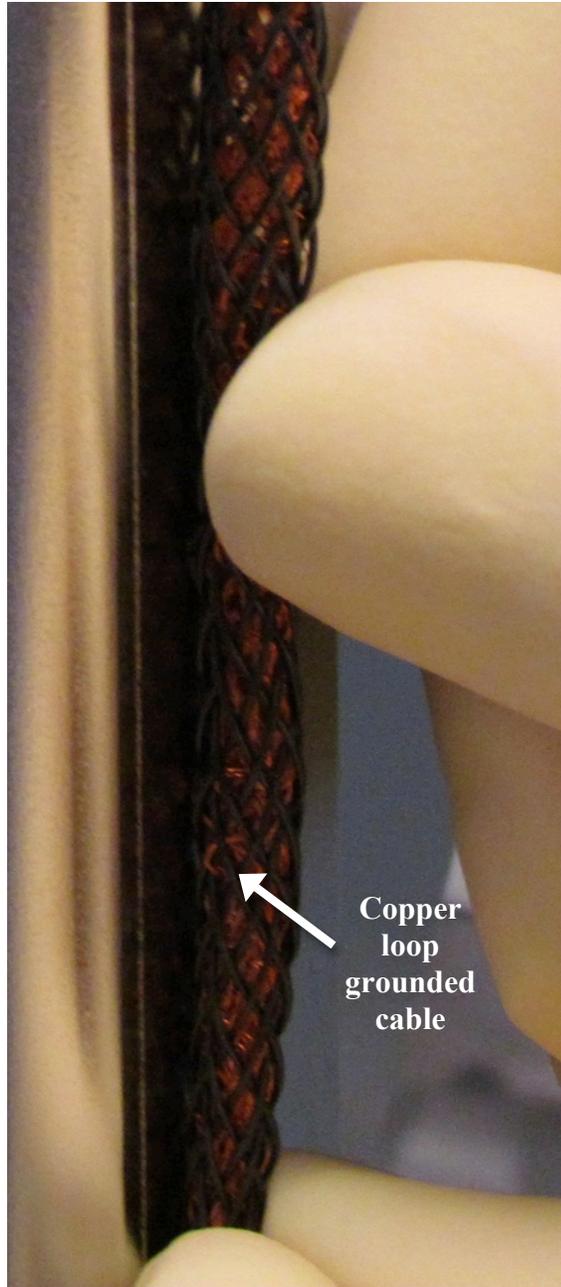
The top quadrapuss was routed last, and was the only cable to cause ground loops. Many stray hairs and tiny copper loops were found protruding through the PEEK overbraid. The copper shield on the top quadrapuss was very loose, and had a "spiderwebby" appearance when held up to a light. Those copper loops poked into other quadrapuss legs, creating shield-to-shield contact between multiple

Figure 12. Copper loop on 78" cable

Figure 13. Spiderweby 78” quadrapuss

All six of the 78” quadrapusses on site had a spiderweby copper shield. When gently laid on the table, the cables would immediately become grounded. The best-looking 78” cable was selected, routed on SR2, and created ground loops in all the cables. After many tries to correct the problem, all but the top shared cable were grounded to the suspension. Additional 78” quadrapusses were shipped to Livingston so SR2’s top cable could be replaced.

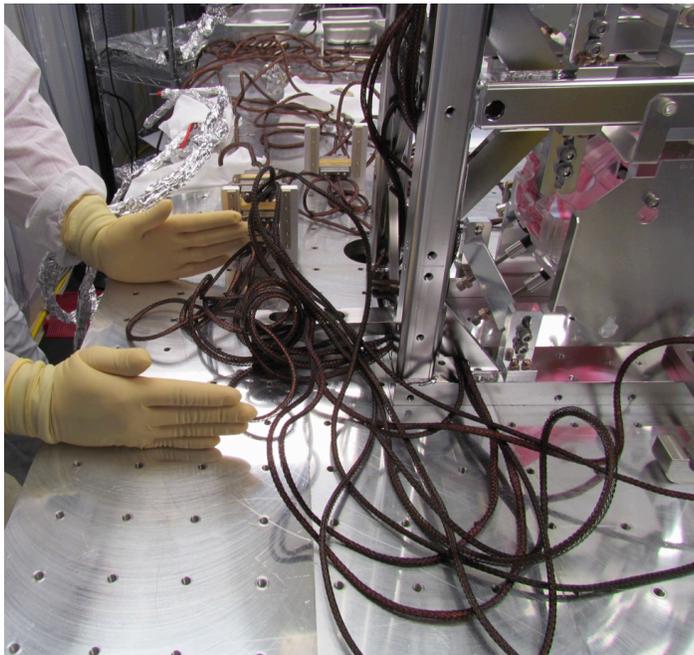
Figure 17. Portion of MC1's top cable that grounded to the table when pressed

Repositioning the bottom SRS and quadrapuss cables, or pushing them against the table did not create a ground loop. However, pressing them into the sharp edge of a dog clamp, AOSEM Alignment Assembly ([LIGO-D0902208](#)), or Barrel EQ Stop Assembly ([LIGO-D0902201](#)) did cause grounding. The intermediate and top shared quadrapusses were not grounded, but would be if their legs became wedged into certain notches. The top cable was not grounded either, and a ground loop was difficult to force in the routing up the suspension. The first few inches of the top cable routing along the table did ground when pressed down. This area should be re-checked before MC1 is moved into HAM2.

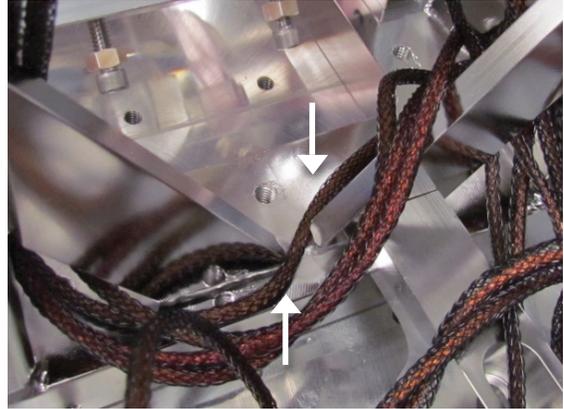
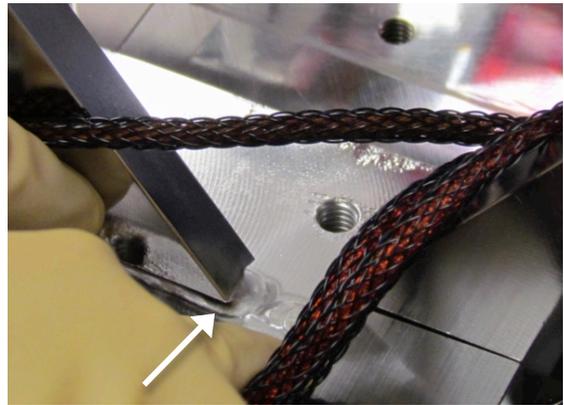
The bottom chain, the first to be tested, was grounded. When the SRS cable was lifted off the table, preventing it from coming in contact with everything except the quadrapuss DB25 connector, grounding continued. The quadrapuss was then lifted off the table, and grounding continued. Starting at the entry gusset, the quadrapuss legs were prodded and wiggled. The cause of the shield short was traced back to the bottom gussets on the Right Side (-Y). The quadrapuss took an S-shaped path between those two gussets, and easily lodged into their notches when pulled. Nudging a quadrapuss leg away from the notches stopped grounding.

Figure 15. Cable stuck between notches

Figure 16. Close-up of sharp notch

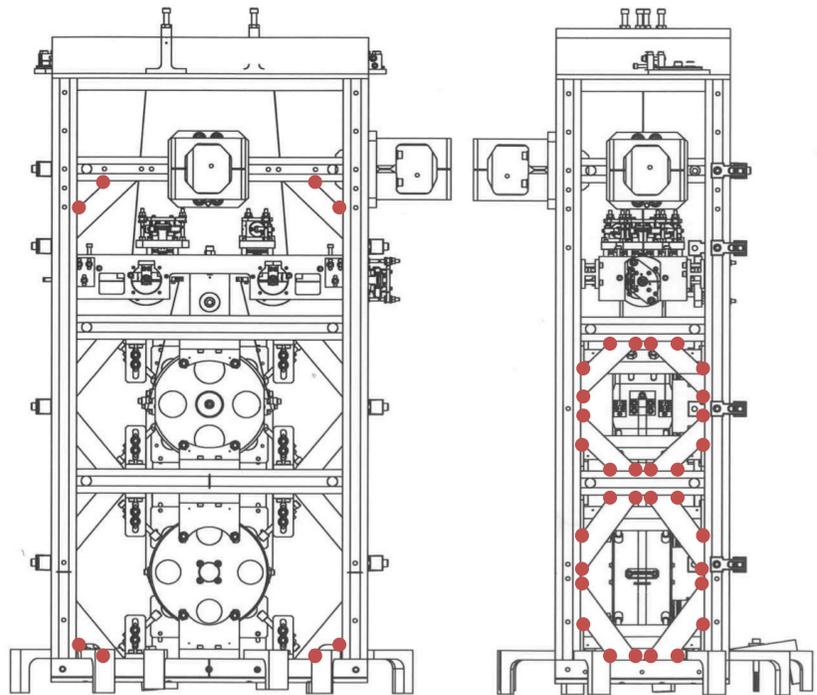
Some gusset holes are not large enough for a 9-pin quadrapuss connector to pass through. The red dots in Figure 21 denote gusset corners that quadrapusses may touch on an HSTS. Cables may be laced through the same gusset holes in the Front Side (+X) as the Back Side (-X). This is also true for the Left (+Y) and Right (-Y). Figure 21 is a summary of routing for all the HSTS's. Quadrapusses will not touch every spot highlighted in red on a single suspension.

Figure 21. HSTS Front (+X) and Left (+Y) gusset corners that laced quadrapusses may contact on an HSTS

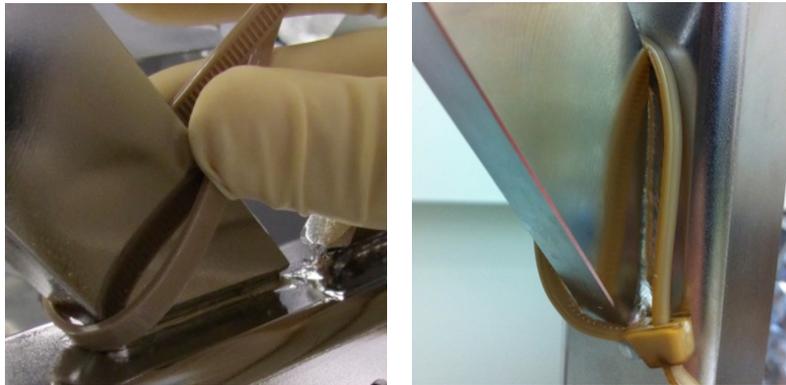
PEEK cable ties were used to cover notches. Even when tightened down as much as possible, there was a gap between the tie and suspension. PEEK ties can slip off the notch edge and slide along the gusset, making them an ineffective tool.

Figure 22. a) and b) Covering notches with PEEK ties

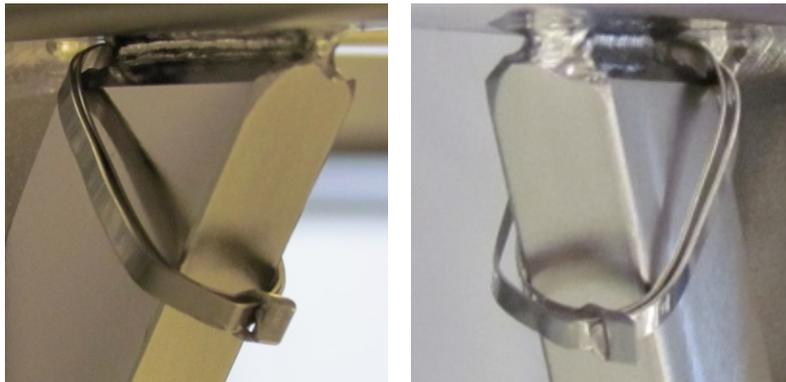
An attempt to use a band-it tool to tighten and tie off an aluminum strip failed miserably. The strip and tool were not compatible. Small band-its were also tested, but could not be pulled tight enough. Ultimately, the half-size aluminum strip was the best tool to cover notches. The technique is shown in more detail in [LIGO-T1200226](#). Quadrapusses could be held away from the notches using the aluminum strips as well.

Figure 23. a) and b) Covering notches with band-its

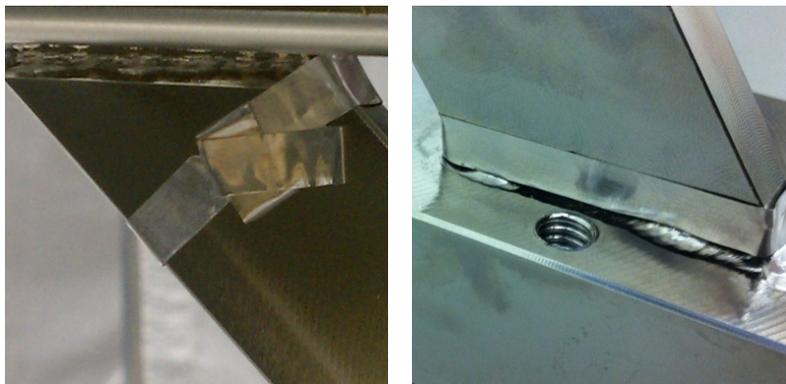
The next trial was with the aluminum strips meant to replace PEEK cable clamps. The aluminum was less malleable post-bake, and a bit difficult to shape on more angled gusset notches. These characteristics were attributed to one batch of strips, and have since been corrected. Like PEEK ties, the strips also had a tendency to slide. Cutting the strips in half, to roughly the height of a notch, made the aluminum much easier to work with. With a little effort, the strips could be molded around and kept flush with the gusset. Tying the strip while keeping it tight could be challenging. If the strip is too loose, it could potentially ground cables just like a notch.

Figure 24. a) and b) Covering notches with Al strips

Tying cables to the suspension in addition to blunting notches is the most effective way to avoid grounding due to sharp notches. Both methods are demonstrated in [LIGO-T1200226](#).

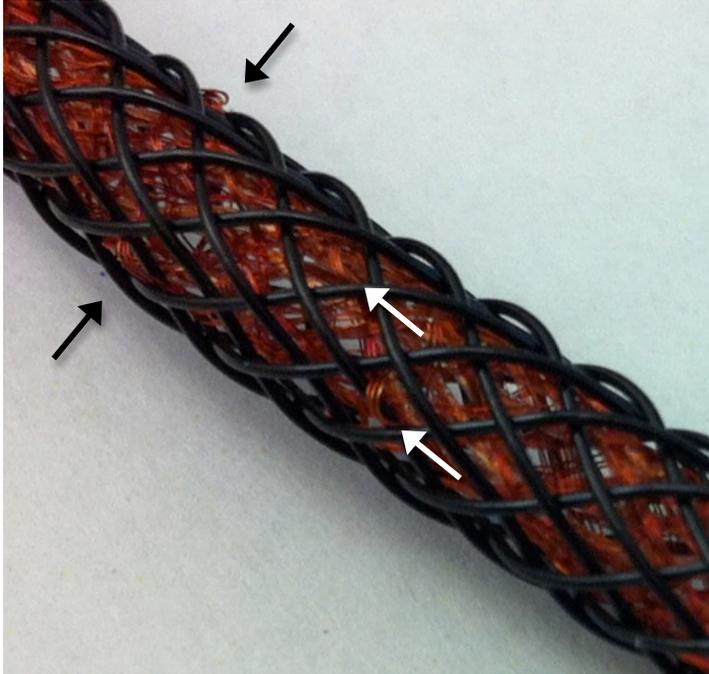
- Copper loops – The copper braid is loose or distorted. It expands into what should be a gap between the copper and PEEK braids, and sticks through the open weave of the PEEK overbraid.

Figure 25. Spiderwebby quadrapuss with copper loops protruding past PEEK overbraid

Gently push copper loops back under the PEEK overbraid with tweezers. If the overbraid is too tight and shrunken to do so, or if there are too many copper loops to fix, then use a different cable. Note the issues in ICS.

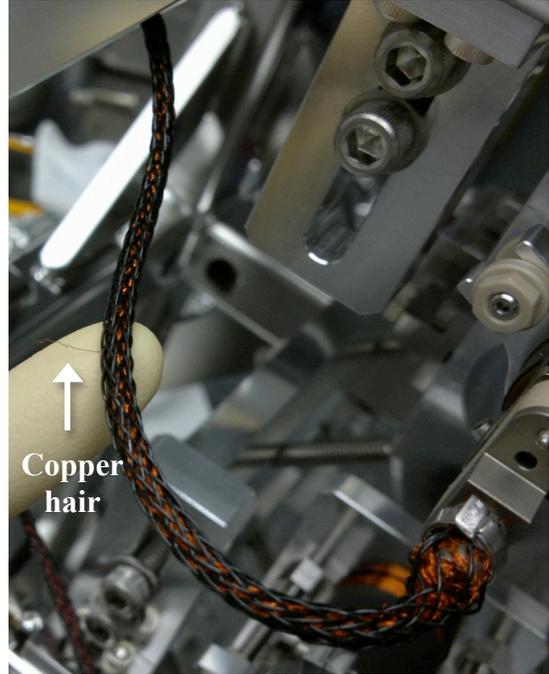
- Shrunken PEEK overbraid – The overbraid shrinks in size during bake, contracting into what should be a gap between the copper and PEEK braids, forcing the copper past the surface of the overbraid.

Figure 26. Shrunken overbraid and stray hair on quadrapuss

Avoid using cables with shrunken overbraids when possible.

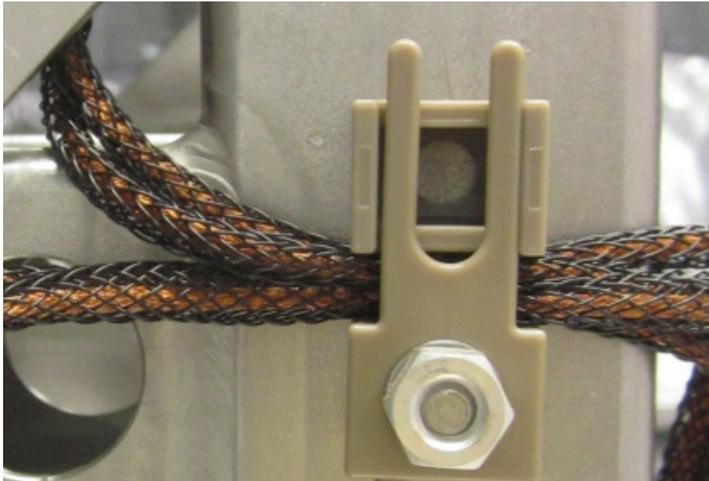
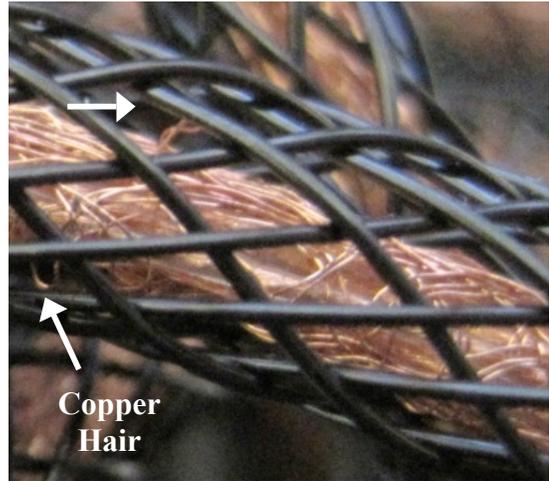
Figure 27. Quadrapuss overbraids are slightly compressed by PEEK clamp

Figure 28. Copper hairs could stick out if overbraid is squished down

- Squished overbraid – Tight routing or clamping can reduce the gap between the braids, forcing the copper past the PEEK overbraid.

Allow for slack in the routing. Cables should be guided, not crushed, on the suspensions and table. Use aluminum strips instead of PEEK cable clamps.
