LASER INTERFEROMETER GRAVITATIONAL WAVE OBSERVATORY

LIGO-T1400035-v1

ITM11 Inspection Report

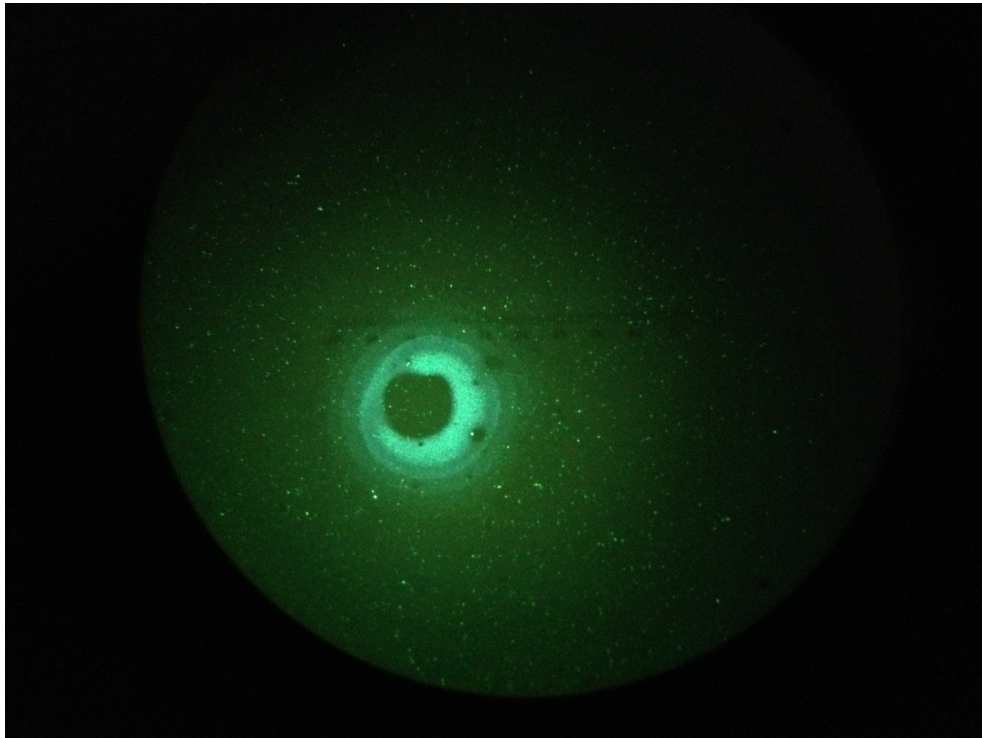
Figure 1: ITM11 HR coating Defect 10x darkfield closeup

1. Numerous coating defects on S1, counted at around 30 over all surface. Greenish, hazy donut shaped defects, ~1mm in diameter. The one closest to the center is ~25mm away from center. These are visible with the flashlight array. Fig. 1 below shows a closeup of the defect taken with an iPhone through the darkfield eyepiece at 10x.
