MEMORANDUM

TO: ISC team
FROM: Daniel Sigg, Koji Arai
SUBJECT: EOM/AOM Diver Modifications
Refer to: LIGO-E1500353-v2

This modifications apply to [D0900761-B](#), [D0900847-B](#), [D0900848-C](#) and [D1000216-B](#) to bring them to revisions C, C, D and C, respectively.

The affected serial numbers are S1500117 to S1500128.

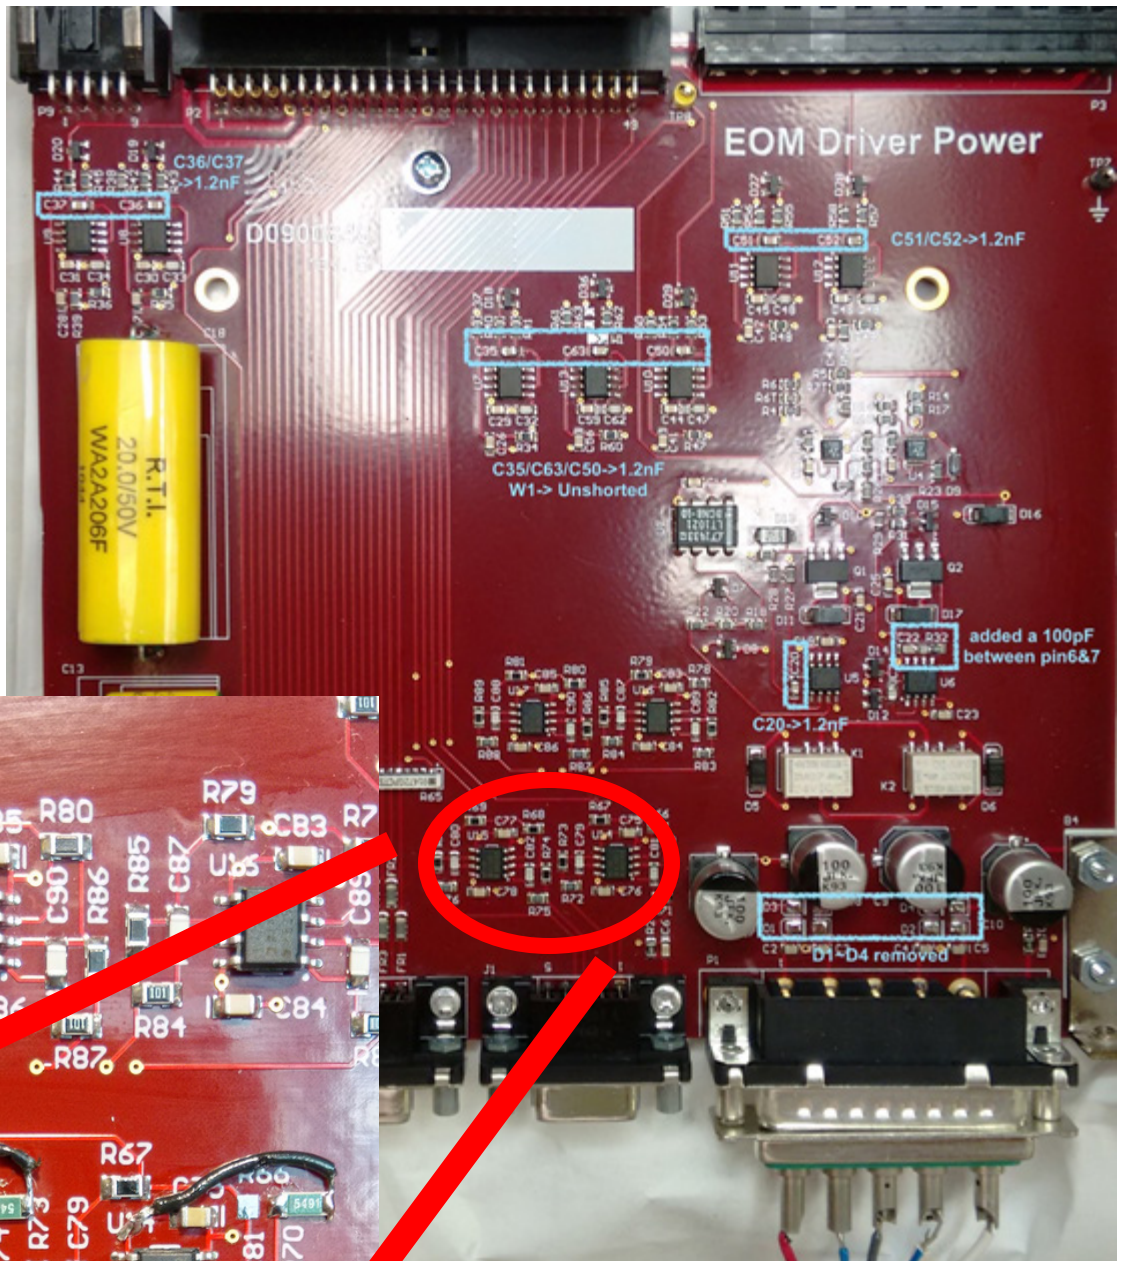
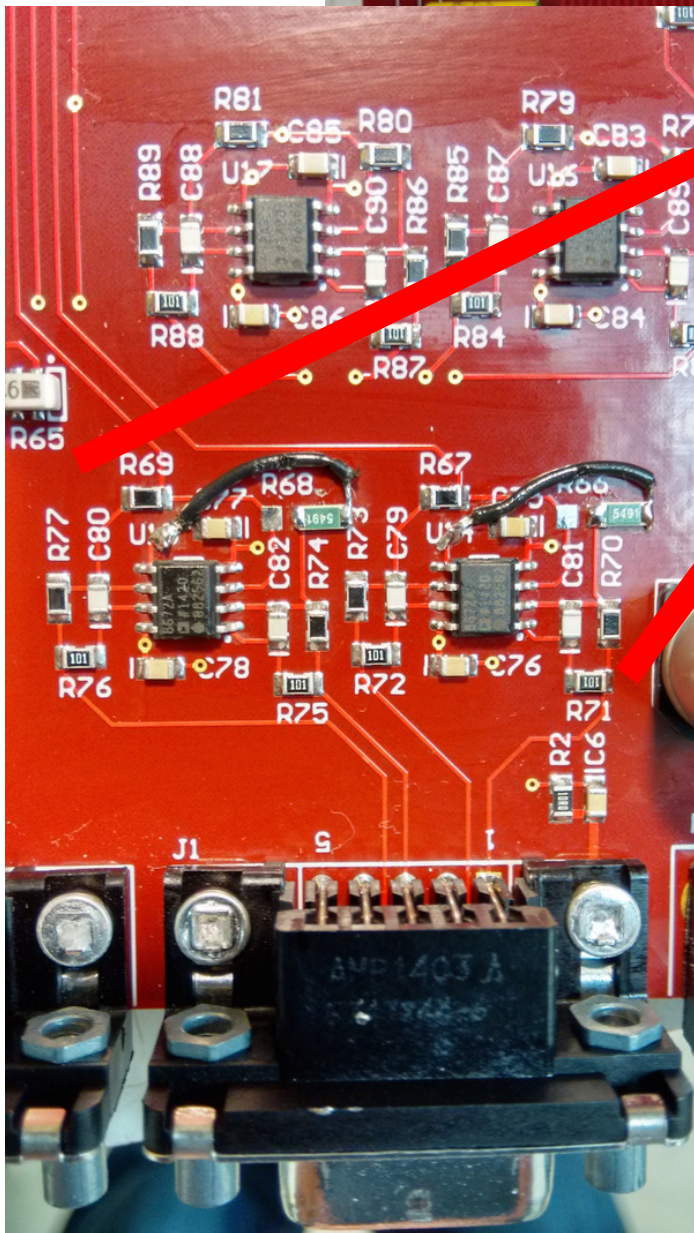
Fix the gain in the differential output stages.

R66, R68 → 5.49K, shift and use only the pad above R70 and R74

J1, J2 → add a jumper wire from the free end to ground (see pic)
