Laser Damage investigations of 1064 nm absorbing materials in vacuum A. <u>Ananyeva</u>, D. Coyne, C. Torrie, E. Sanchez

Motivation

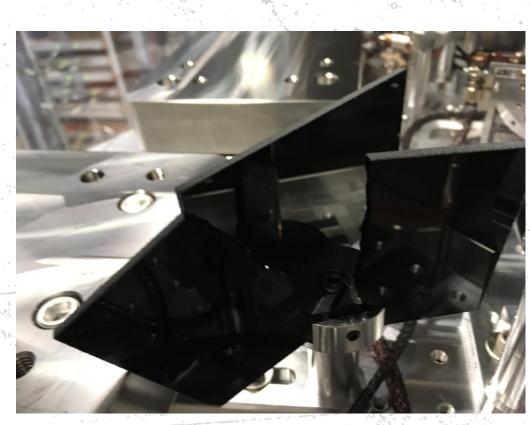
Broken black glass beam dumped due to overheating by the laser

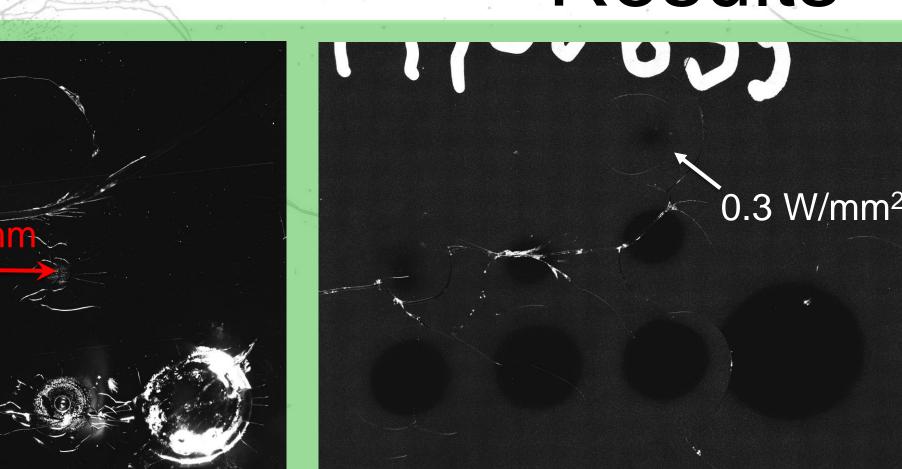
AR coated blk glass sample S1700635 Uncoated black glass sample S1700633

At around 0.3 W/mm² uncoated and coated black glass started to melt and to break. Cracks occurred in a similar patter which was presumably defined by the method the sample was mounted on the holder's plate.

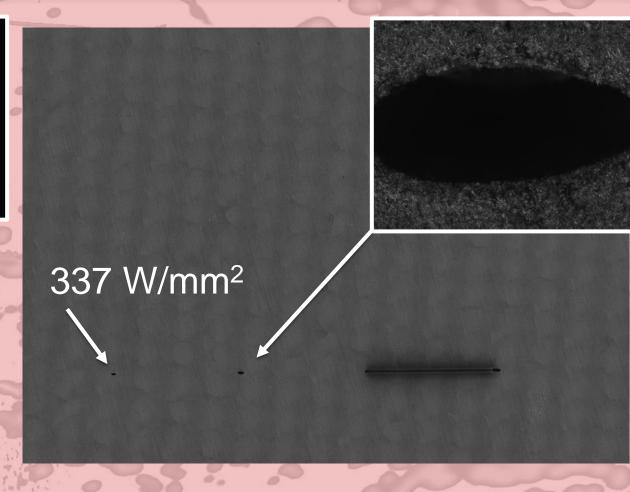
Sintered silicon carbide S1700637

Silicon and silicon carbide samples were first irradiated with low power levels equivalent to those used on the previous black glass and DLC samples. None of the two runs resulted in damage. The figures on the left show surfaces of the samples after irradiation at ten points at incremental power densities up to 1102.80 W/mm². Silicon started to damage at 371.13 (16 W total power) and silicon carbide at 736.97 W/mm² (37.05 W total power). The samples did not crack or break.
