LIGO-T080245-02-D

ADVANCED LIGO

ALIGO NP-type: - Report on bonding Viton stops, magnet holders and break-off prisms at LASTI

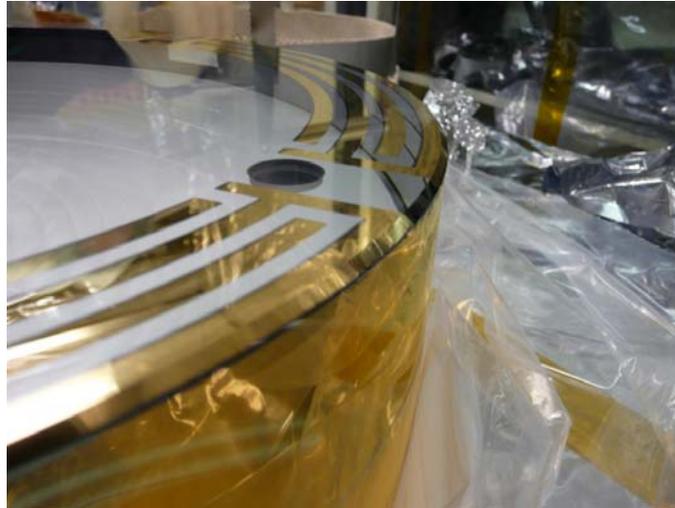
The electrostatic drive coating also had an off-set from the centre towards the top of the mass, such that the coating went over the chamfer of the mass and came within a millimetre from the barrel coating (Figure 5.2).

Figure 5.2 Electrostatic drive coating over the chamfer, 1 mm away from the barrel coating

1. The electrostatic drive coating was damaged with shallow scratches. The scratches are unlikely to affect its functionality.
2. The electrostatic drive coating is off-set from the COM with the coating coming within 1 mm from the barrel coating at the top.
3. The barrel coating is very soft and fragile and shows scratches, wipe marks and finger marks.

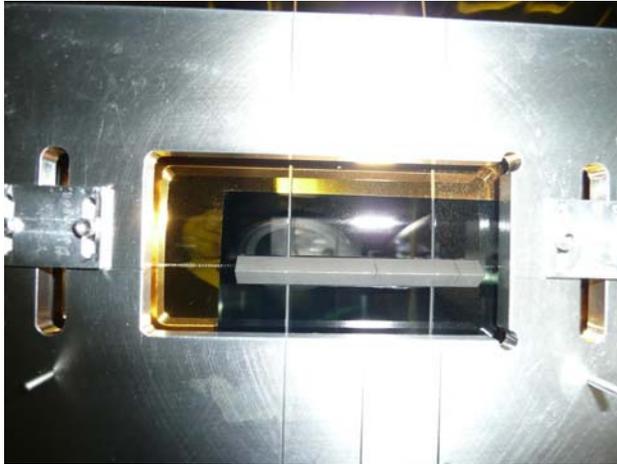
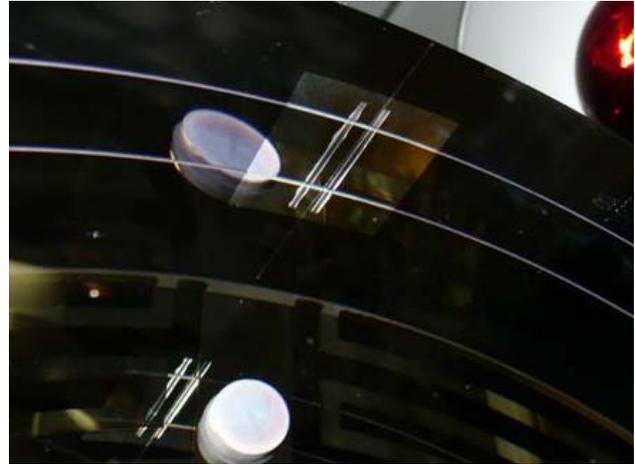
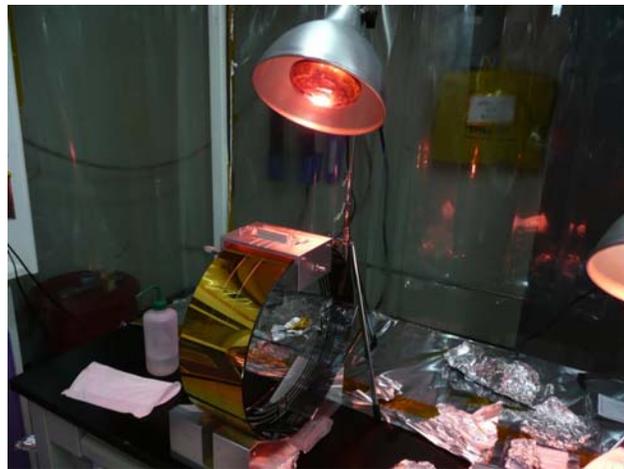
9. Prepared the VacSeal (mix the two components in the package, apply the VacSeal in a UHV aluminum boat, put the VacSeal in the backing vacuum chamber to reduce the number of bubbles).
10. Checked both bonding surfaces for dust
11. Dipped the 0.3 mm copper wire in the VacSeal and apply a thin and even layer on the both contact surfaces of the break-off prism.
12. Glued the break-off prism to the CP by using the alignment jig.
13. Turned on the heat lamps and cured under the heat lamp overnight. Adhesive contact was made over the entire length of the prism on both bonding surfaces. Very little excess adhesive was observed (Figure 6.2).

bonded prism (side 1)

contact lines (side 1)

Adhesive curing on side 1

Figure 6.2 Bonding prism on side 1

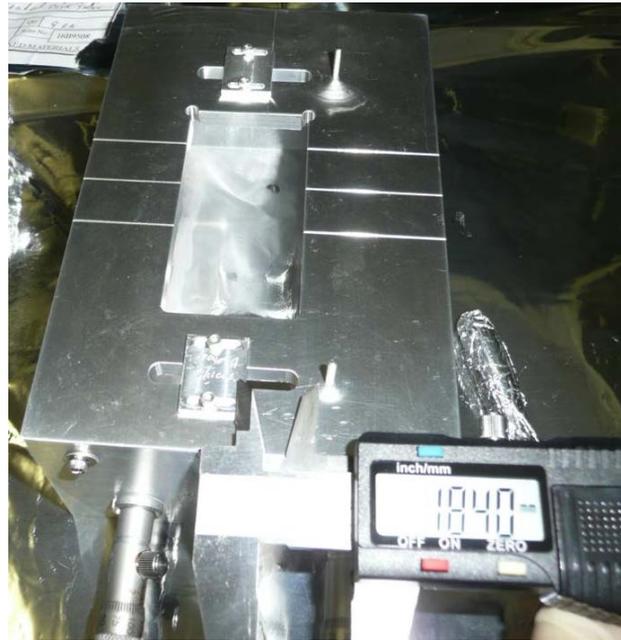
On side 2 the bonding jig had to be used upside down leading to

$$d_{\text{slider}} = d_{\text{jig prism}} - d_{\text{prism}} = 18.8 - 0.41 \text{ mm} = 18.4 \text{ mm}$$

It was expected that there were 2 mirrored bonding jigs present: one for each side. Since the same (non-wedged) surface needs to be referenced for both sides (especially in a wedged mass), the bonding jig had to be used upside down. This means one must be very careful to apply the jig to the correct side (know what is the top of the mass). This procedure was

Figure 6.4 Setting prism bonding jig for side 2

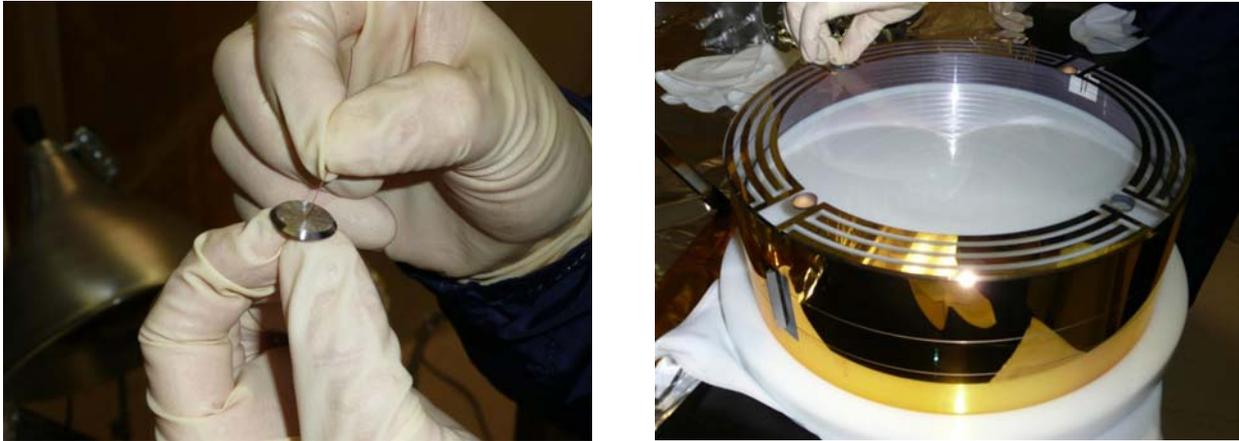
1. Using the cleaned Teflon face cover the CP was sat from the V-block onto its back surface.
2. Cleaned the mount plates stops with methanol and blow dry them with the de-ionizing nitrogen gun
3. Cleaned the copper wire with methanol
4. Prepared the VacSeal
5. Dipped the copper wire in the VacSeal
6. Apply the VacSeal to the mount plates (Figure 6.8 left)

Figure 6.8 Applying adhesive and bonding the mount plates for the Earthquake stops on the CP

7. Glued in the mount plates
8. Put the heat lamp on the surface and cure the adhesive overnight. Adhesion is good.
9. The mass was packed back into its container as discussed in section 5.2. The Viton earthquake stops were stored with the mass as was a cutter. The Viton stops will need to be cut to a shorter length just before assembly. Joe O'Dell mentioned a length of 8 mm in stead of the current 10 mm. This will however need to be checked prior to assembly. The silica tips are with Brett Shapiro. Assembly of the silica tips into the Viton stops is not trivial. Joe O'Dell mentioned on 16/09/2008 that a tool for that is in development.

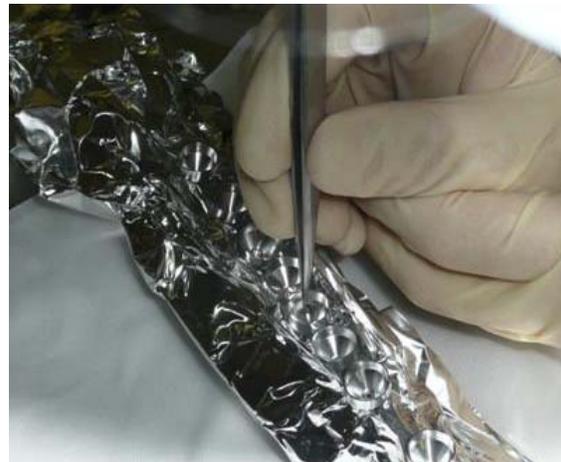
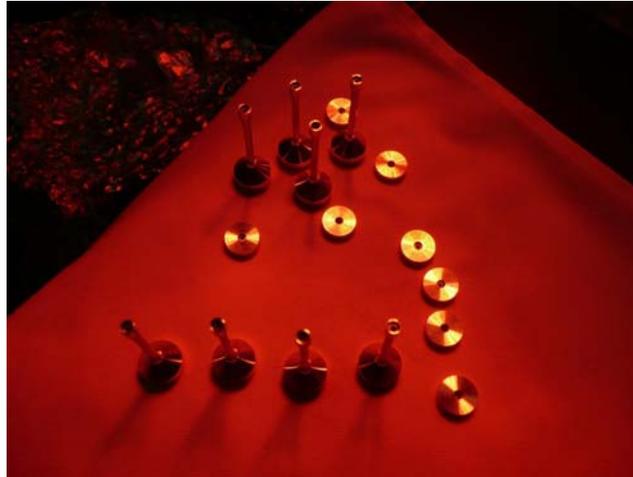
1. The steel rings, magnet based and magnet flags were wiped with methanol. A set of 8 magnet flags were prepared by glueing in the steel rings over 2 days.
2. Prepared VacSeal.
3. Dipped the copper wire in the VacSeal
4. Picked up the steel rings with a pair of tweezers and applied the VacSeal to the back
5. Glued in the steel rings
6. A heat lamp was used to cure the adhesive overnight. No excess adhesive protruded at the front to prevent the magnets from properly adhering to the steel rings.

Figure 6.10 Glueing steel rings into the magnet flags

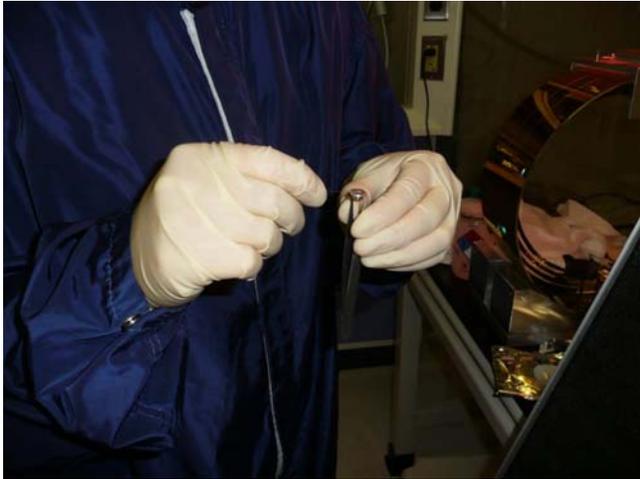
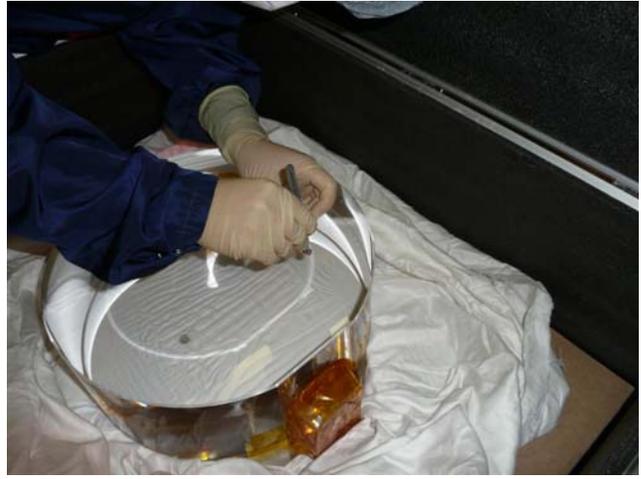
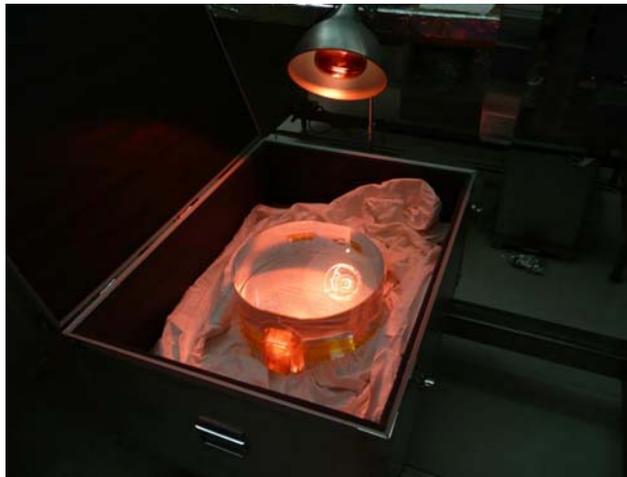
10. Cleaned the copper wire with methanol
11. Prepared the VacSeal
12. Dip the copper wire in the VacSeal
13. The magnet bases were held using a pair of tweezers and the VacSeal to the back using the copper wire

14. Glued in the magnet bases
15. Put the heat lamp on the surface and cure the adhesive overnight
16. The mass was packed again and the assembled magnet flags were stored with it, including the spares. The only items missing were the magnets themselves. Amanda Brummit will order them and have them sent to LASTI.

**Applying adhesive**

**Glueing magnet base**

**Curing****Figure 6.11 Bonding magnet bases to the 2nd PM**
