LIGO--T020130-00-D

Subject CRYSTAT - GLASSY METALS

crystal measurement of Viti sample which was prepared by charlotte

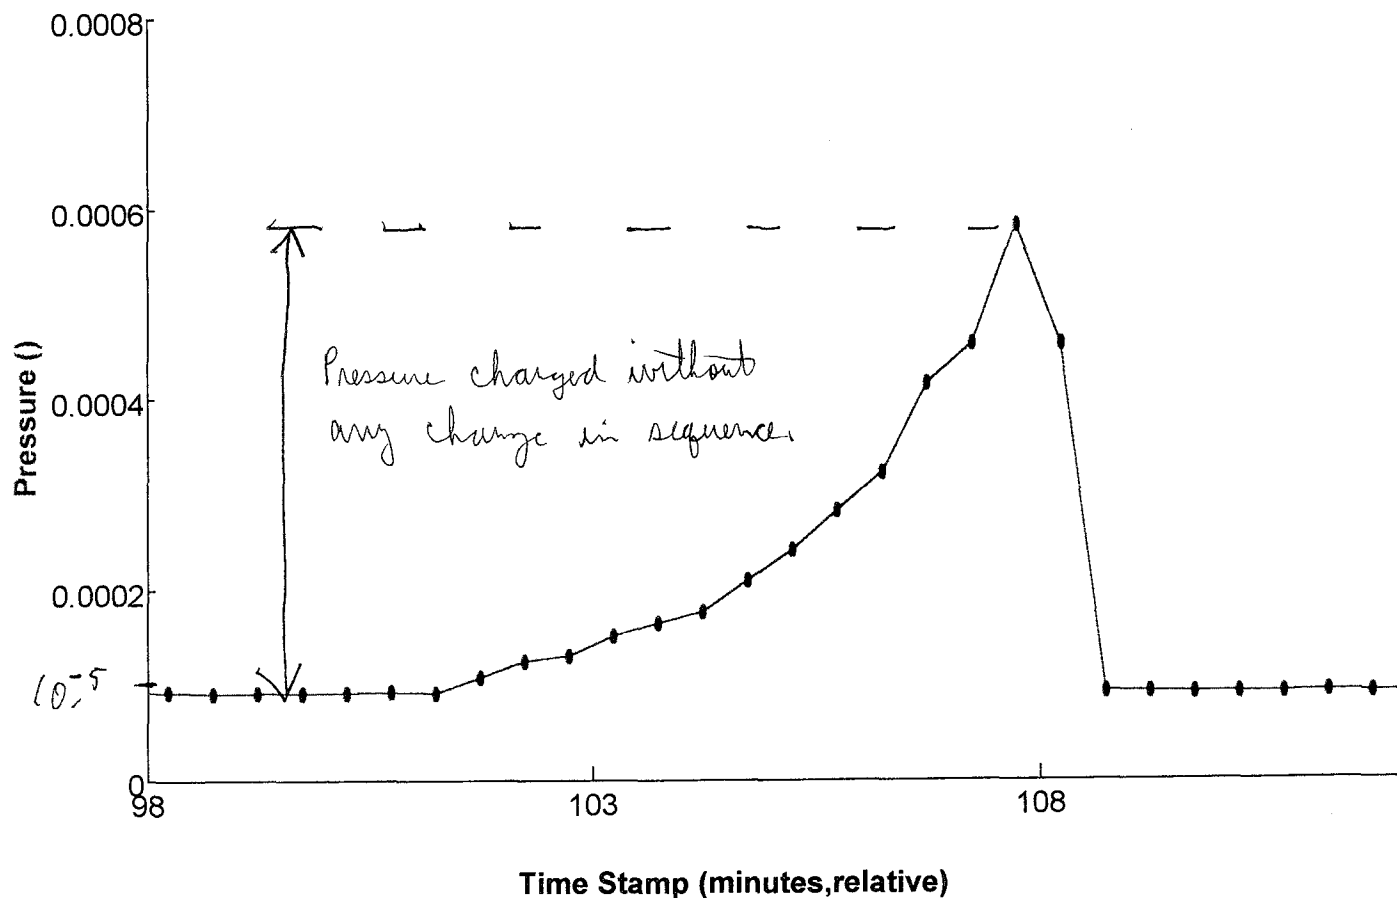
Pressure "Stability" At 320K at HiVac

- After charcoal regeneration, the first HiVac operation was successful, although a long time was needed to achieve  $9 \times 10^{-5}$  Torr. It remained stable for awhile, but the next morning the pressure spiked when no charges had been made to the system.
- Quantum Design was notified on April 19, and plots were sent to them on April 22.

- On April 18, the charcoal was regenerated 4 times:

- (1) Warm regeneration in room.
- (2) Warm " " in room using heat guide to warm the charcoal.
- (3) chr room regeneration but "dewar" was selected to take advantage of the heater in the cryopump.
- (4) Normal warm regeneration in room.

- The cryopump was then held at 400K for 30 minutes to cool down after regeneration.
