Inspection of shipping and carrying mirror cases

Inspection of the aluminum mirror carrying case

Inspection of the gray shipping case

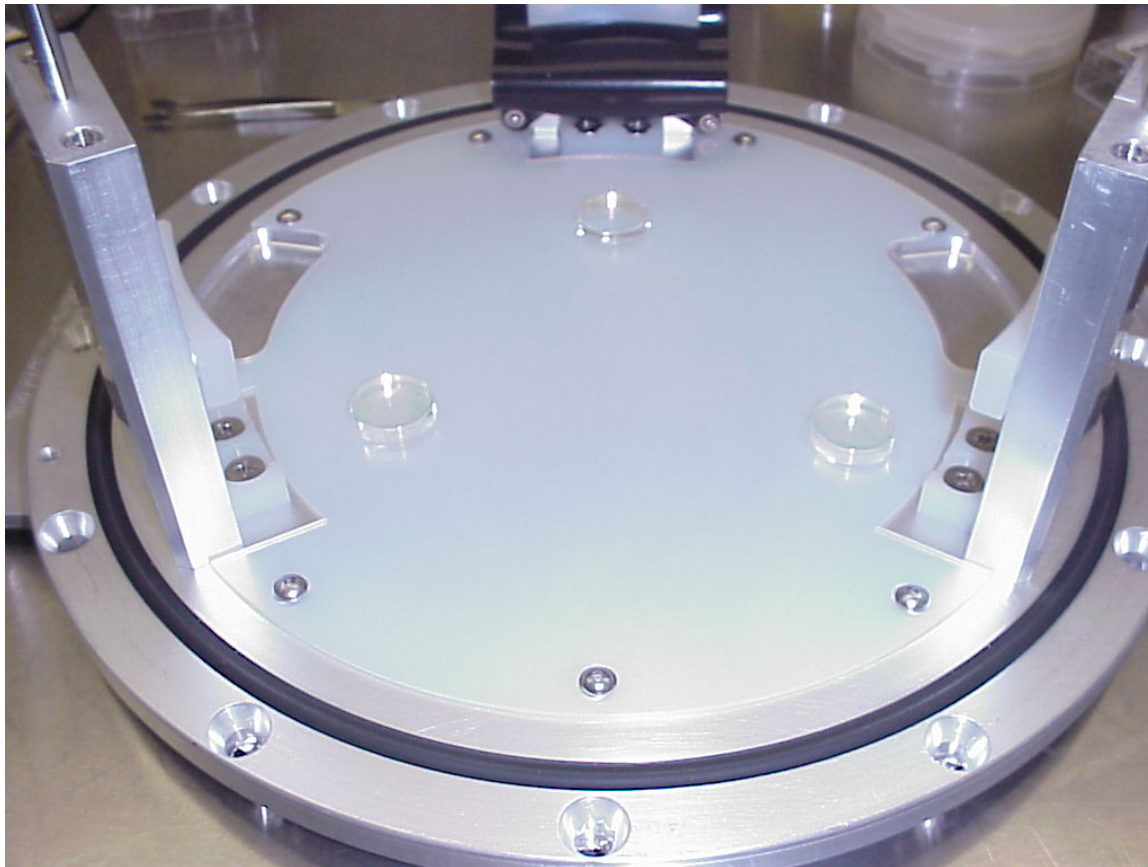
- 1) Opened the case and checked the seal's integrity, it was fine.
- 2) Inspected for dust particles with a high intensity light source. Observed a few dark particles and some fibers.
- 3) Checked that there were not problems with the screws when closing. All worked fine.
- 4) Installed 3 cleaned 1" dia. mirrors to the base of the case secured with double sided tape. These mirrors were previously inspected under a dark field microscope and with a high intensity light source to ensure their cleanliness.

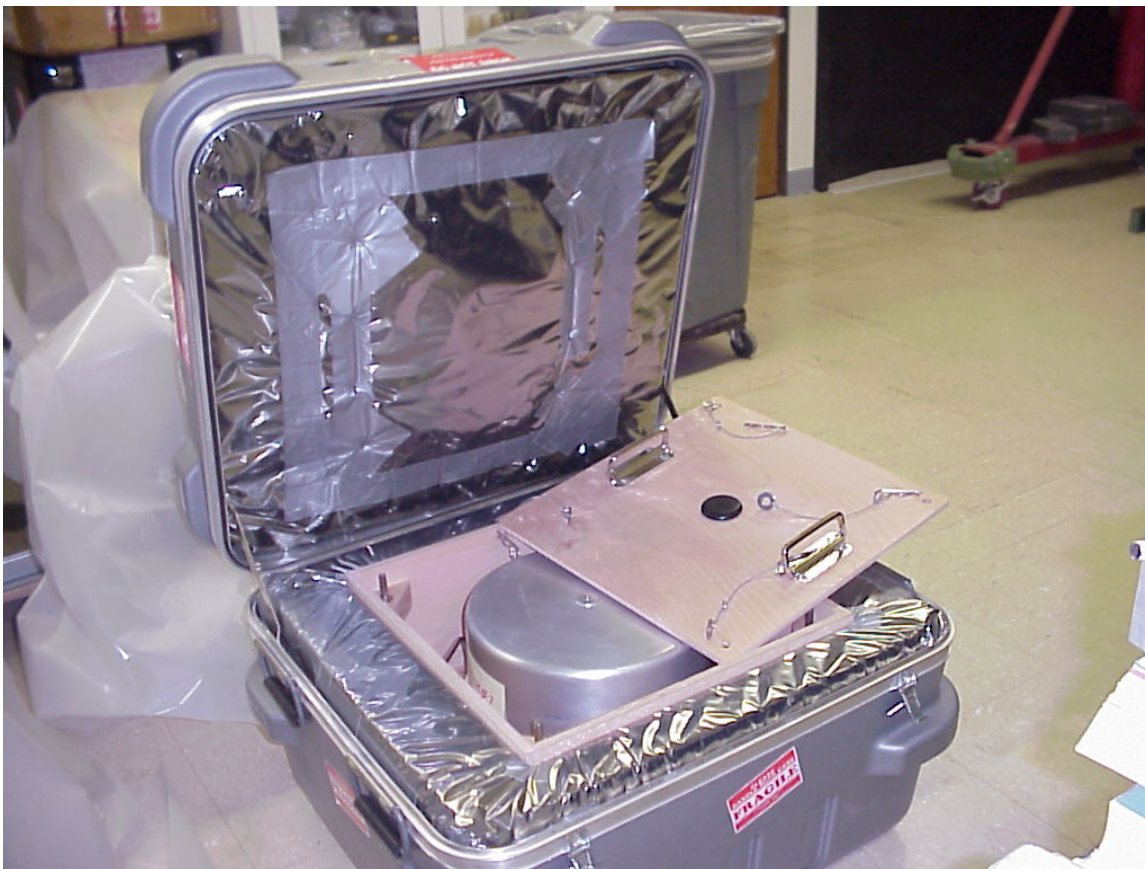
- 1) Checked the drop sensors. They were OK.
- 2) Checked the grey case’s lining foam; it was OK and there were not tears.
- 3) Visually checked the wooden case. It appeared in good condition.

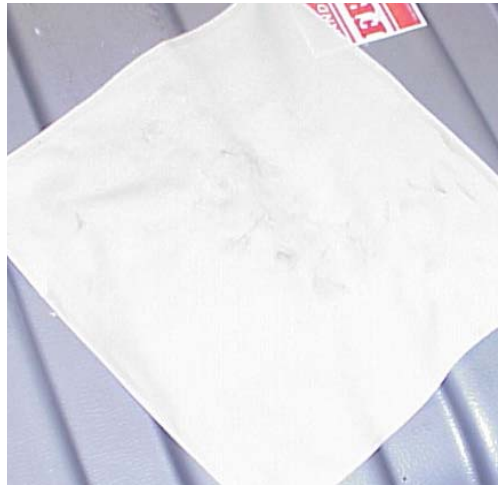
- 4) Placed the aluminum case with the 3 cleaned mirrors inside the wooden case. The mirrors attached to the aluminum case were cleaned and inspected.
- 5) Closed the wooden case and the large grey case.
- 6) Turned the grey case upside down several times (5 at least) and allow it to drop from side to side about 5 times. Left undisturbed over the weekend.
- 7) Opened the grey shipping case and the wooden box and removed the aluminum case.
- 8) Upon close inspection of the wooden case, a few dark particles were observed on the bottom. Cleaned with a white cloth wetted with methanol, dark stains were visible on the cloth.

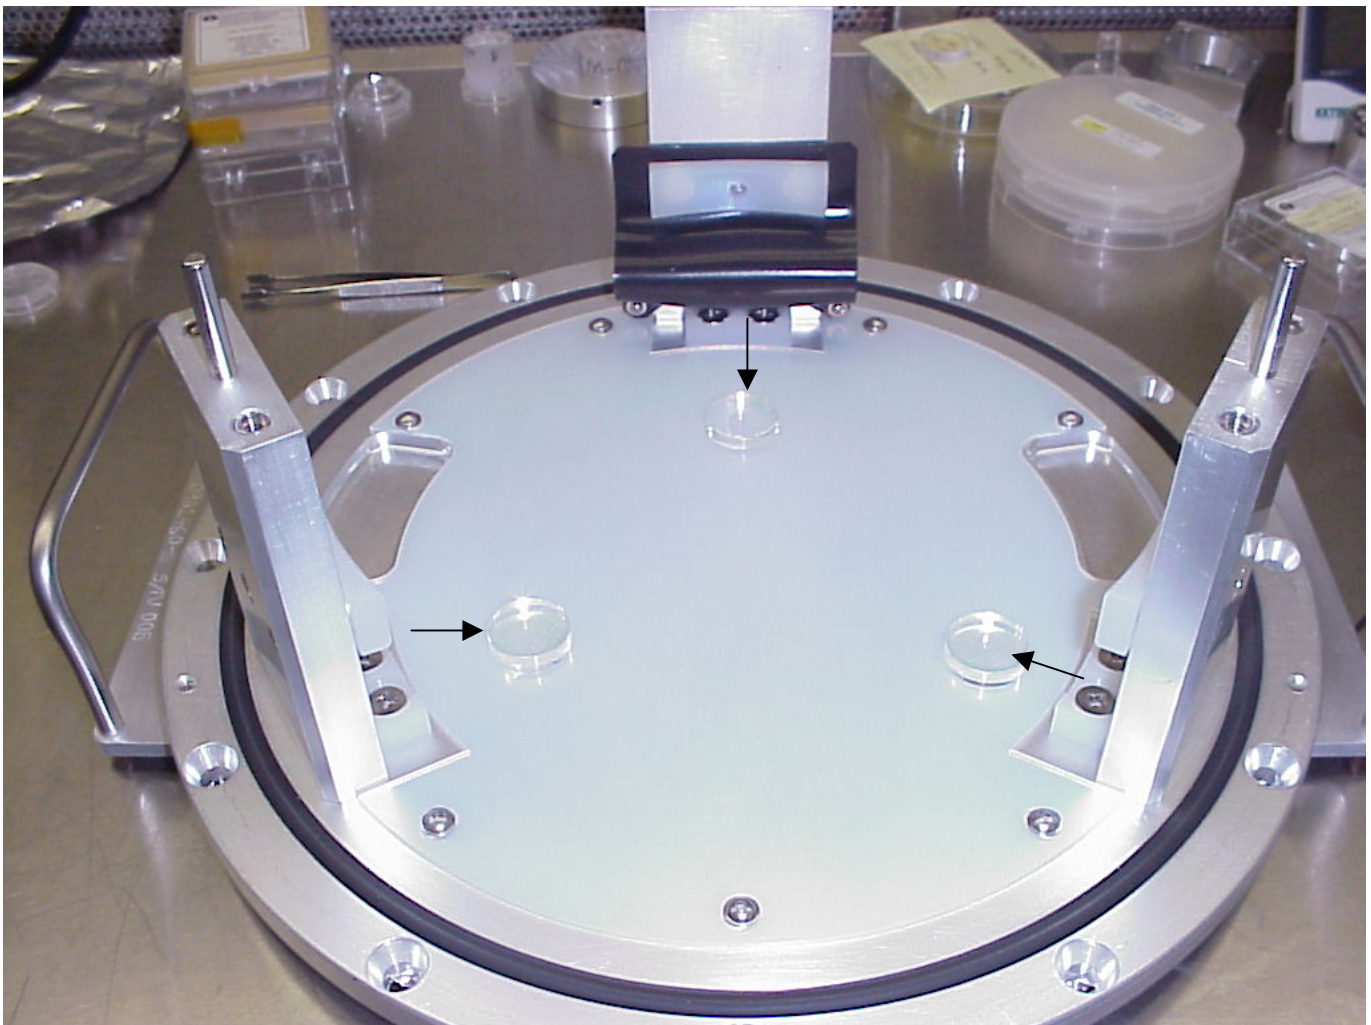
- 9) Opened the aluminum case and inspected the mirrors for dust particles
- 10) All three mirrors showed fine dust particles on the edge facing the aluminum posts.

The arrows point to the edge of the mirrors that showed an increased incidence of dust
