ADVANCED LIGO SUSPENSIONS LSC-Virgo Meeting, Hannover 22nd - 25th October 2007

Suspensions/Isolation Working Group Parallel Sessions

Welding <u>Experiences</u>: Output modecleaner and

Recycling Mirror designs

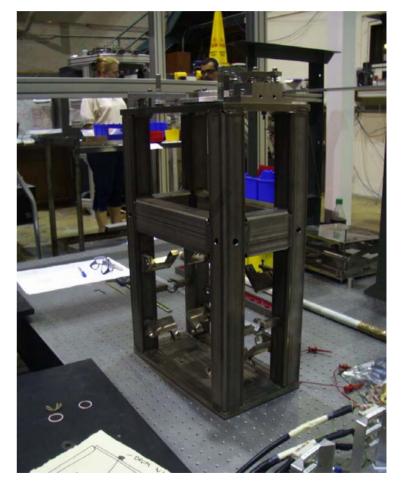
- LIGO I has history of welding stainless and Alum
 - e.g. LOS structure
- HAM-SAS
 - aluminum (5083) welding practice & experience: LIGO-T060109
- ALIGO ÜK (RAL)
- Why?
 - To meet LIGO Vacuum requirements
 - e.g. trapped contaminants could leak out!
 - Stiffness Not strength!

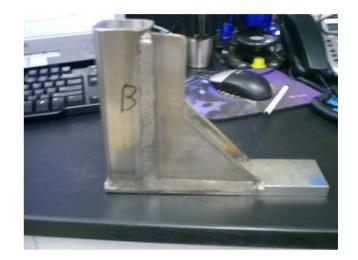
RM Tests & History

- 304 SSTL Weld Sample
- LIGO I LOS Structure

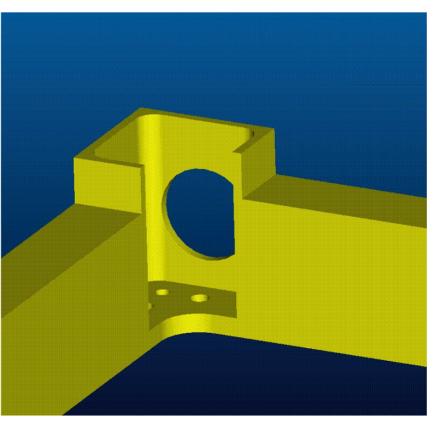
- Idea is that all of this work will lead to ability to better classify welds for Advanced LIGO e.g. class C low porosity no cracks!
- To achieve this probably also consider additional weld samples e.g.
 - To match new OMC design
 - RAL design see picture & previous talk
 - RM design
