# Alignment Monument Layout, LHO Y-End Station, BSC Mechanical Test Stands

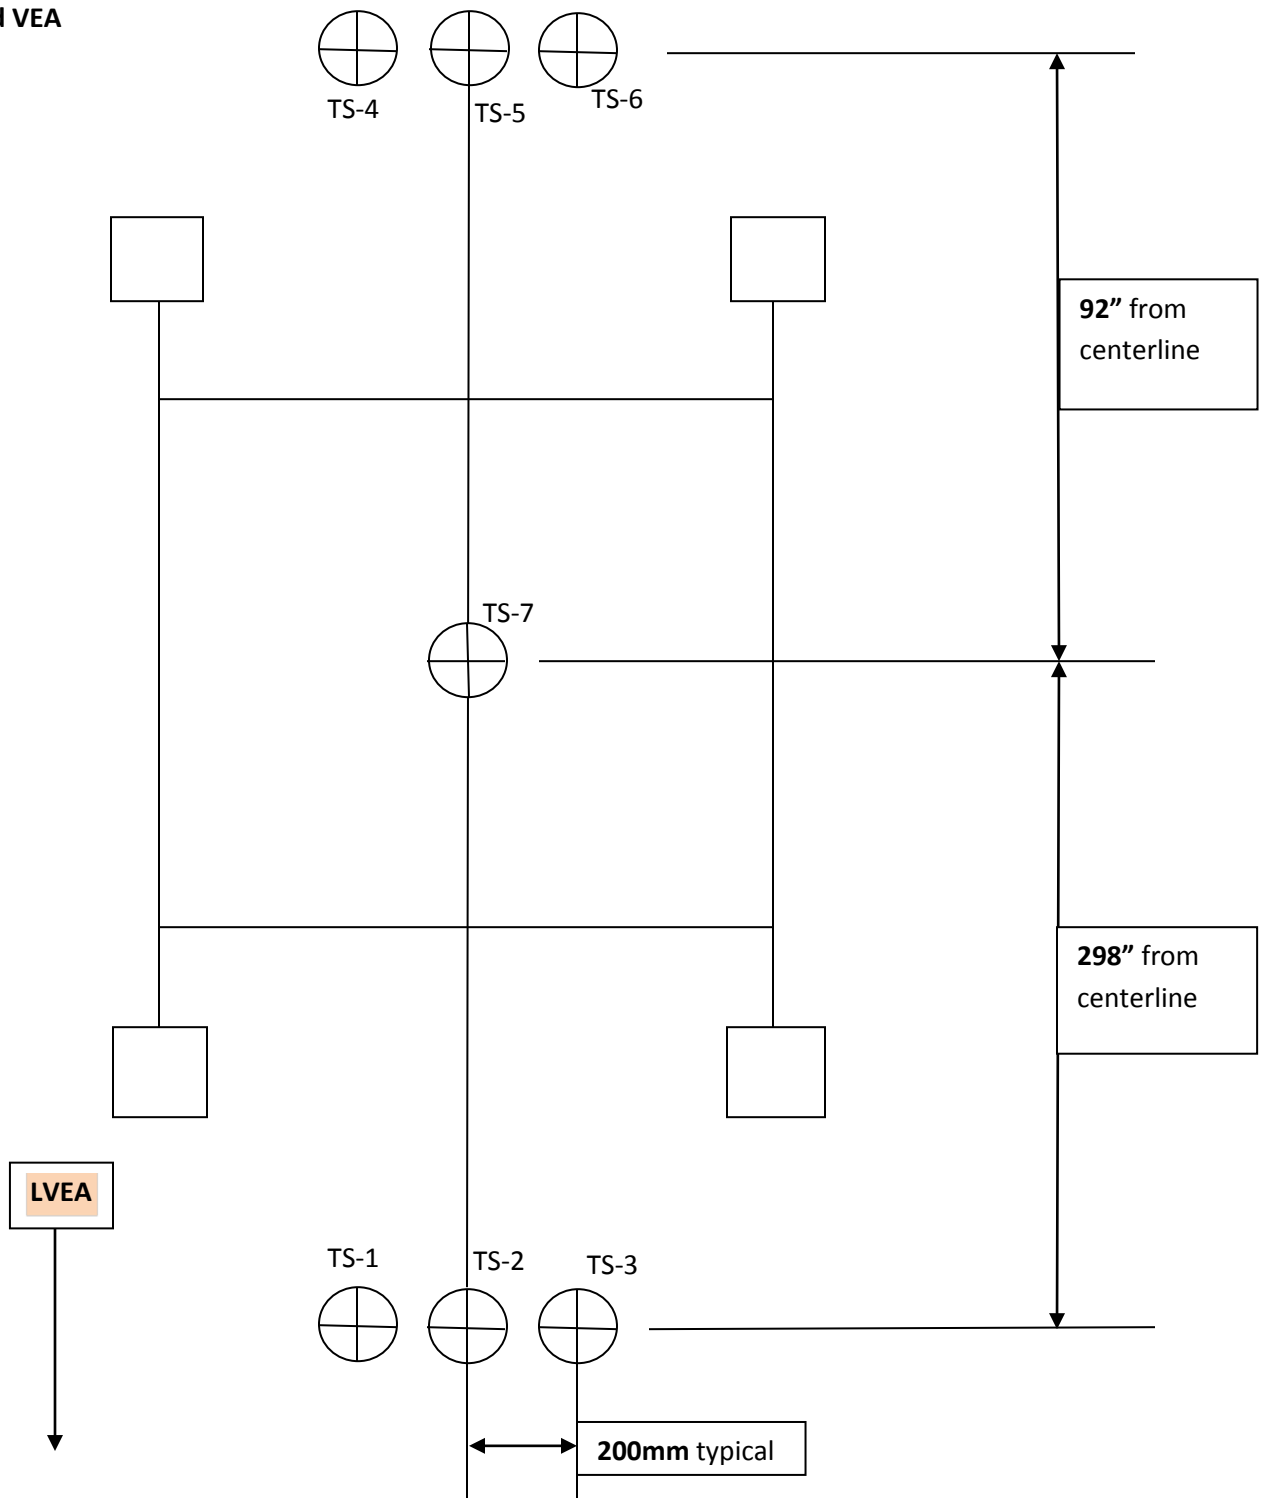
Y-end VEA

When the Test Stand was reset it was found to be **0.008"** to the RIGHT ( → ) of centerline
