OFI Hammer Test LLO HAM5 5/22/13 Stuart Aston

HAM5 OFI (OFIS) Results of B&K hammering - VA are functional

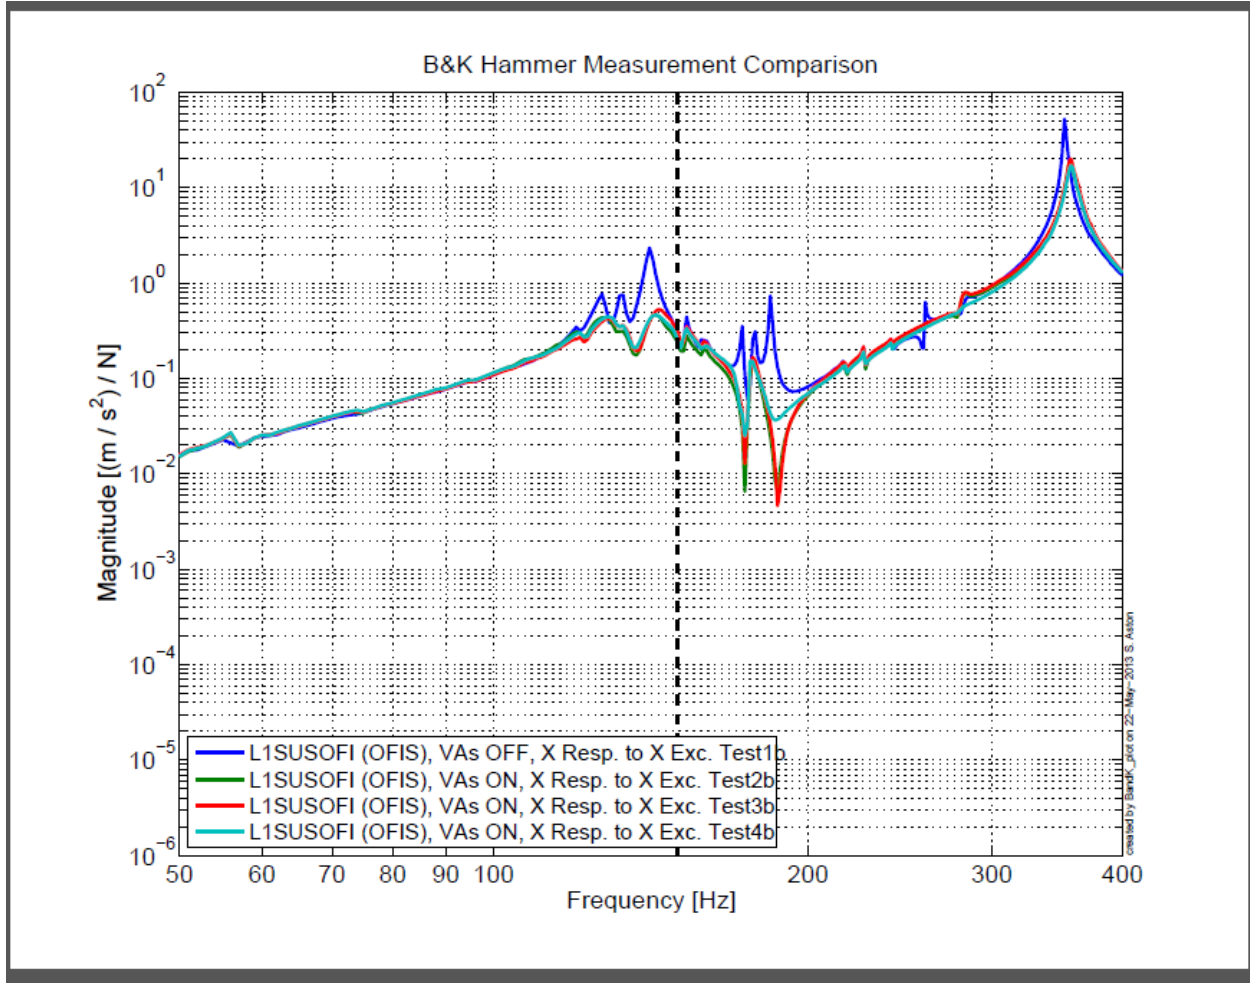
A tri-axial accelerometer was attached (via interface plates) to a horizontal strut near the top of the HSTS structure, as shown in Image #478. For convenience the axes of the accelerometer were aligned with the axes of the suspension (i.e. X = longitudinal, Y = transverse, Z = vertical). The hammer was used in two places to excite the structure, the first being +Y at the back of the structure, and the second being +X on the side of the structure.

These results are convincing, with the VA damping the Q's of the first mode peak around 130 Hz, and second mode peak around 175 Hz, clearly visible. It

also appears that having the full compliment of dog-clamps, and rotating the location of the vibration absorbers on the structure has had little/no effect upon damping performance.
