# Experimental Search for Avalanches of Entangled Dislocations as a Source of Dissipation and Mechanical Noise

A Thesis Defense

Presented By, Morgan Shaner

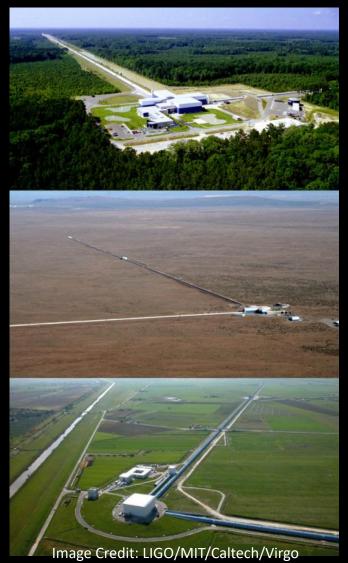
# LIGO (Laser Interferometer Gravitational Wave Observatory)

Capable of measuring changes in the length of the 4 km cavity arm a trillion times smaller than the width of a strand of hair.

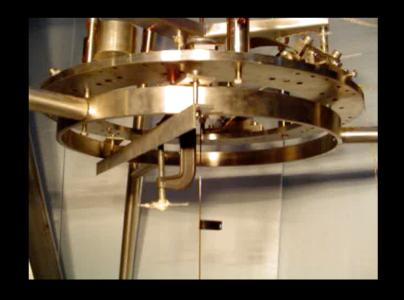
- Suspend from a GAS Filter
- Stabilize Temperature
- Position Measurement Precision
- Move to a collet mount for fastening the test-wire
- Eddy Current Brake Modifications
- Move to a higher quality steel (Maraging)
- Tracking Program

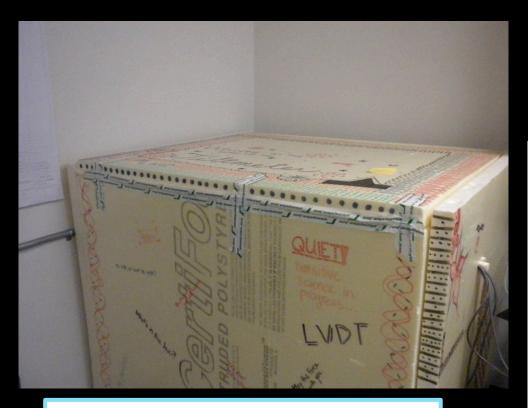
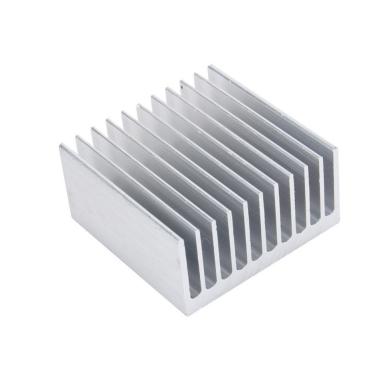
# Stabilize Temperature

- Styrofoam Box, isolate experiment
- **Heat Sink**, draw heat away from experiment
- Water-cooling system, keep the system at a stable temperature

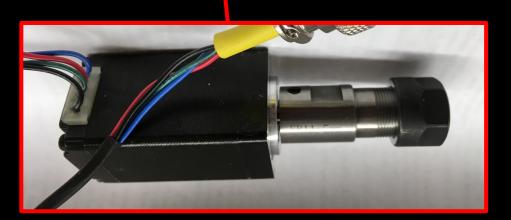
# New Collet Mount Design

Will remove the problem with the glue

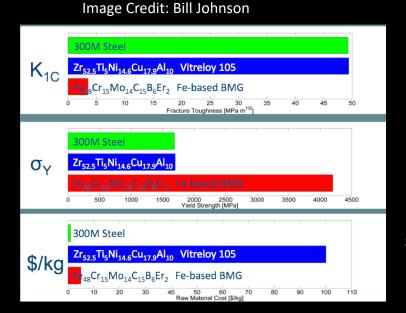
# Section 2: Glassy Metals as a Possible Replacement Material

Glassy metals have no crystalline structure and therefore no dislocations. Therefore, they are free of all dislocation-mediated loss mechanisms, both the traditional Granato-Lücke and the anomalous mechanism investigated here.

Chose to study Vitreloy 105
