**California Institute of Technology
Massachusetts Institute of Technology**

DCN No. E021115-00-C

Document Change Notice (DCN)

DOCUMENT No. (DOC-REV-GP.ID)	TITLE	NEW REV
D000347 -B	Gain Slider Problem Fix	B1
D990694 -00		A1
D000086 -02		A3

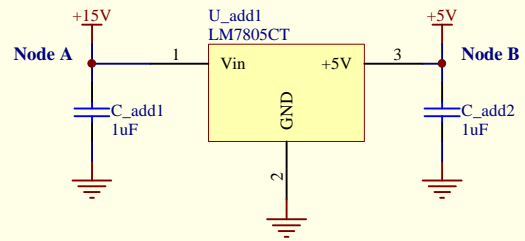
REASON FOR CHANGE: Gain value changes were occurring due to improper voltage reference for the ADCs.

- (1). Cut the trace on connector P1 pins 9B and 10B
- (2). Connect U_add1 regulator pin1 and the one side of the C_add1(1uF) capacitor to the testpoint TP2
- (3). Connect U_add1 regulator pin3 and the one side of the C_add2 (1uF) capacitor to the testpoint TP6
- (4). Connect U_add1 regulator pin2 to the ground.
- (5). After the changes on the board mark the front panel as Rev A3.

Note: Please see the attached schematic
