# LASER INTERFEROMETER GRAVITATIONAL WAVE OBSERVATORY

Document Type <b>Technical Note</b>	<b>DCC Number</b> <b>LIGO-t-10112-00-R</b>	Date 5 <sup>th</sup> of October 2001
<b>The GAS blade creep measurements, problems and some solutions.</b>		
Lia Stellacci, Alessandro Bertolini, Riccardo DeSalvo, Francesco Fidecaro, Charlotte Py, Virginio Sannibale

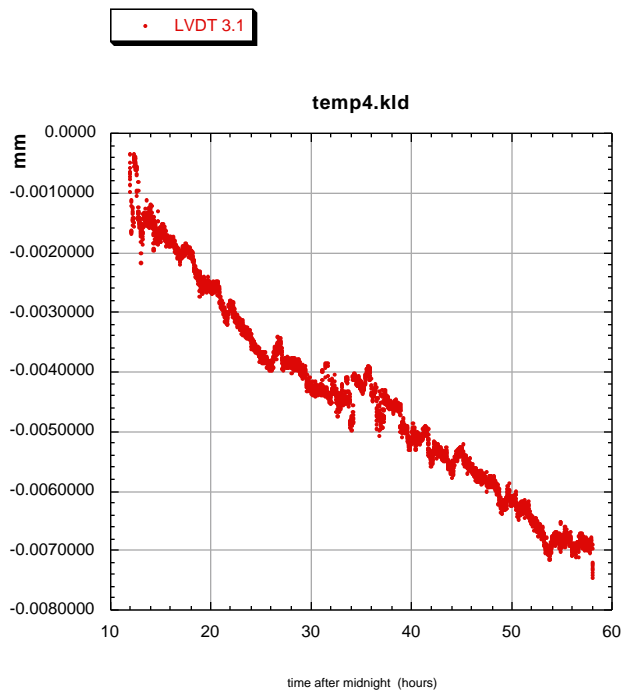
The most likely explanation for this effect is the following. Since the system was not intended for “in vacuum” applications, we decided to make the LVDTs of nylon, and some of PVC. It turns out that nylon absorbs up to 4% in weight of water and can expand more than 1% in length, which, over the 50 or 60 mm of LVDT, makes for up to a few hundred microns. We suspect that the plastics, in the dry oven atmosphere, will lose humidity and shrink. As they shrink the emitter and the receiver are effectively separated, just as it would happen in creep.

The observed “creep” is not in the electronics, as can be seen by examining the signal of a resistive bridge “LVDT”. Also this effect was not visible in Virgo where ceramic LVDTs were used.

The LVDT shrinkage and the blade's creep are indistinguishable. The only solution is to **replace all the LVDTs with ceramic or Peek ones.**

Of course the creep observed in certain channels is only the upper limit of the real creep, because creep and LVDT shrinkage add up with the same sign.

This is the second fix to be applied to the totem system.
