Items culled from elog on the 6/28/02 suspension wire breakage incident/
AJW, 8/28/02

Suspension Wire Broken on 2k MMT2

EVENTS LEADING UP TO THE FAILURE OF THE 2K MMT2
SUSPENSION
and some wild speculations

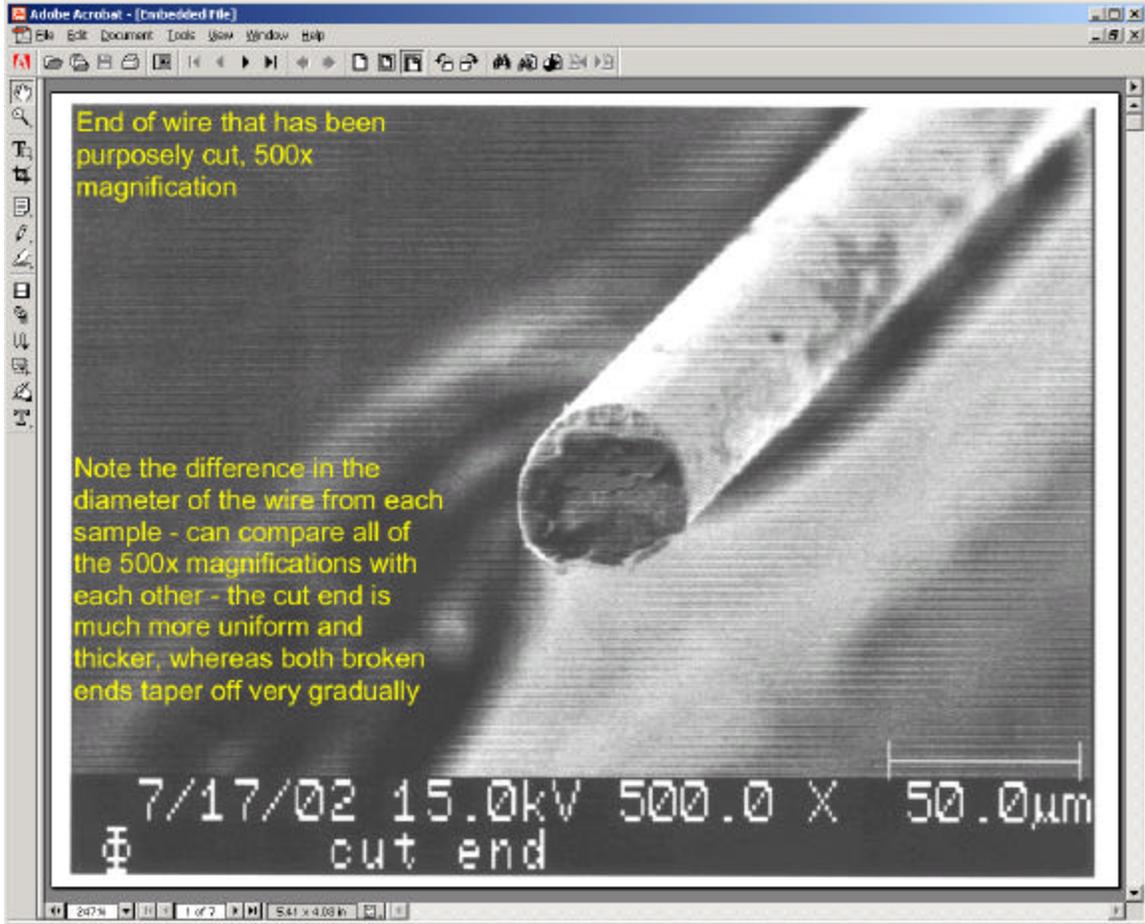
SCANNING ELECTRON
MICROSCOPE PICTURES OF
BROKEN WIRE FROM SM2

Attached is an unfortunately large
(7MB) pdf file of SEM pictures of the
broken wire at both ends as well as
reference wires that were broken
by cutting and by tension at room
temperature in air. We are indebted to
Libby Shaw MIT Surface Laboratory
Megan Goldman MIT Undergraduate
Research Student in Physics
Marie Woods MIT/LIGO Group
administrative assistant
for these pictures. To me it is clear that
the SM2 wire was actually
heated.

Note typo; the broken wire is from
MMT2.
