LIGO-T1200266-v3

May 21, 2012

Ground Loop Hunting on HXTS Suspensions at LLO

Kate Gushwa
Nichole Washington

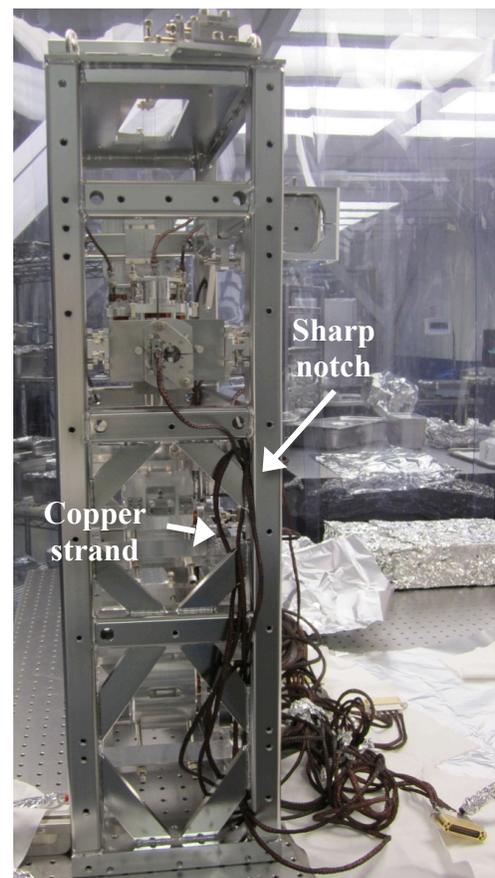
Figure 1. MC3 Left Side (+Y)

until the connection between the backshell and suspension was broken. On the Left Side (+Y) of the suspension, near the third gusset on the right leg, a stray strand of copper was found sticking through the PEEK overbraid. The initial placement of the quadrapuss made it impossible to see the protruding hair, which was sandwiched between the cable and the structure. Pulling the quadrapuss leg away from the suspension, and turning it slowly against a light backdrop (glove or wipe) made the tiny and highly reflective copper strand easier to find.

The strand was snipped, but grounding continued. Wiggling the top cable near where the copper strand was found would start and stop grounding of the cable to the suspension. The movement would pull the cable into and out of a notch on the Left Side (+Y) where the top right gusset and suspension leg meet. All cables were pulled away from that sharp notch.

When grounding had been corrected, cables were gently pulled and prodded to induce a ground loop. Moving the cables around emphasized flaws in the top shared quadrapuss. Stray copper hairs were snipped, and protruding loops of copper were gently pushed under the PEEK overbraid with tweezers. Even when pressed against the edge of a gusset with more force than they should normally encounter during routing, the quadrapusses did not ground to the structure. However, the top cable frequently wedged back into the problematic notch when handled. As an experiment, a strip of aluminum was molded over that notch to prevent contact with the cable's copper shield. The quadrapuss could not be grounded to the structure while the strip was in place. This was captured in a video, [LIGO-T1200216](#).

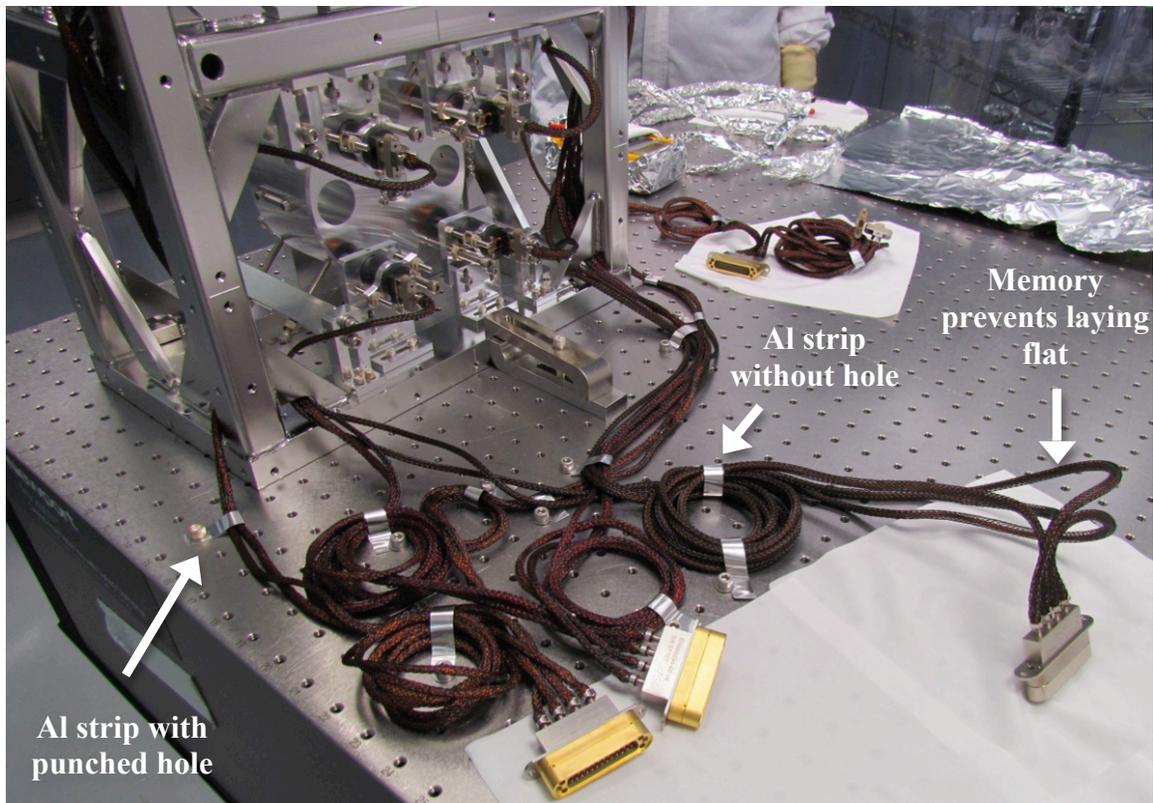
Figure 9. MC3's quadrapusses routed on table

Routing cables along the table, especially the bundling of excess length near the cable brackets, was thought to be partially to blame for ground loops. After identifying and correcting the causes of shield shorts in the lacing up MC3, the in-chamber routing along the table was simulated. Aluminum strips were tried out for the first time as a replacement for PEEK clamps. The strips can be circled around cables and fastened to the table by using a screw in pre-cut holes. The available strips were not pre-cut, and the hole-punch only worked on one strip before failing. As a temporary fix, the edges of the strips were held down with washers and screws. The issues with the hole punch have since been resolved.

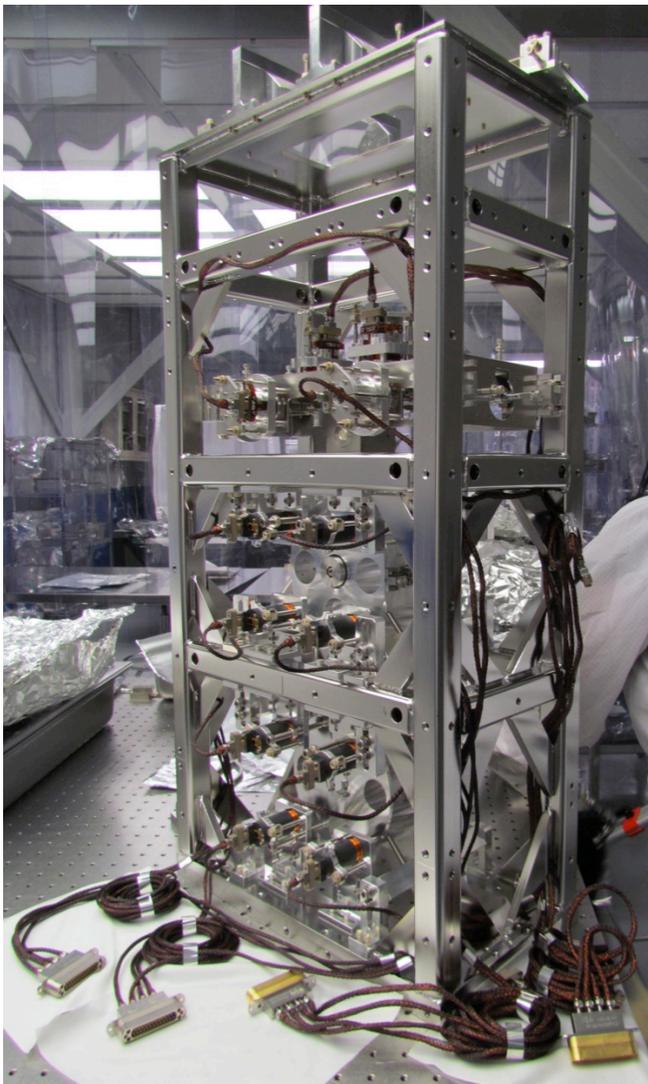
Figure 10. SR2 AR Side/Back (-X) – Right (-Y)

The estimated required length was 60" for the bottom, intermediate, and top shared cables. There were none on site, so 55" and 66" quadrapusses were used instead. The 55" bottom and intermediate cables had hairy snouts and loose double band-its. Due to time constraints and limited cable inventory, these issues were not corrected. The cables need to be refurbished or replaced.

The top quadrapuss was routed last, and was the only cable to cause ground loops. Many stray hairs and tiny copper loops were found protruding through the PEEK overbraid. The copper shield on the top quadrapuss was very loose, and had a "spiderwebby" appearance when held up to a light. Those copper loops poked into other quadrapuss legs, creating shield-to-shield contact between multiple

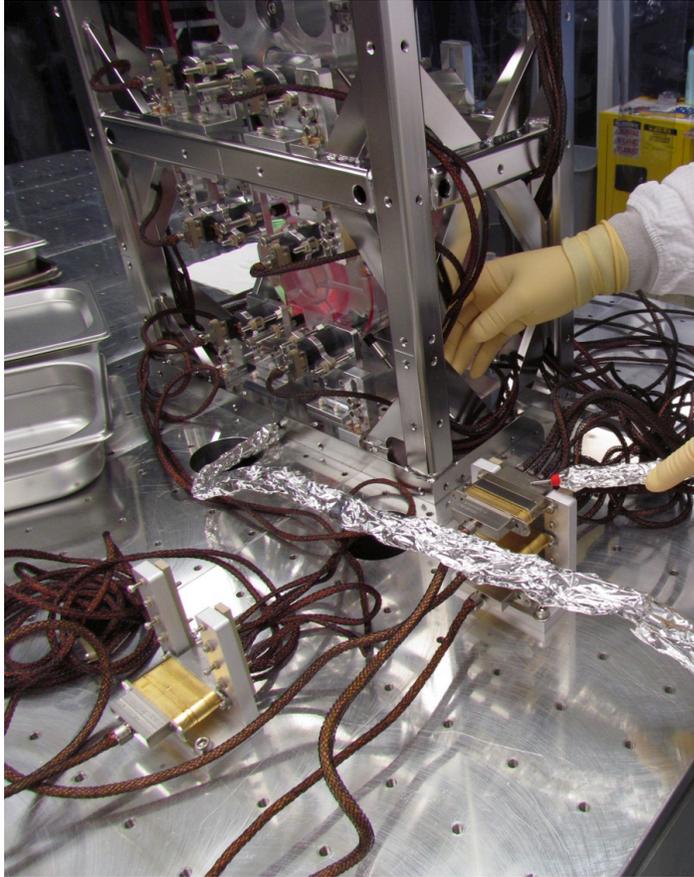
Figure 14. Ground loop hunting on MC1

The lacing up MC1 had noticeably loosened, and the cables on the table were a jumbled mess. The SRS D1000225 cables had shrunken PEEK overbraid, gaps in copper shielding, and visible Kapton wires. There was concern these attributes might lead to grounding or shorting. The SRS cables plug into a fake vacuum feedthrough bolted to the table in the chamber-side testing area. While plugged in, the cables were grounded. One SRS cable was disconnected at a time, and its J1 connector (to the flange) was laid on a cleanroom wipe. The quadrapuss and SRS cables were allowed to rest

The bottom chain, the first to be tested, was grounded. When the SRS cable was lifted off the table, preventing it from coming in contact with everything except the quadrapuss DB25 connector, grounding continued. The quadrapuss was then lifted off the table, and grounding continued. Starting at the entry gusset, the quadrapuss legs were prodded and wiggled. The cause of the shield short was traced back to the bottom gussets on the Right Side (-Y). The quadrapuss took an S-shaped path between those two gussets, and easily lodged into their notches when pulled. Nudging a quadrapuss leg away from the notches stopped grounding.

Repositioning the bottom SRS and quadrapuss cables, or pushing them against the table did not create a ground loop. However, pressing them into the sharp edge of a dog clamp, AOSEM Alignment Assembly ([LIGO-D0902208](#)), or Barrel EQ Stop Assembly ([LIGO-D0902201](#)) did cause grounding. The intermediate and top shared quadrapusses were not grounded, but would be if their legs became wedged into certain notches. The top cable was not grounded either, and a ground loop was difficult to force in the routing up the suspension. The first few inches of the top cable routing along the table did ground when pressed down. This area should be re-checked before MC1 is moved into HAM2.

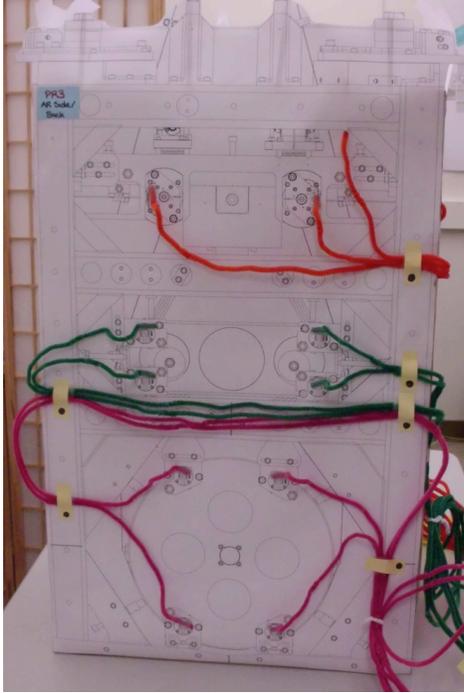
Figure 18. Quadrapusses routed externally on PR3 “dollhouse”

Figure 18 shows the model for the intended external cable routing for PR3. The memory of the quadrapusses used for PR3 was difficult to work with, and might have caused cables to curl into the path of the laser beam. A combination of lacing and routing along the outside of the structure was used to compensate for memory, as shown in Figure 19. PR3 was the only HLTS inspected for ground loops at Livingston, and the only triple suspension with a mix of the two routing methods.

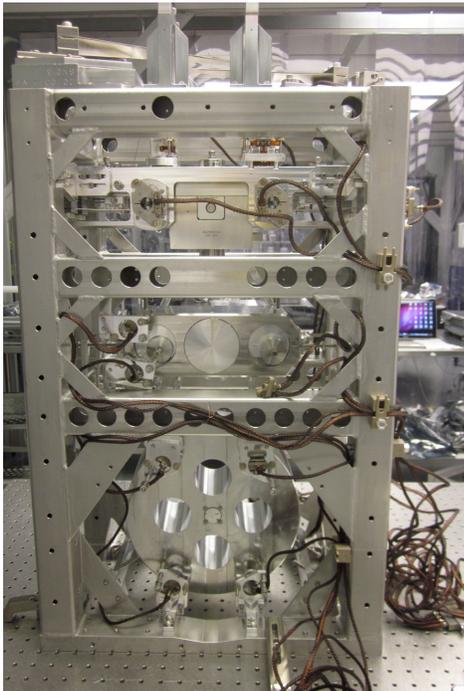
Figure 19. PR3 Back (+X) in LBR

None of PR3’s cables were initially grounded. It was difficult to force grounding because the structure did not have any sharp gusset notches like the HSTS’s. Also, the quality of the quadrapusses was fairly good, aside from the memory. Just like MC1, the quadrapuss overbraids were flexible and loose, and few copper hairs were found.

The cables were loosely guided, not crushed, by PEEK cable clamps ([LIGO-D0900004](#)). When two clamp pieces were pushed closer together, the quadrapuss legs between them were squished into each other and became grounded to the structure. A small hair jutting away from the copper braid did not poke through the PEEK overbraid and make contact with the suspension until the cable was clamped too tightly. Shield-to-shield contact between two quadrapusses occurred when their legs were held with a single tight clamp.
